**HISTORIC AND DESIGN REVIEW**  
**COMPLIANCE AND TECHNICAL ADVISORY BOARD**  
**June 21, 2024**

**HDRC CASE NO:** 2024-152  
**ADDRESS:** 250 QUENTIN DR  
**LEGAL DESCRIPTION:** NCB 6708 BLK 18 LOT 21  
**ZONING:** R-6, H  
**CITY COUNCIL DIST.:** 7  
**DISTRICT:** Monticello Park Historic District  
**APPLICANT:** Maziyar Entezami/ENTEZAMI MAZIYAR  
**OWNER:** Maziyar Entezami/ENTEZAMI MAZIYAR  
**TYPE OF WORK:** Roof reconstruction and modifications, exterior modifications, fencing  
**APPLICATION RECEIVED:** March 29, 2024  
**60-DAY REVIEW:** May 28, 2024  
**CASE MANAGER:** Edward Hall

1. Reconstruct the fire damaged roof structure to feature a modified roof pitch and an increased ridge height over an existing side addition. The applicant has not proposed to reconstruct the previously existing chimney.
2. Modify the façade materials by installing black stucco and wood siding with a natural finish.
3. Modify the façade of the existing, side addition by installing a front facing garage door, a recessed balcony, wood siding and a fifth column. The proposed side addition's mass will be extended forward to align with the primary façade of the historic structure.
4. Install both

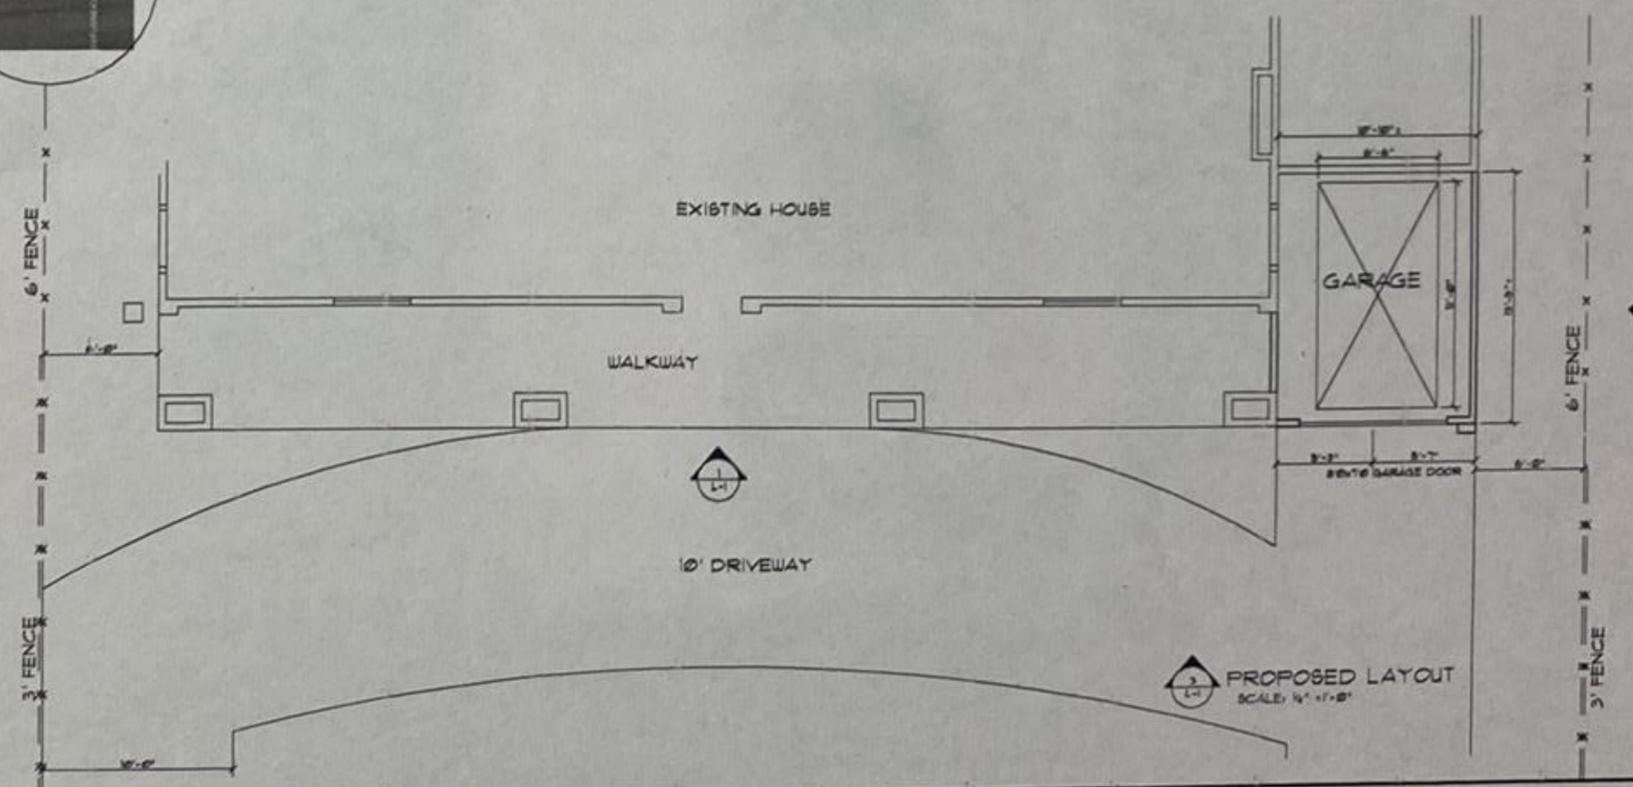
PROPOSED LAYOUT  
SCALE: 1/4" = 1'-0"

HOUSE LAYOUT FOR  
REMODEL  
2500 GLENN DRIVE  
DALLAS, TEXAS 75229

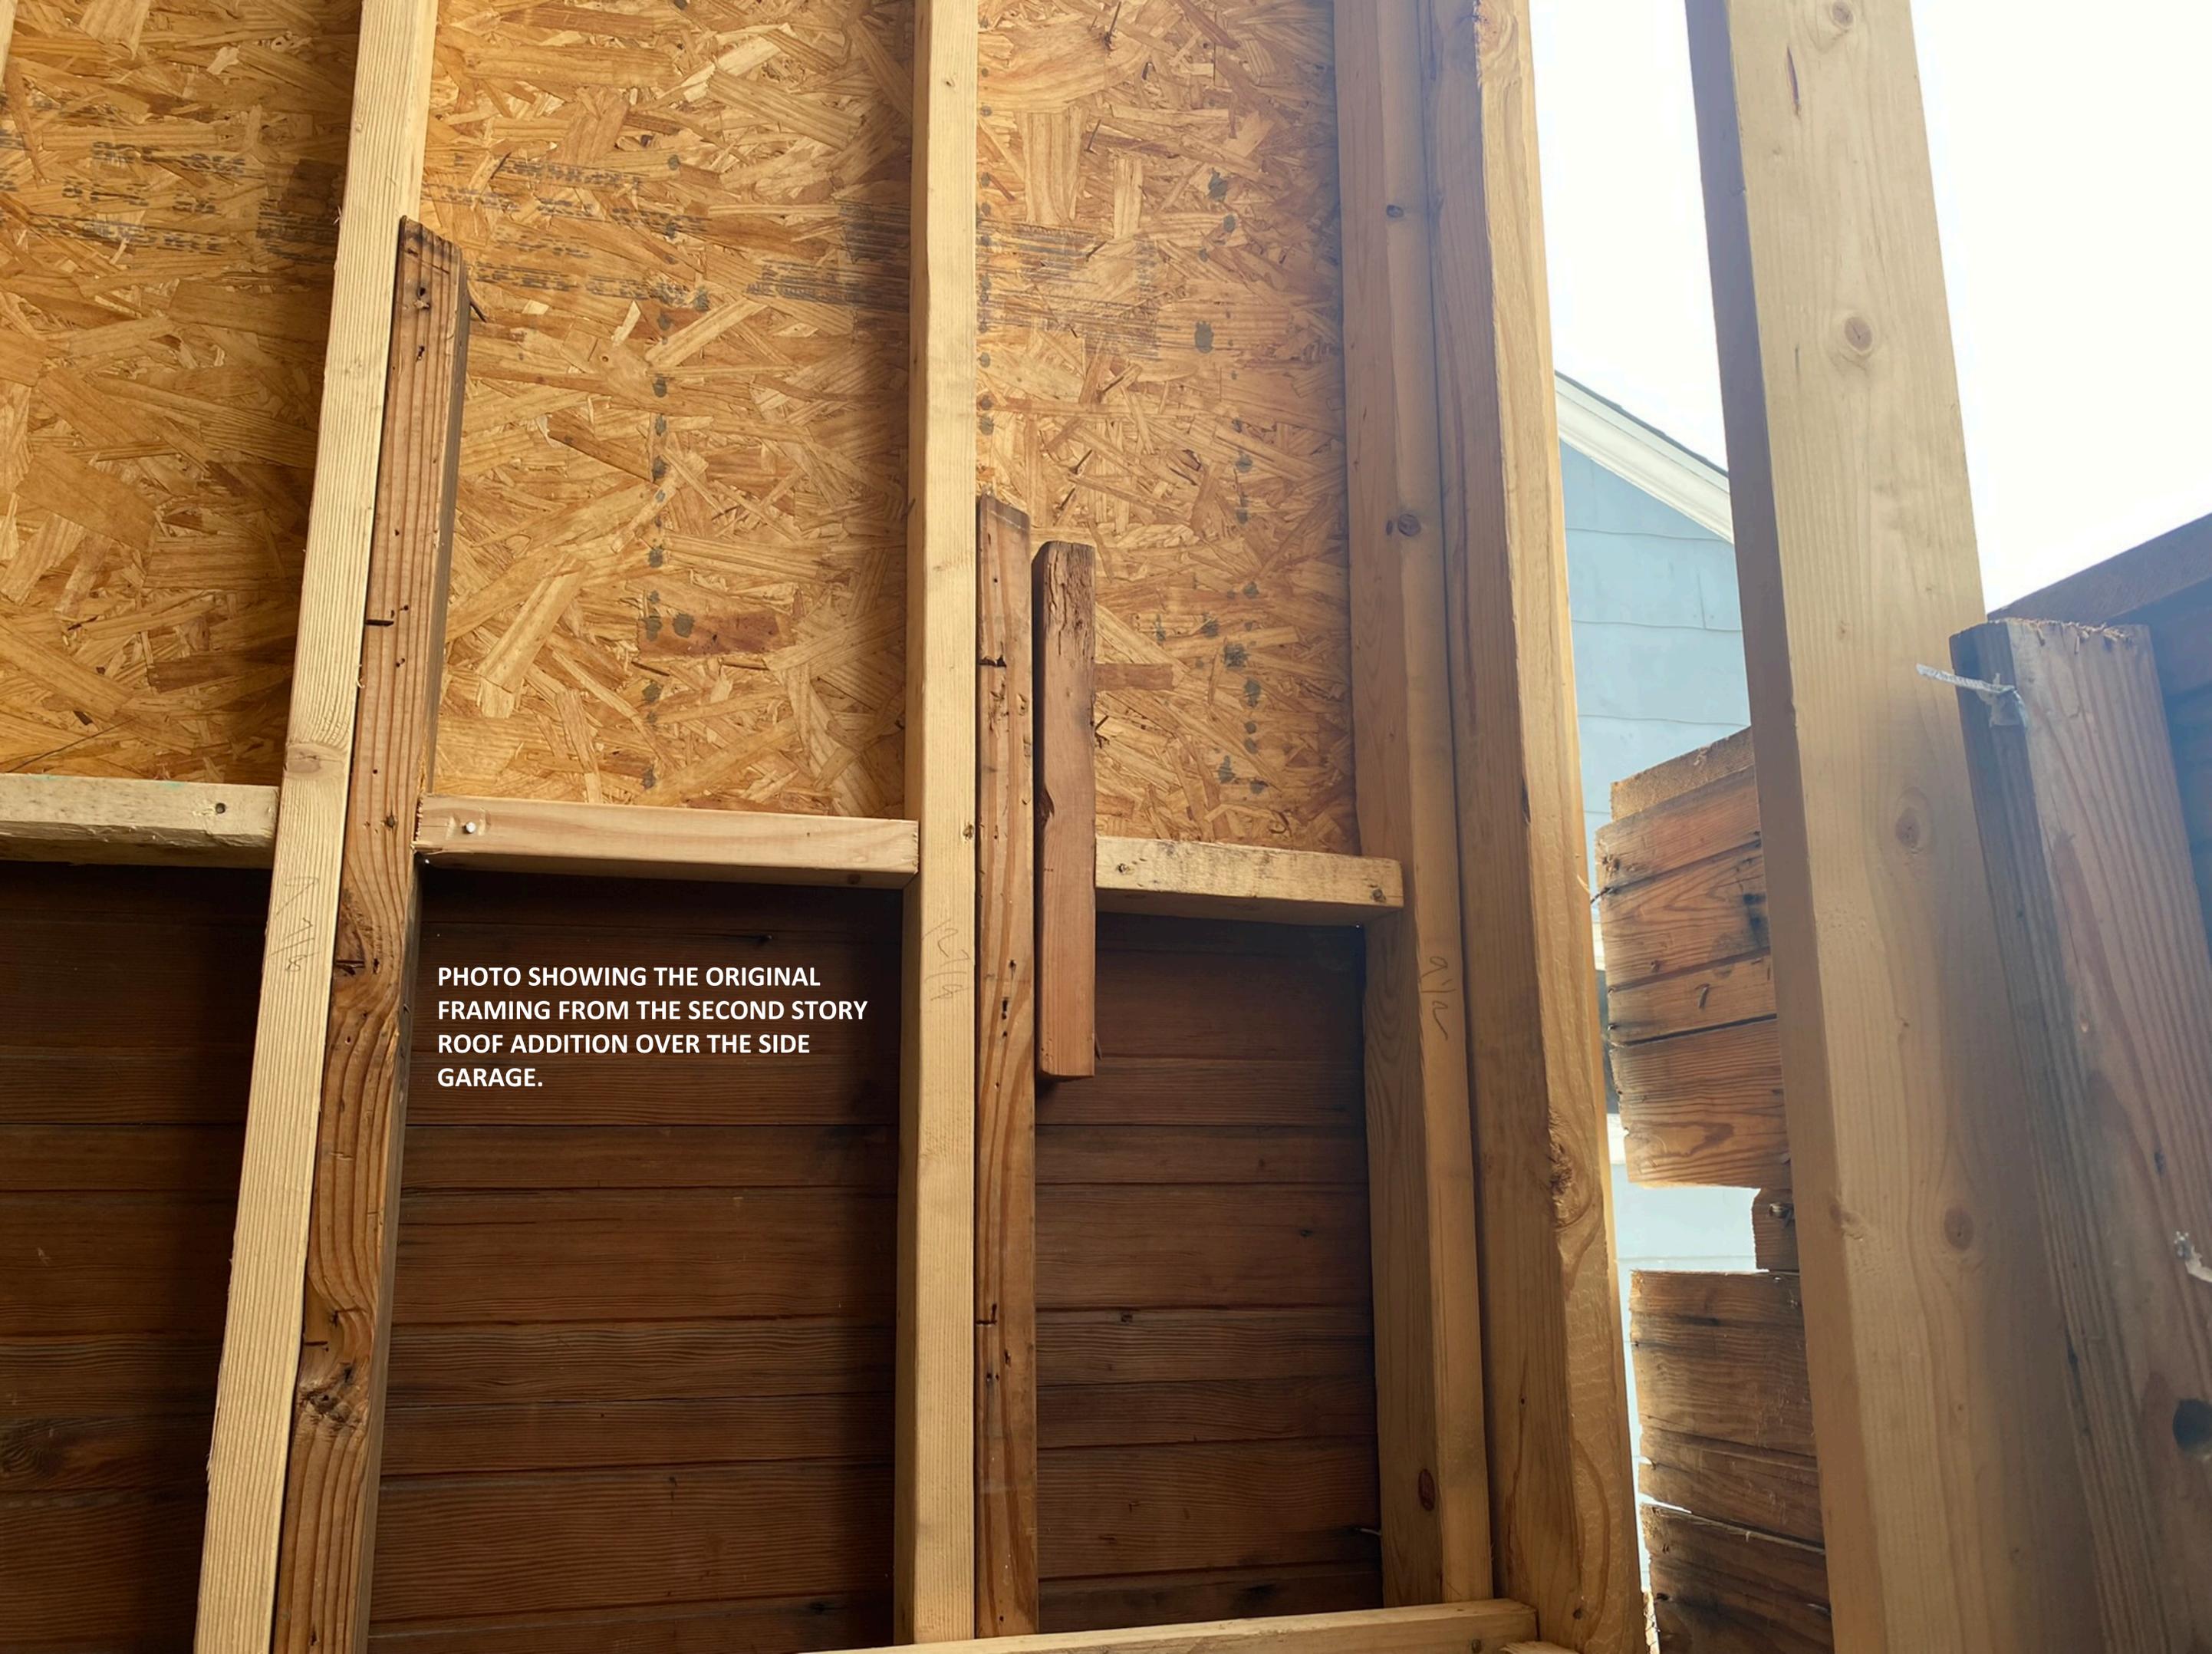
The image shows the interior of a wooden roof structure. The upper portion is covered with oriented strand board (OSB) sheathing. Below the sheathing, several vertical wooden studs are visible, with handwritten markings '2x10' on them. A horizontal wooden beam runs across the middle. To the right, there is a gap in the structure, revealing a blue exterior wall and a wooden fence. The lower portion of the image shows horizontal wooden planks, likely the garage floor or another level of the structure.

PHOTO SHOWING THE ORIGINAL  
FRAMING FROM THE SECOND STORY  
ROOF ADDITION OVER THE SIDE  
GARAGE.

- e. ROOF RECONSTRUCTION – The applicant has proposed to reconstruct the fire damaged roof structure to feature a modified roof pitch and an increased ridge height over an existing side addition. The applicant has not proposed to reconstruct the previously existing chimney. The previously constructed roof featured modifications from the original profile and a modified ridge height. Generally, staff finds the construction of one, centered ridge line to be appropriate; however, staff finds that the side addition should maintain a subordinate ridge height, as was previously constructed. The Guidelines for Additions notes that the roofs of additions should feature subordinate ridge heights.

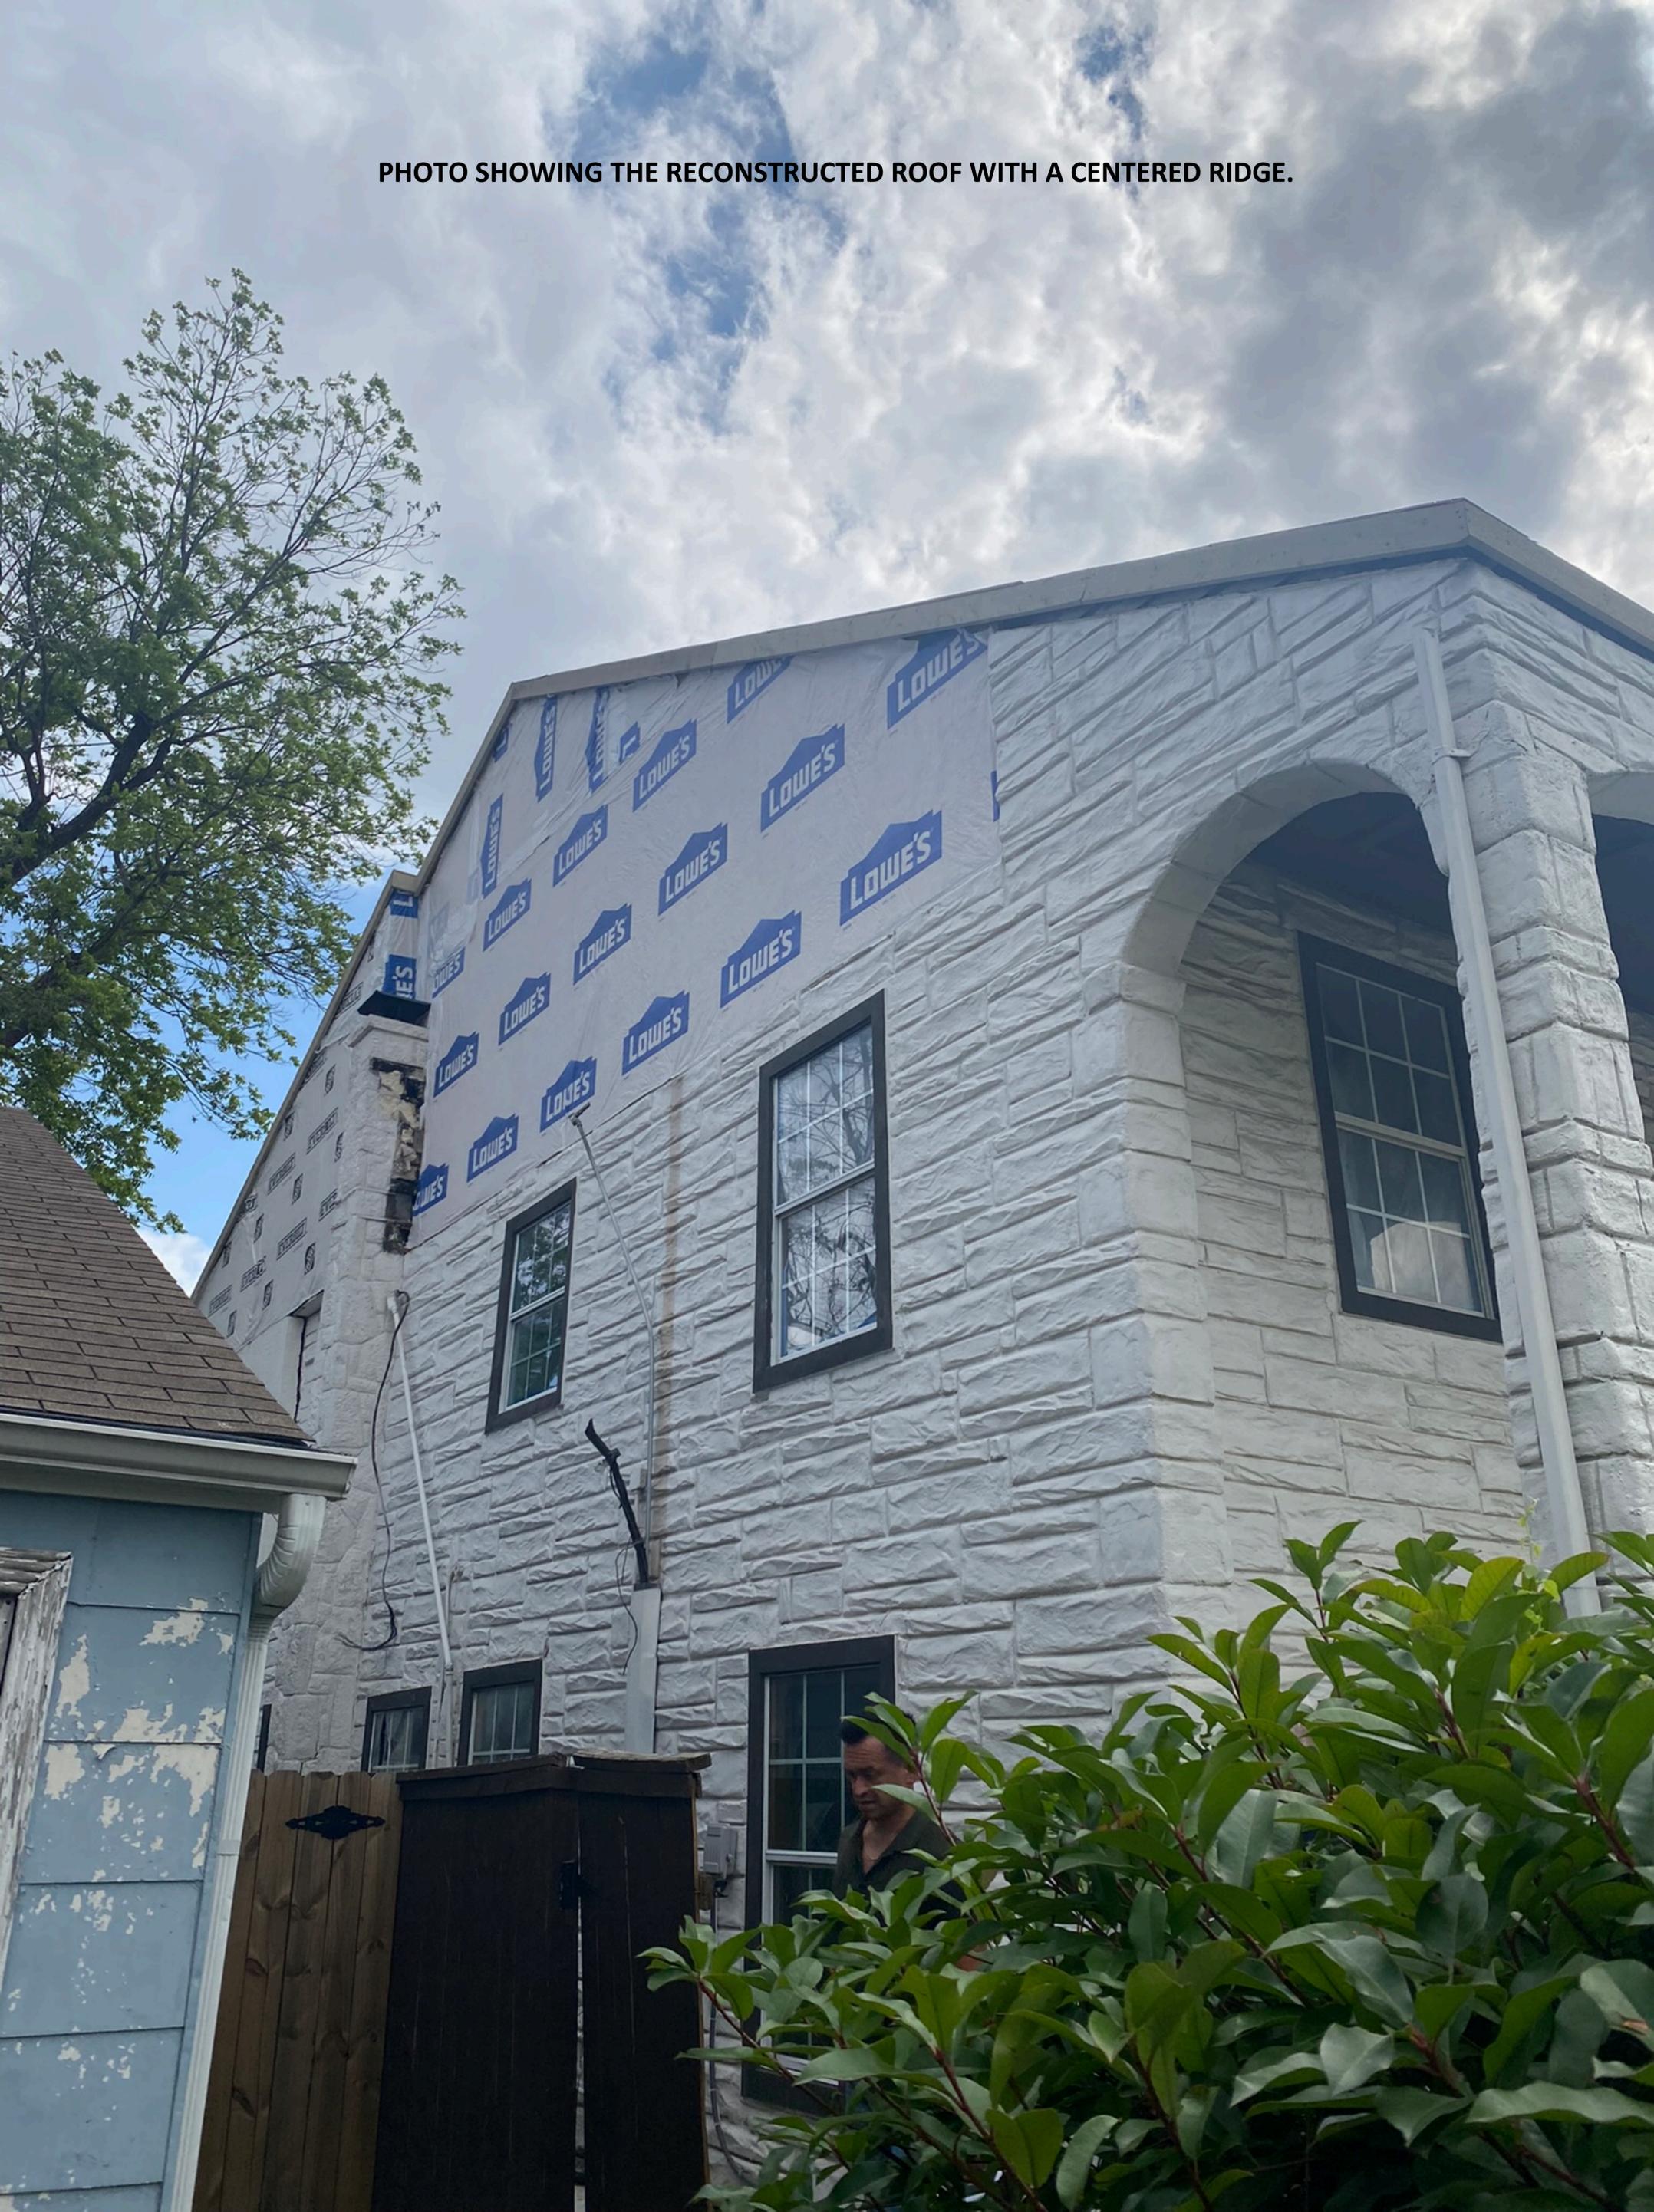
PHOTO SHOWING THE RECONSTRUCTED ROOF WITH A CENTERED RIDGE.
