HISTORIC AND DESIGN REVIEW
COMPLIANCE AND TECHNICAL ADVISORY BOARD
July 19, 2024

HDRC CASE NO: 2024-152
ADDRESS: 250 QUENTIN DR
LEGAL DESCRIPTION: NCB 6708 BLK 18 LOT 21
ZONING: R-6, H
CITY COUNCIL DIST.: 7
DISTRICT: Monticello Park Historic District
APPLICANT: Mazyar Entezami/ENTEZAMI MAZIYAR
OWNER: Mazyar Entezami/ENTEZAMI MAZIYAR
TYPE OF WORK: Roof reconstruction and modifications, exterior modifications, fencing
APPLICATION RECEIVED: March 29, 2024
60-DAY REVIEW: May 28, 2024
CASE MANAGER: Edward Hall
REQUEST:

1. Reconstruct the fire damaged roof structure to feature a modified roof pitch and an increased ridge height over an existing side addition. The applicant has not proposed to reconstruct the previously existing chimney.
2. Modify the façade materials by installing black stucco and wood siding with a natural finish.
3. Modify the façade of the existing, side addition by installing a front facing garage door, a recessed balcony, wood siding and a fifth column. The proposed side addition's mass will be extended forward to align with the primary façade of the historic structure.
4. Install both front yard and privacy fencing on site.

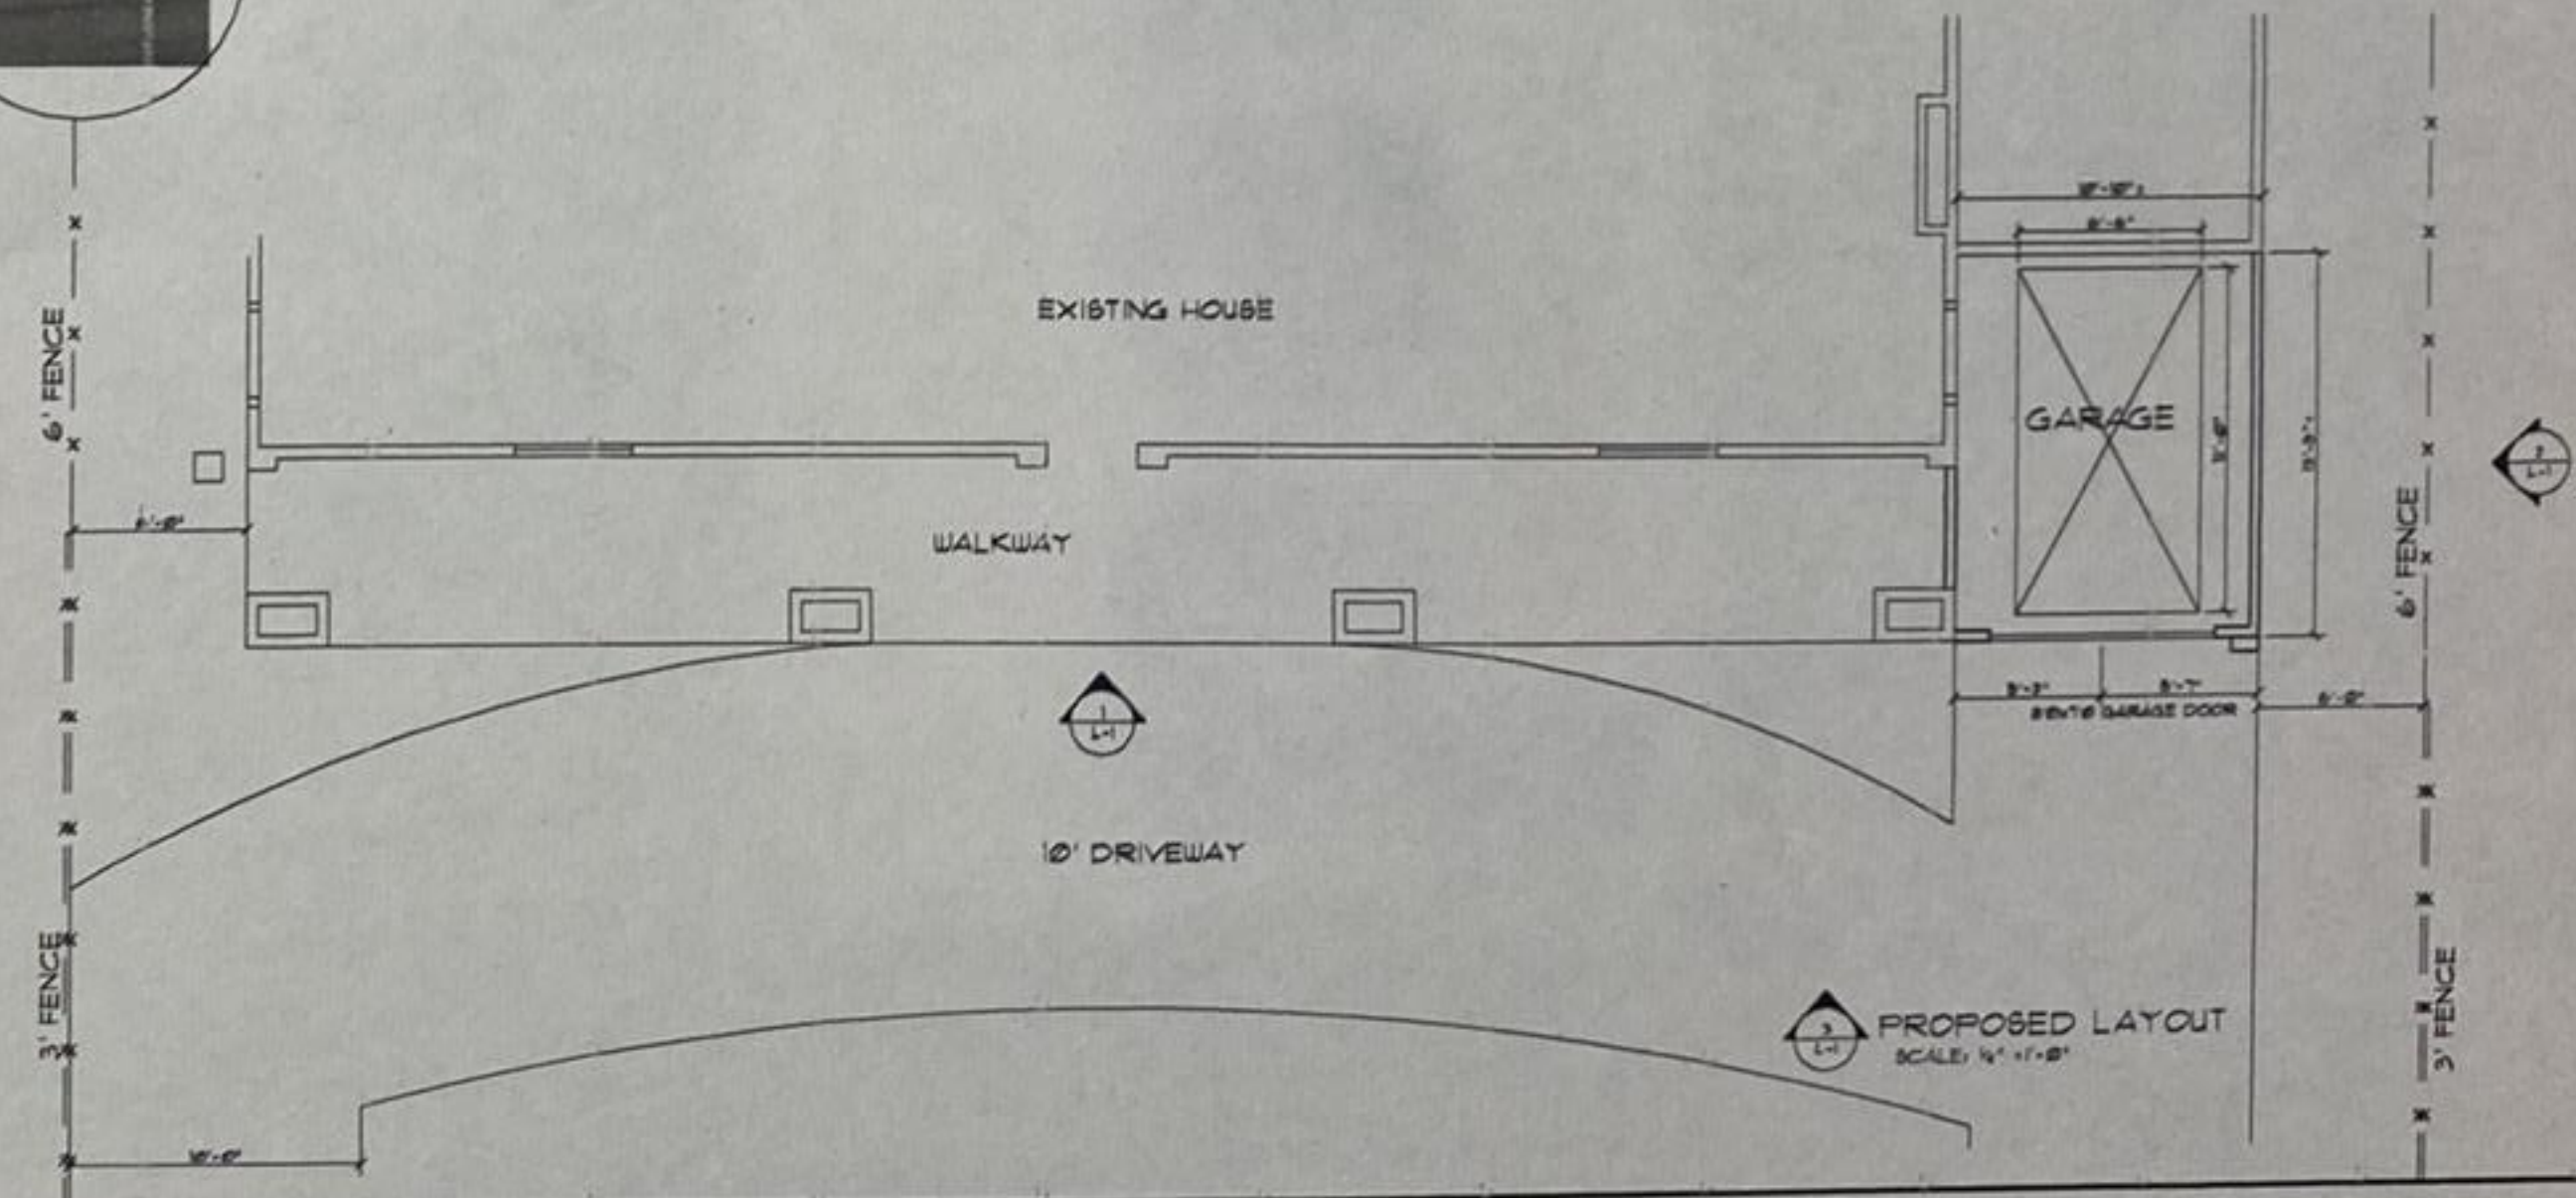
PROPOSED LAYOUT
SCALE: 1/4" = 1'-0"

HOUSE LAYOUT FOR
REMODEL
3500 GLENVIEW DRIVE
SAN ANTONIO, TEXAS 78218
