HISTORIC AND DESIGN REVIEW COMMISSION

HDRC CASE NO: 2024-167
ADDRESS: 1943 W SUMMIT AVE
LEGAL DESCRIPTION: NCB 1941 BLK 29 LOT 11
ZONING: R-6, H
CITY COUNCIL DIST.: 7
DISTRICT: Monticello Park Historic District
APPLICANT: ROBERT SAUCEDO
OWNER: MENG TESSI/MENG TESSIE & HSIN NIEN
TYPE OF WORK: Demolition of the rear accessory structure and new construction of a rear accessory structure
APPLICATION RECEIVED: April 03, 2024
60-DAY REVIEW: June 02, 2024
CASE MANAGER: Rachel Rettaliata

1. Demolish the existing rear accessory structure.
2. Construct a new approximately 405-square-foot, 1-story rear accessory structure.

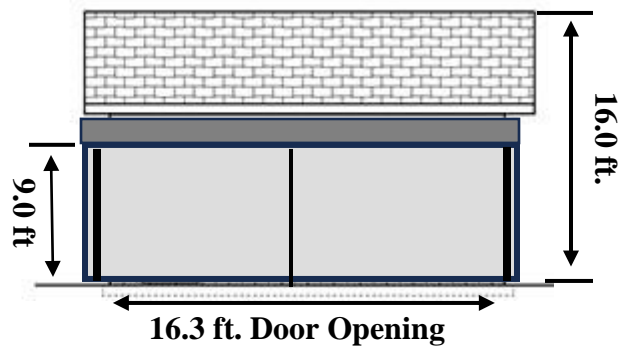
**Front View Facing South.
Two 8 ft. wide x 7 ft. high
classic steel insulated doors**

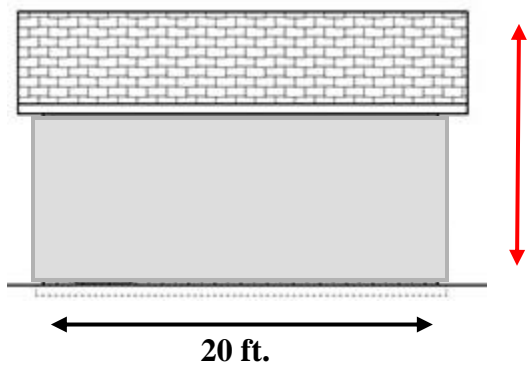
**Rear View facing North to backyard fence.
No Windows on Rear of Structure**

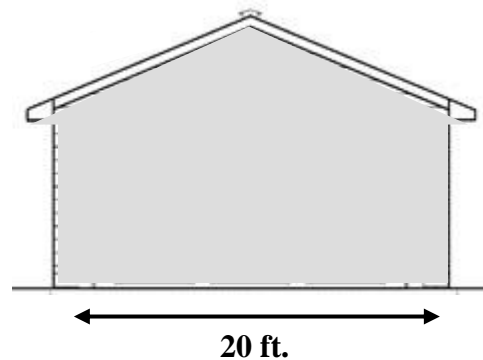
**Side View facing East. No windows
or doors.**

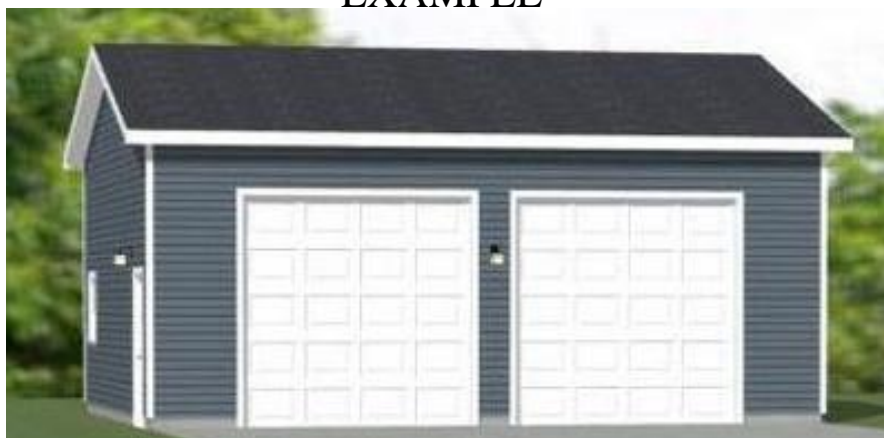
Material: Brown Wood Composite Panel Siding

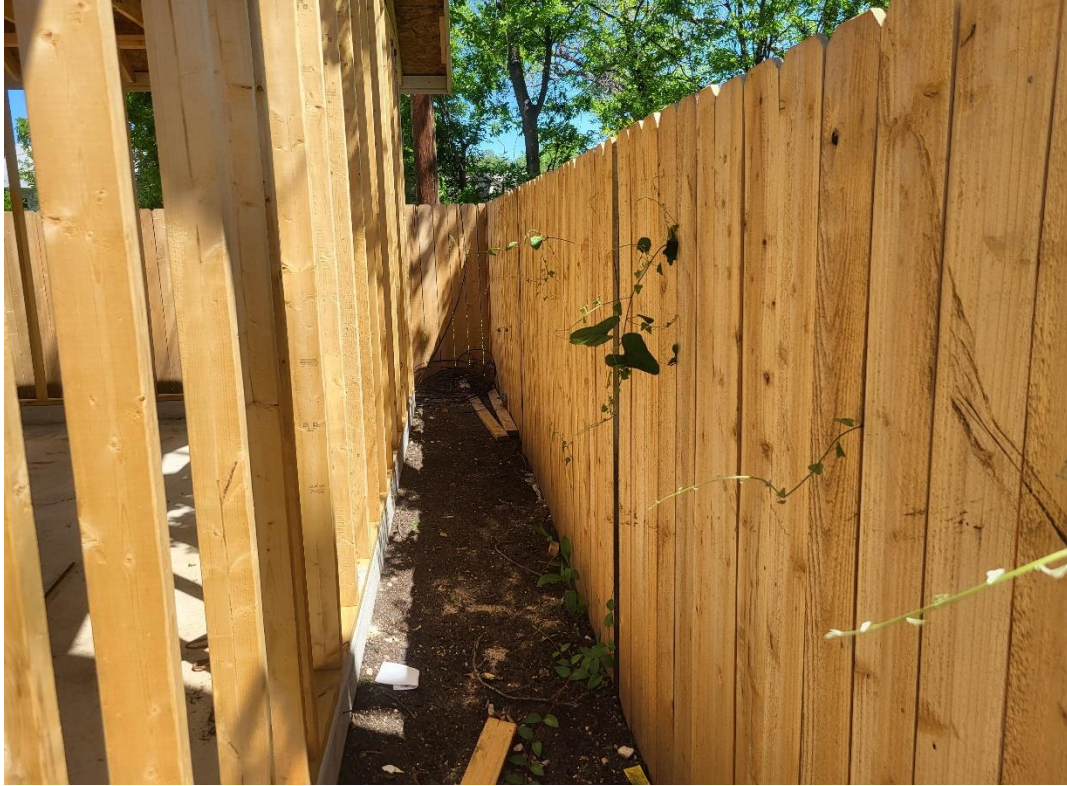
Picture 4

Picture 3 & 4 shows the right side of the yard when viewed from the main house

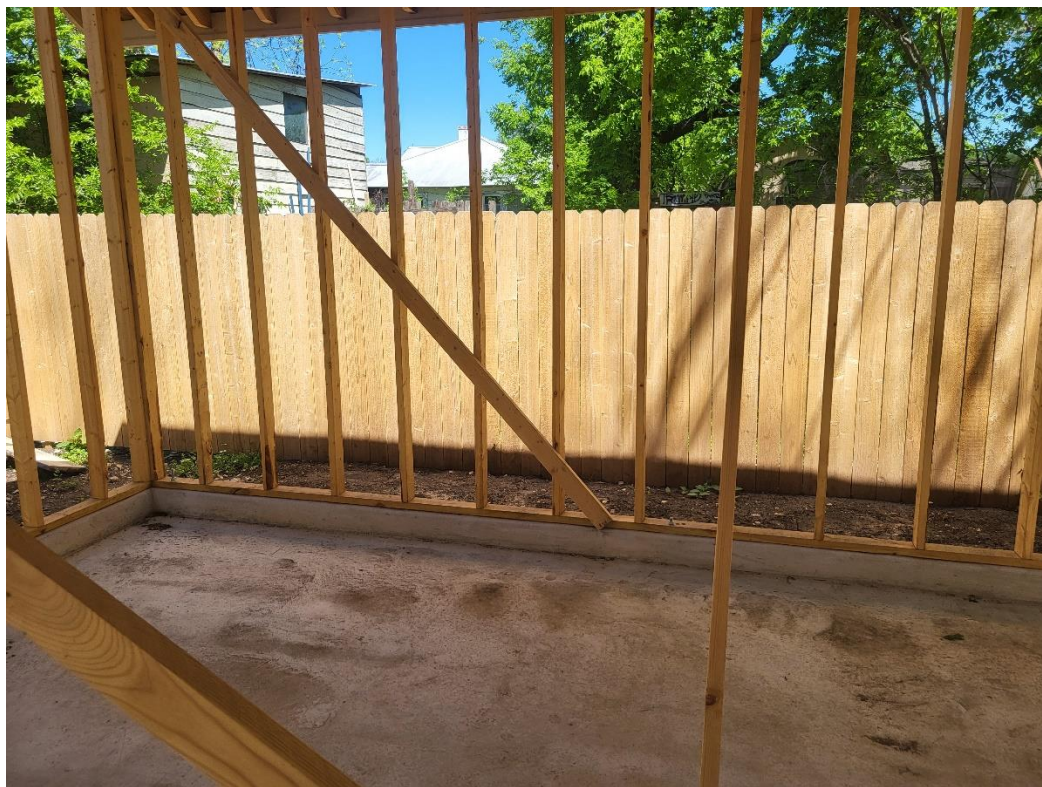
Picture 5 & 6 shows the rear of the fence bordering the alley
