HISTORIC AND DESIGN REVIEW COMMISSION

HDRC CASE NO: 2024-420
ADDRESS: 301 BRAHAN BLVD
LEGAL DESCRIPTION: NCB 3855 BLK 1 LOT 18
ZONING: RM-4 CD, H
CITY COUNCIL DIST.: 2
DISTRICT: Westfort Historic District
APPLICANT: Ben Bowman/Assets and Architects
OWNER: Laura Miller/MILLER LAURA DELAINE
TYPE OF WORK: Exterior Alterations, Fenestration Modifications, Repair and Maintenance
APPLICATION RECEIVED: December 18, 2024
60-DAY REVIEW: February 16, 2025
CASE MANAGER: Caitlin Brown-Clancy
REQUEST:

MILLER HOUSE

The project proposal for 301 Brahan Blvd includes a complete interior remodel in addition to limited exterior repairs and improvements.

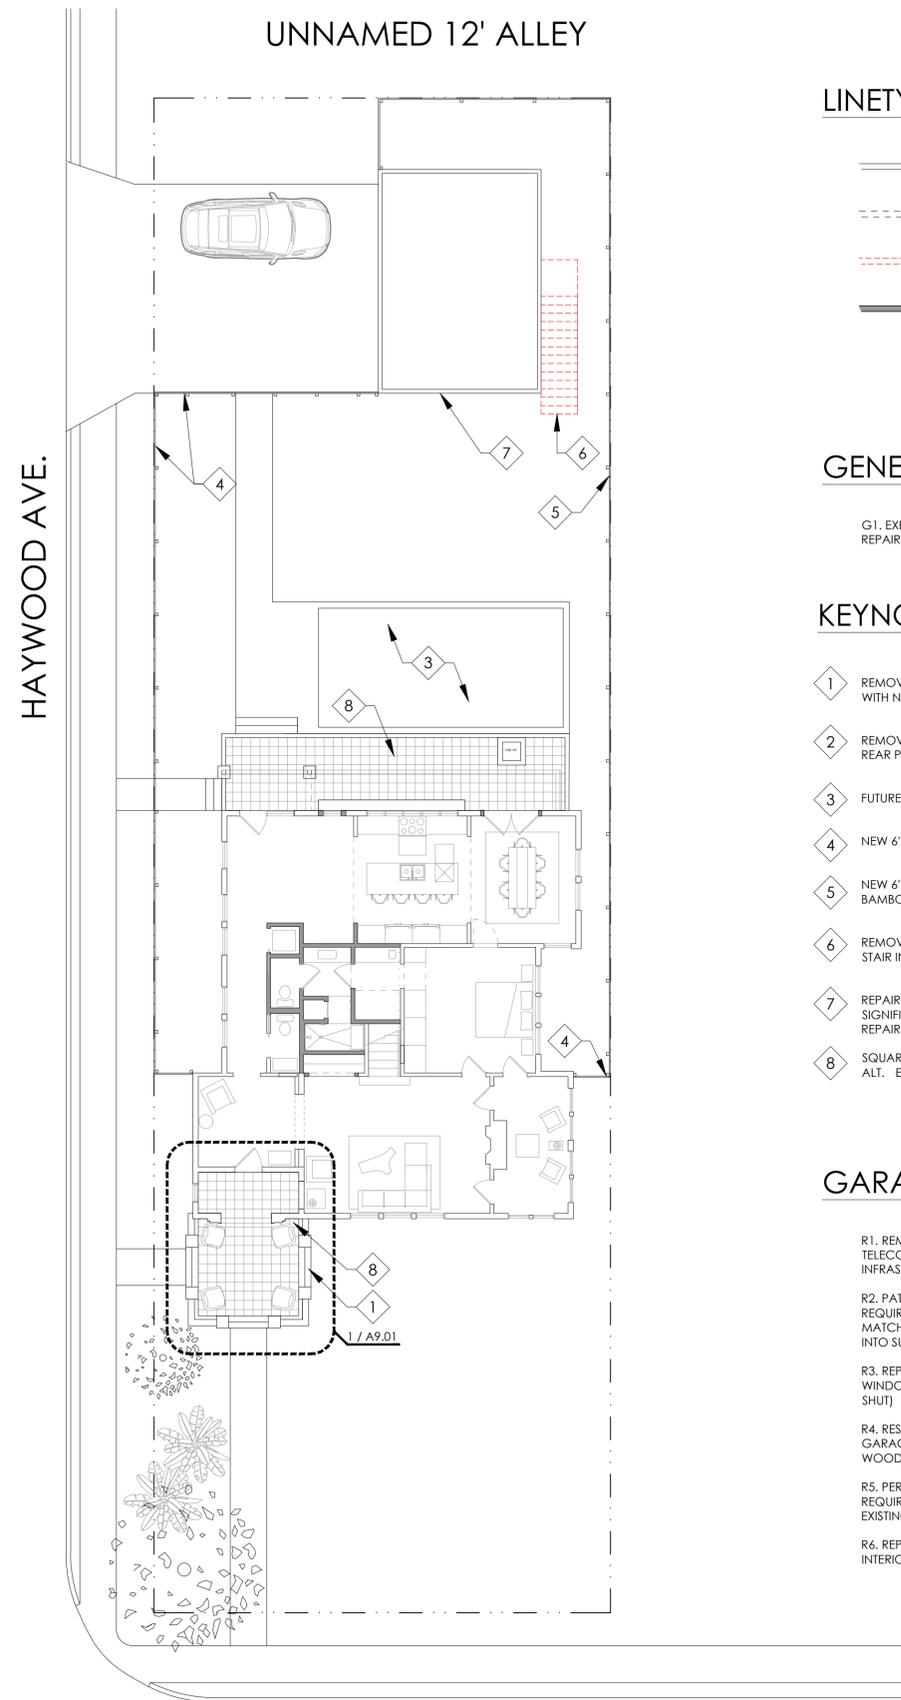
2 PROPOSED SITE PLAN
SCALE: 1" = 10'

- 1 REMOVE EXISTING ENTRYWAY FLATWORK, REPLACE WITH NEW ENTRYWAY PATIO
- 2 REMOVE EXISTING WOOD STAIR, REPLACE WITH NEW REAR PATIO
- 3 FUTURE-PHASE POOL BY OTHERS
- 4 NEW 6' WOOD PRIVACY FENCE
- 5 NEW 6' WOOD PRIVACY FENCE AND CLUMPING BAMBOO PRIVACY PLANTINGS (OR SIM.)
- 6 REMOVE AND REPLACE EXISTING FAILING WOOD STAIR IN KIND
- 7 REPAIR EXISTING 2-STORY GARAGE IN KIND, NO SIGNIFICANT CHANGES TO EXTERIOR. SEE 'GARAGE REPAIR SCOPE' TO FOLLOW.
- 8 SQUARE-EDGE SALTILLO TILE, PATIO SURFACE ALT. ENCAUSTIC TILE

- b. **ENTRANCE** - The applicant has requested to remove the existing flatwork leading up to the front door and replace with a raised patio accessed by stairs on three sides featuring stucco and Saltillo tile. The Guidelines for Exterior Maintenance and Alterations 6.b.ii. states that new entrances should be compatible in size, scale, shape, proportion, material, and massing with historic entrances. Staff finds the design appropriate based on the architectural style and scale of the primary structure. The applicant has also requested to replace the existing front door with a new solid wood door; however, the applicant has not submitted any product specification for the front door. Staff finds the applicant should submit product specifications for review prior to final approval.

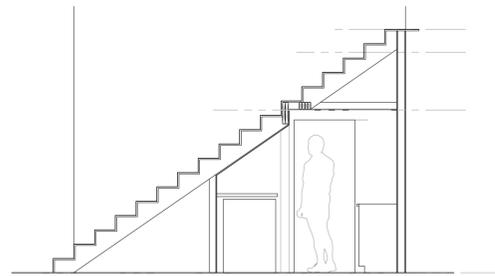
3 STAIR GEOMETRY

16 RISERS @ 7"
15 TREADS @ 11"

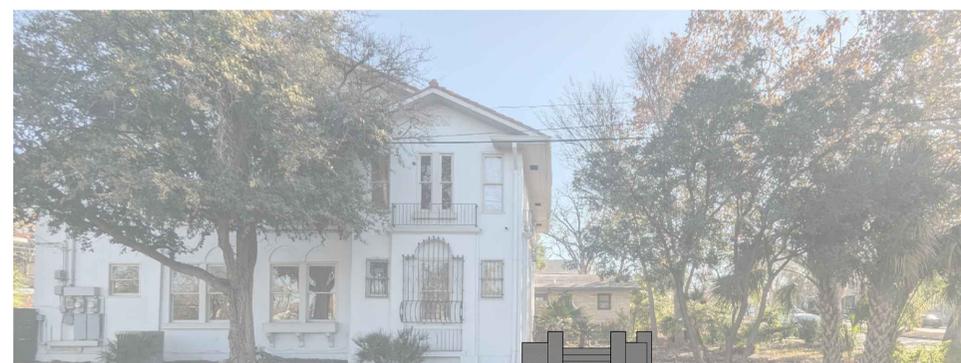
EXTENTS OF PATIO

3 SOUTH ELEVATION REFERENCE
SCALE: NTS

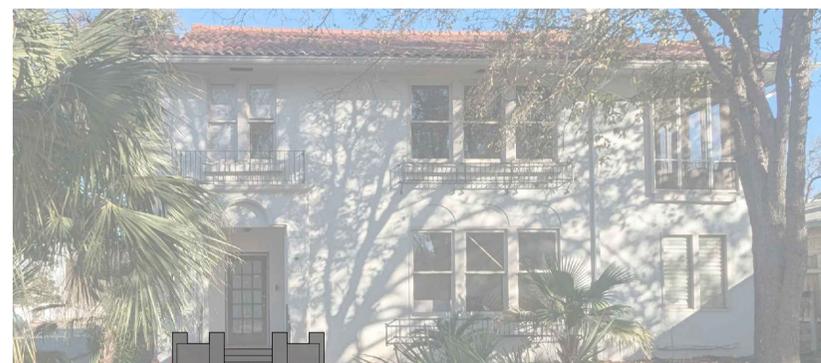
EXTENTS OF PATIO

4 SOUTH ELEVATION REFERENCE
SCALE: NTS

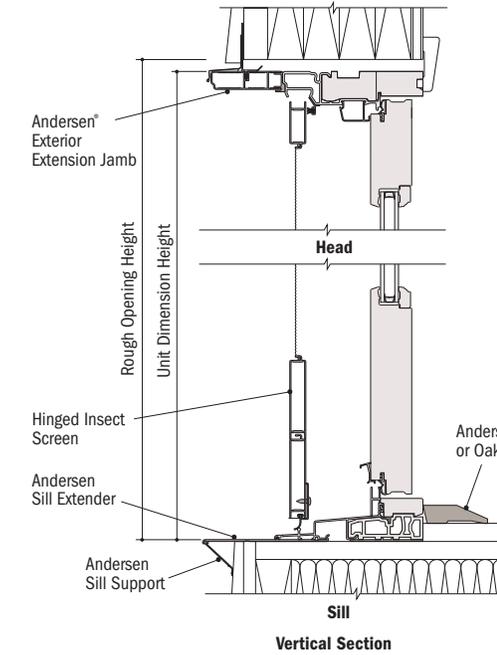
Frenchwood® Hinged Inswing Patio Door Details

Vertical Section

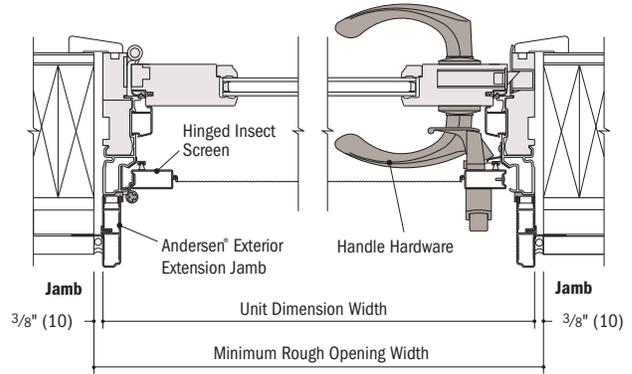
- 4 9/16" (116) overall jamb depth measurement is from back side of installation flange.
- Light-colored areas are parts included with door. Dark-colored areas are additional Andersen® parts required to complete door assembly as shown.
- **Minimum rough openings may need to be increased to allow for use of building wraps, flashing, sill panning, brackets, fasteners or other items.**
- Details are for illustration only and are not intended to represent product installation methods or materials. Refer to product installation guides at andersenwindows.com.
- Dimensions in parentheses are in millimeters.
- Dimension indicates location of astragal centerline.

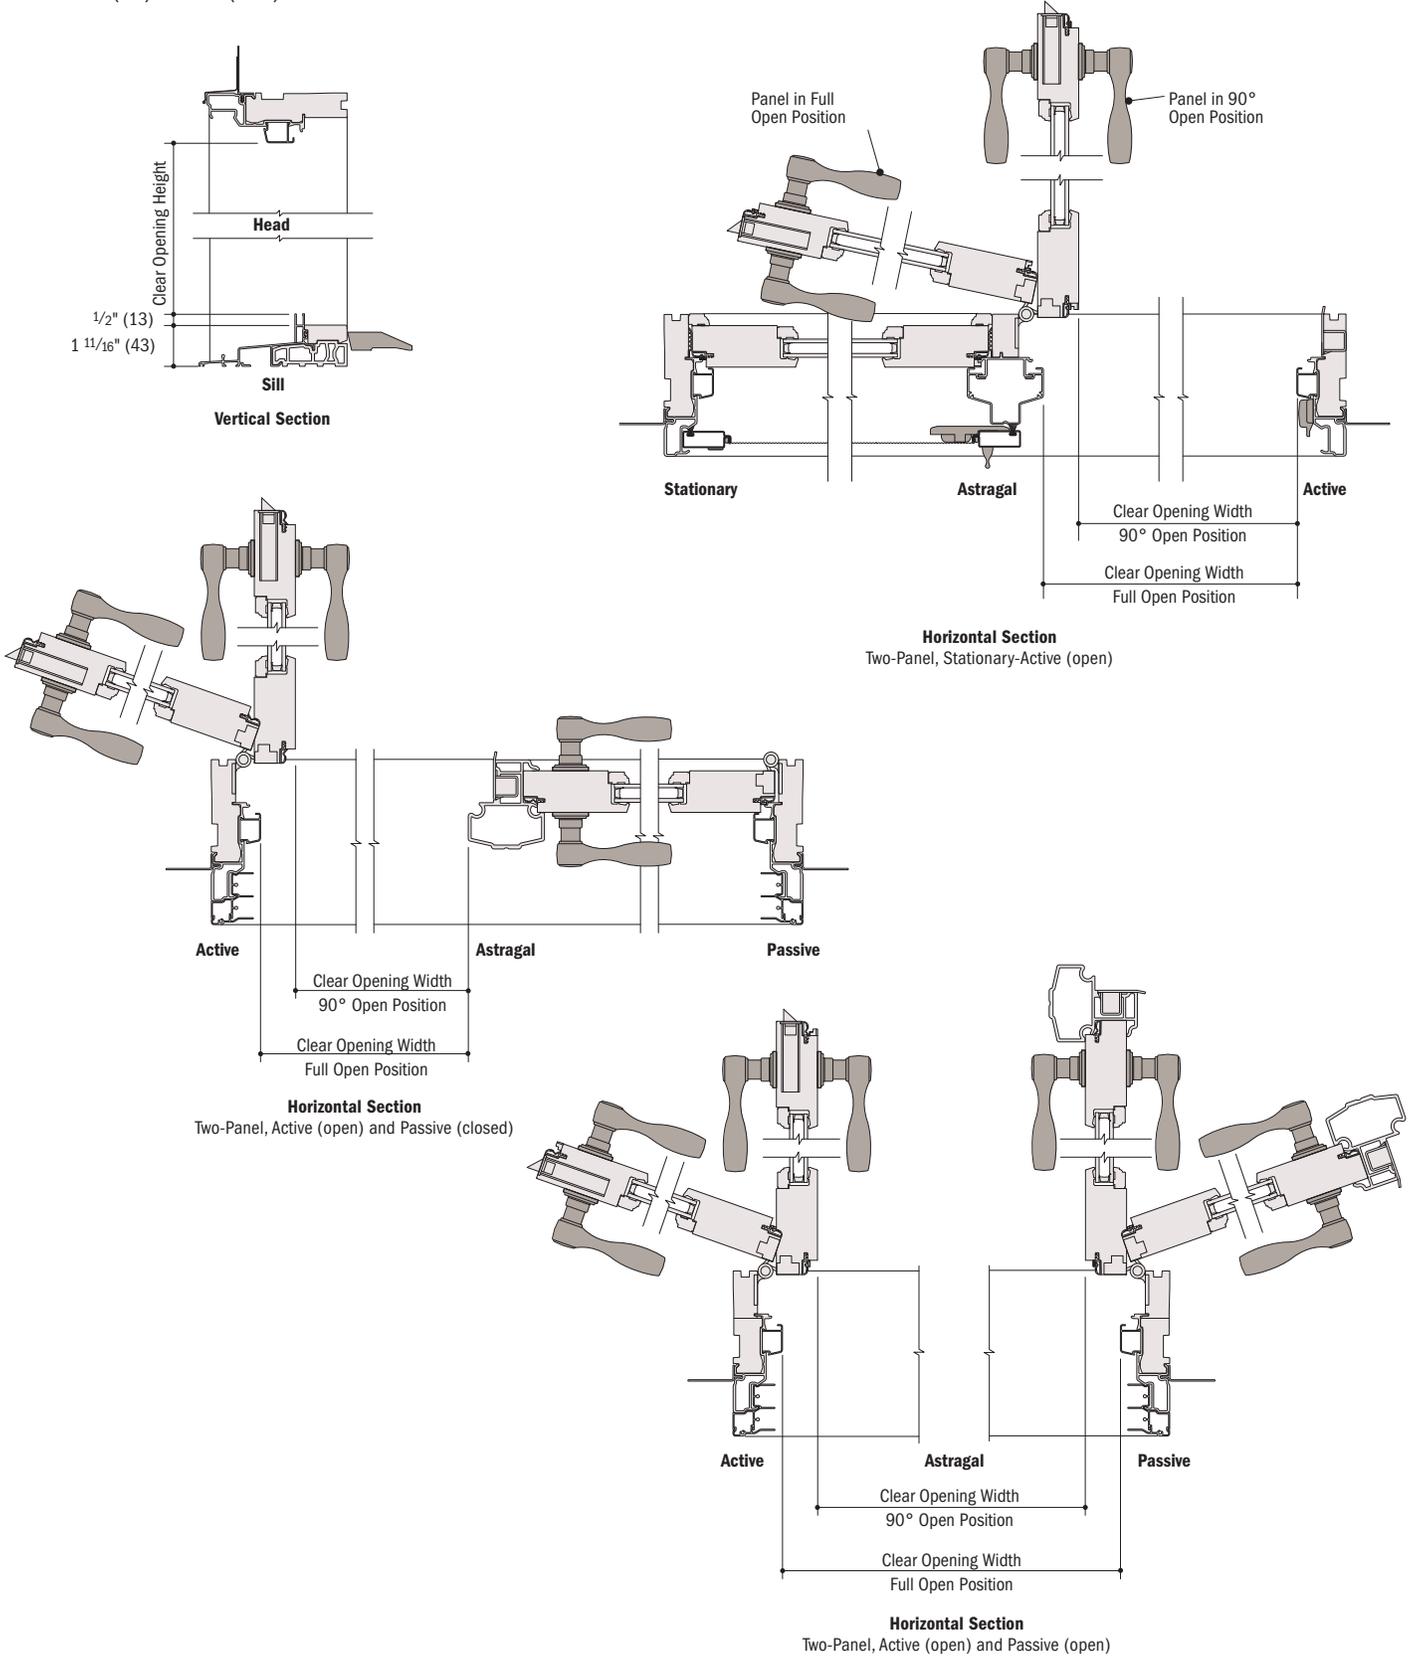
Clear Opening Details

- Light-colored areas are parts included with door. Dark-colored areas are additional Andersen® parts required to complete door assembly as shown.
- **Minimum rough openings may need to be increased to allow for use of building wraps, flashing, sill panning, brackets, fasteners or other items.**
- Details are for illustration only and are not intended to represent product installation methods or materials. Refer to product installation guides at andersenwindows.com.
- Dimensions in parentheses are in millimeters.

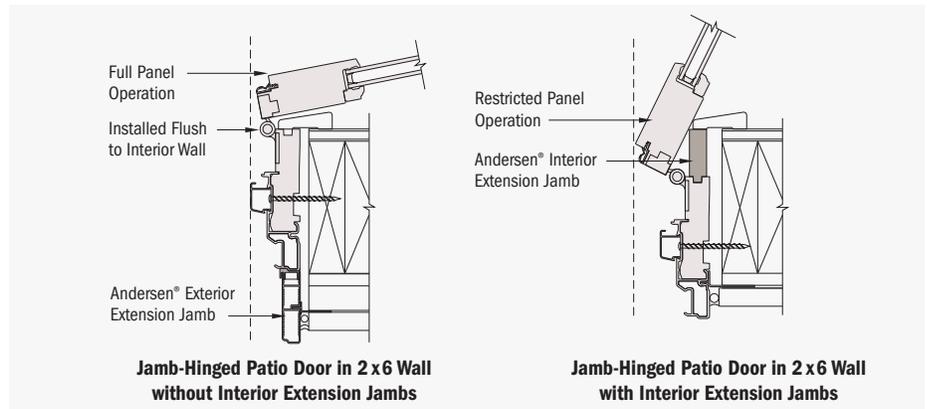
Interior Extension Jambs

Use of interior extension jambs or drywall return will restrict panel operation on jamb-hinged patio doors. Jamb-hinged patio doors must be installed flush to the interior to achieve full panel operation.

* Light-colored areas are parts included with door. Dark-colored areas are additional Andersen® parts required to complete door assembly as shown.

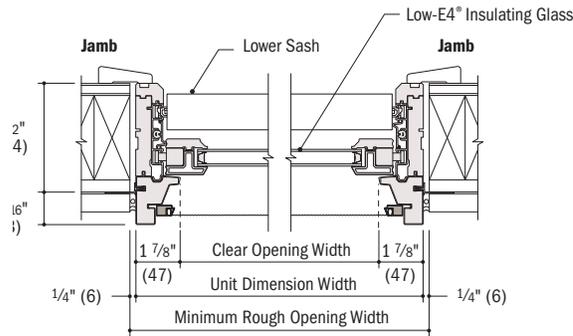
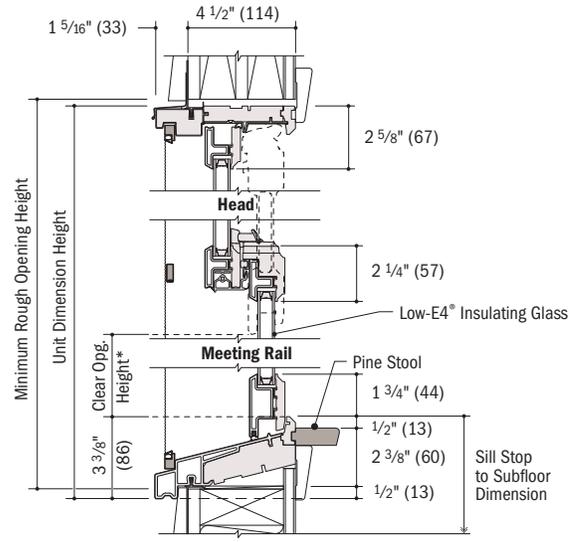
Woodwright® Double-Hung Window Details

Horizontal Section

Vertical Section

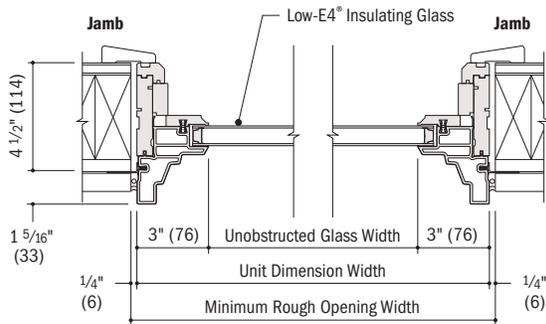
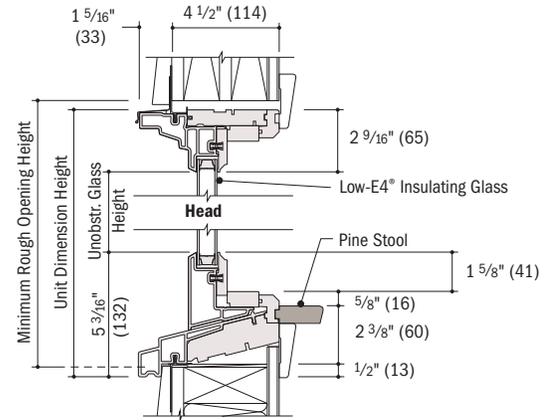
Woodwright® Picture Window Details

Horizontal Section

Vertical Section

* Light-colored areas are parts included with window. Dark-colored areas are additional Andersen® parts required to complete window assembly as shown.

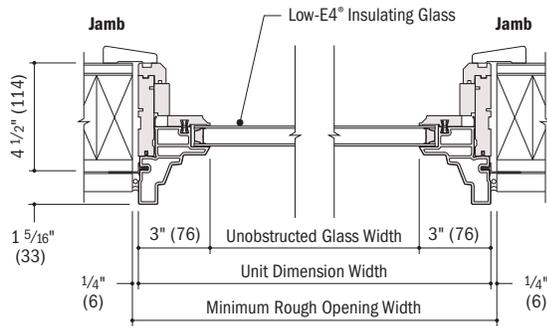
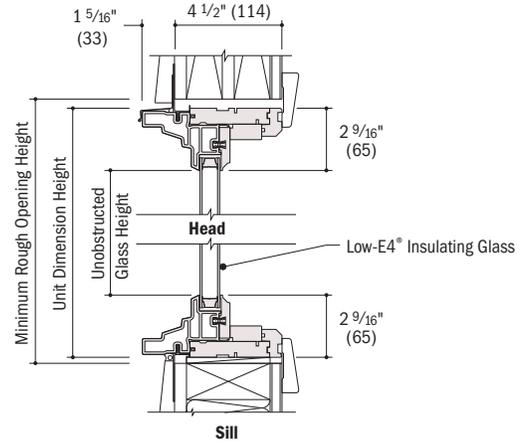
Woodwright® Transom Window Details

Horizontal Section

Vertical Section

- Minimum rough openings may need to be increased to allow for use of building wraps, flashing, sill panning, brackets, fasteners or other items.
- Details are for illustration only and are not intended to represent product installation methods or materials. Refer to product installation guides at andersenwindows.com.
- Dimensions in parentheses are in millimeters.
