HISTORIC AND DESIGN REVIEW COMMISSION

HDRC CASE NO: 2024-271
ADDRESS: 254 E SUMMIT AVE
LEGAL DESCRIPTION: NCB 6885 BLK LOT 6, 7 & W 22.92 FT OF 8
ZONING: R-5, H
CITY COUNCIL DIST.: 1
DISTRICT: Monte Vista Historic District
APPLICANT: Don McDonald/Don b McDonald Architect
OWNER: Patricia Ruiz/NUNEZ-RUIZ ANA PATRICIA & RUIZ-HEALY PATRICIA FERNANDA
TYPE OF WORK: Carport construction
APPLICATION RECEIVED: July 19, 2024
60-DAY REVIEW: September 17, 2024
CASE MANAGER: Claudia Espinosa

The applicant is requesting a Certificate of Appropriateness for approval to install one (1) pergola like carport based on the following two options below:

RUIZ HEALY RESIDENCE
254 E. SUMMIT AVE.
San Antonio, Texas, 78212

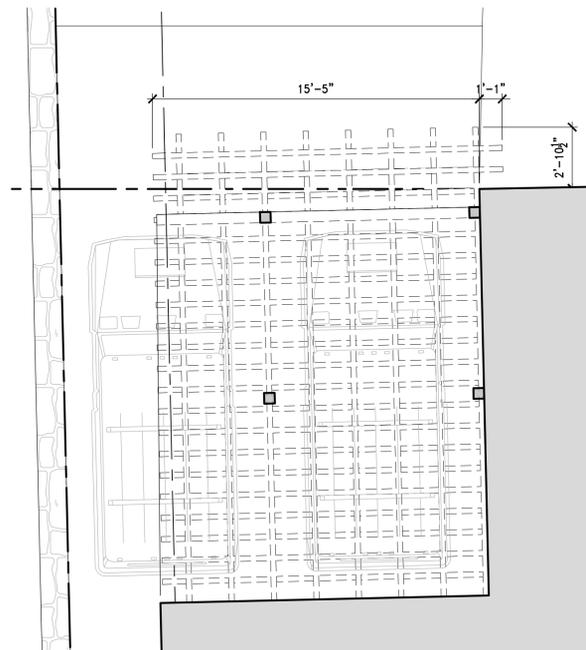
1 Floor Plan - Option 1

PROJECT INFORMATION	
AREA CALCULATIONS	
CONDITIONED PERGOLA	336 S.F.

1. Construct a 336-square-foot carport with metal posts and wood rafters, measuring 10-feet in height.
2. Construct a 425-square-foot carport with metal posts, wood rafters, and an approximate 4-foot addition to an existing stone wall, measuring approximately 10-feet in height overall.

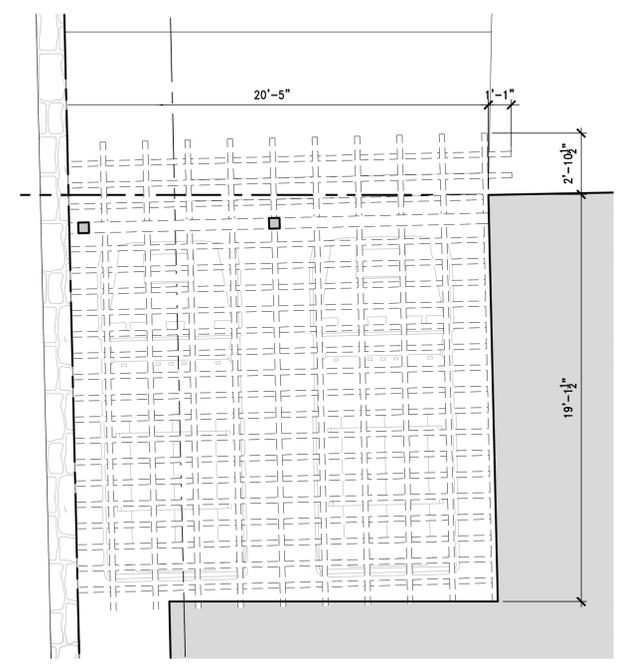
1 Floor Plan - Option 2

PROJECT INFORMATION	
AREA CALCULATIONS	
CONDITIONED PERGOLA	425 S.F.
