HISTORIC AND DESIGN REVIEW COMMISSION

HDRC CASE NO: 2022-271
ADDRESS: 1933 W MULBERRY AVE
LEGAL DESCRIPTION: NCB 1944 BLK 22 LOT 9
ZONING: R-6, H
CITY COUNCIL DIST.: 7
DISTRICT: Monticello Park Historic District
APPLICANT: Jennifer Stimmel/Statewide Remodeling.
OWNER: Rudy Blanco/BLANCO RUDY L & GUADALUPE
TYPE OF WORK: Window replacement
APPLICATION RECEIVED: May 04, 2022
60-DAY REVIEW: Not applicable due to City Council Emergency Orders
CASE MANAGER: Rachel Rettaliata

The applicant is requesting a Certificate of Appropriateness for approval to replace ten (10) original wood windows with vinyl windows.

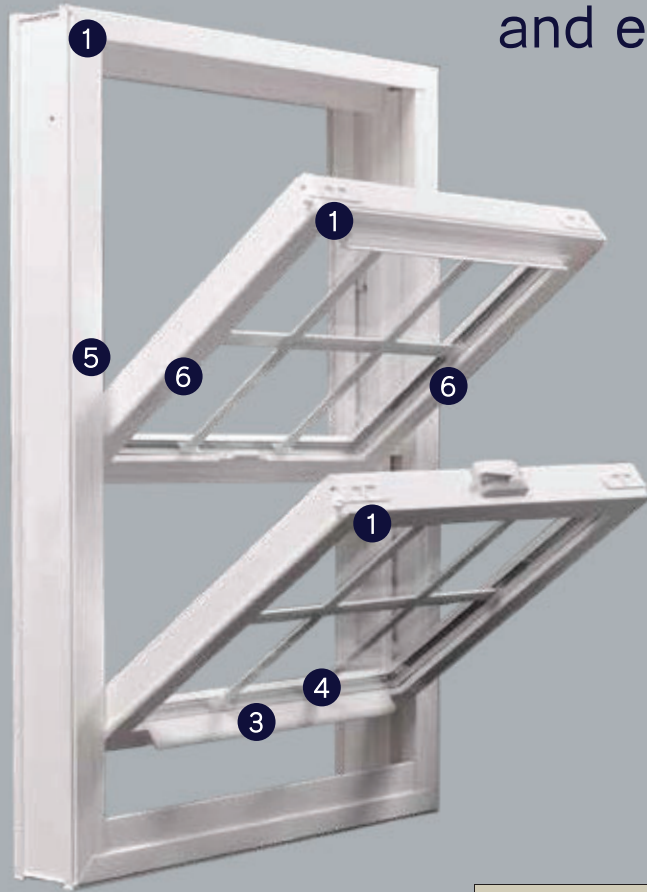
Standard features for exceptional value and efficiency

- 1 **Fusion welded sashes and frame** are built to be exceptionally strong and durable, which helps prevent air and water infiltration.
- 2 **Exterior beveled mainframe** provides contemporary beauty and style.*

- 3 **Integral lift rail** features comfortable, ergonomic design and is significantly stronger and more durable than snap-in lift rails.
- 4 **MagnaSeal™ Spacer** and sealant system is fully automated for condensation resistance and seal integrity.

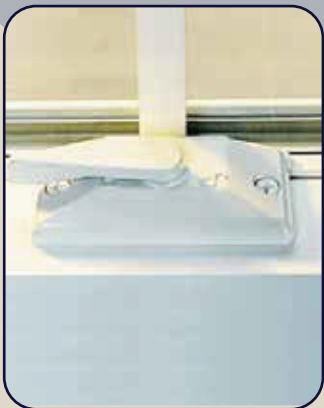
Delta heavy-duty lock secures sashes and offers maximum weather protection.

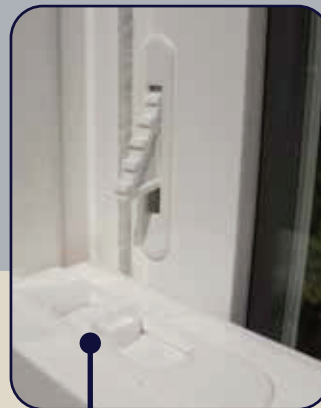
Q-Lon compression gasket system adds barriers and diversions for exceptional water resistance. (photo above shows optional Comfort Foam®.)

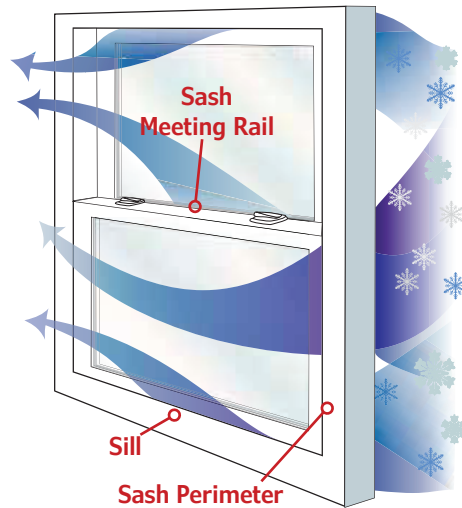
POINTS OF AIR INFILTRATION

Poorly designed windows don't have the built-in airlocks, weather stripping, and barriers necessary to keep air from forcing its way in. Without these design features, air will push between the sash meeting rails and around the sash perimeter where it meets the sill, jambs, and head.
