HISTORIC AND DESIGN REVIEW COMMISSION

HDRC CASE NO: 2023-042
ADDRESS: 211 W SHERIDAN
LEGAL DESCRIPTION: NCB 930 BLK LOT S 120 FT OF E 50 FT OF A6
ZONING: RM-4, H
CITY COUNCIL DIST.: 1
DISTRICT: Individual Landmark
APPLICANT: Lilian & Carlos Otterbach | Spensen Management LLC
OWNER: Lilian & Carlos Otterbach | Spensen Management LLC
TYPE OF WORK: Wood Window Screen Removal and Historic Tax Certification
APPLICATION RECEIVED: January 26, 2023
60-DAY REVIEW: Not applicable due to City Council Emergency Orders
CASE MANAGER: Bryan Morales

1. Remove all wood window screens.
2. Obtain Historic Tax Certification for the property 211 W Sheridan.

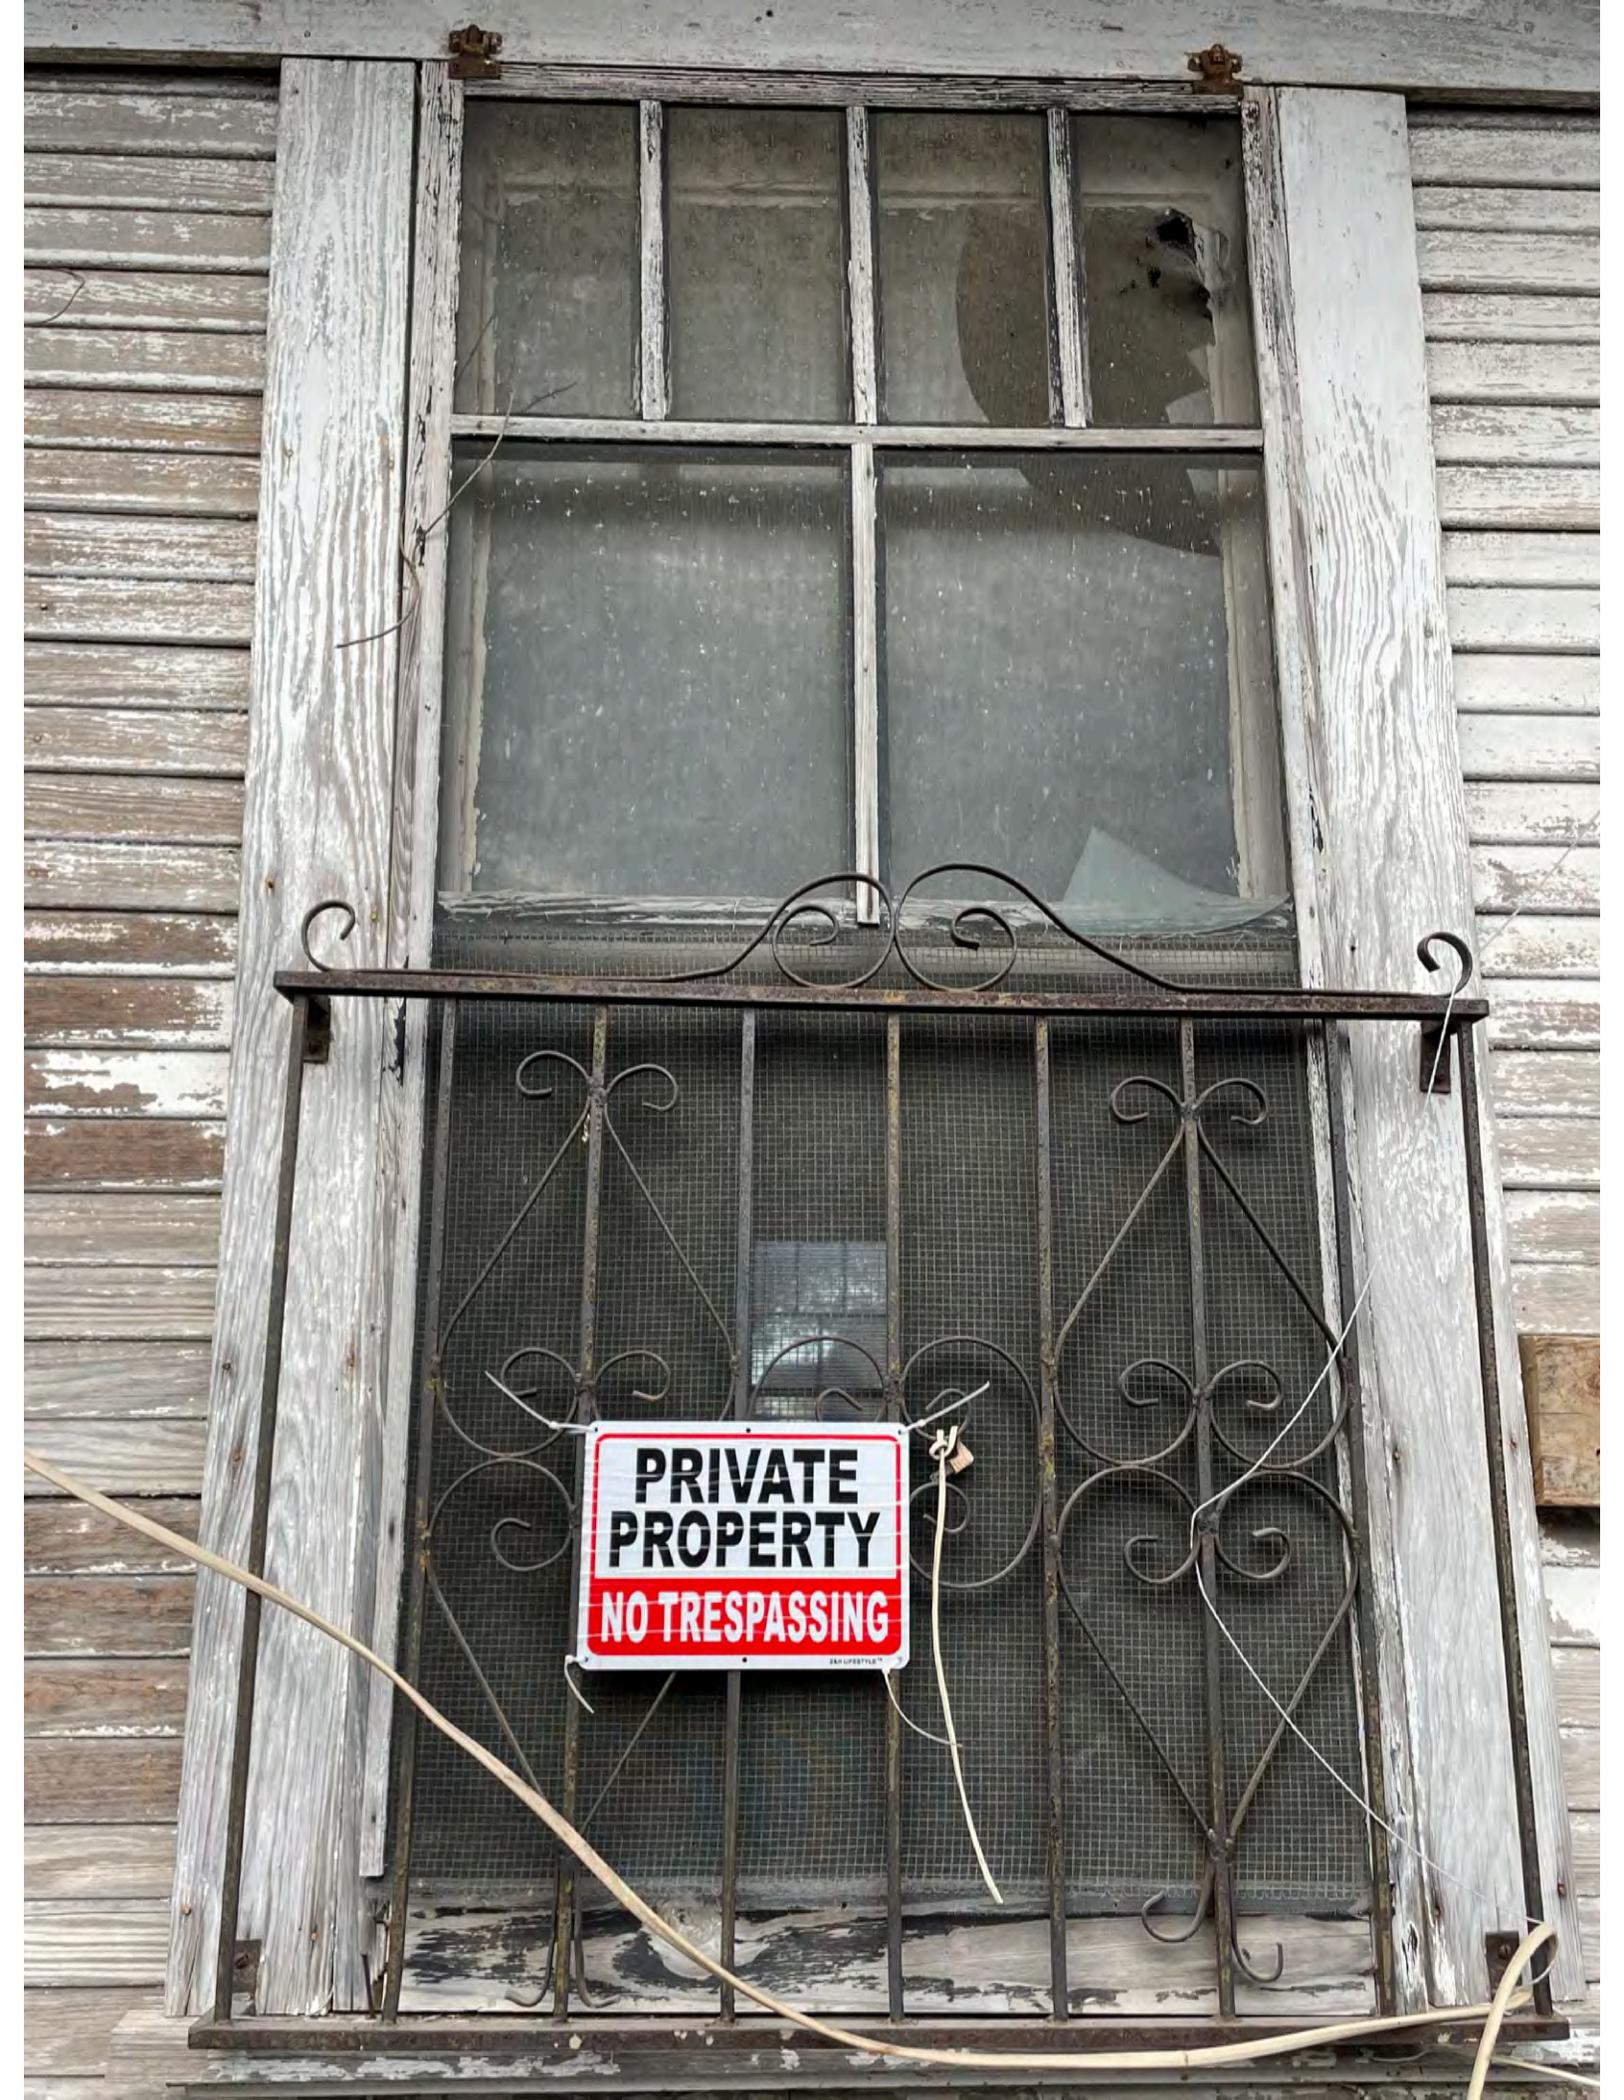
A photograph of a window on a weathered wooden building. The window is covered by a decorative metal grille with a mesh screen. A red and white sign is attached to the grille. The sign has the text 'PRIVATE PROPERTY' in black on a white background and 'NO TRESPASSING' in white on a red background. The window frame is made of wood and shows signs of decay. The building's siding is also weathered and peeling.
