brackenridge park

A POSTCARD PLACE LOST IN TIME

HDRC MEETING

19 APRIL 2023

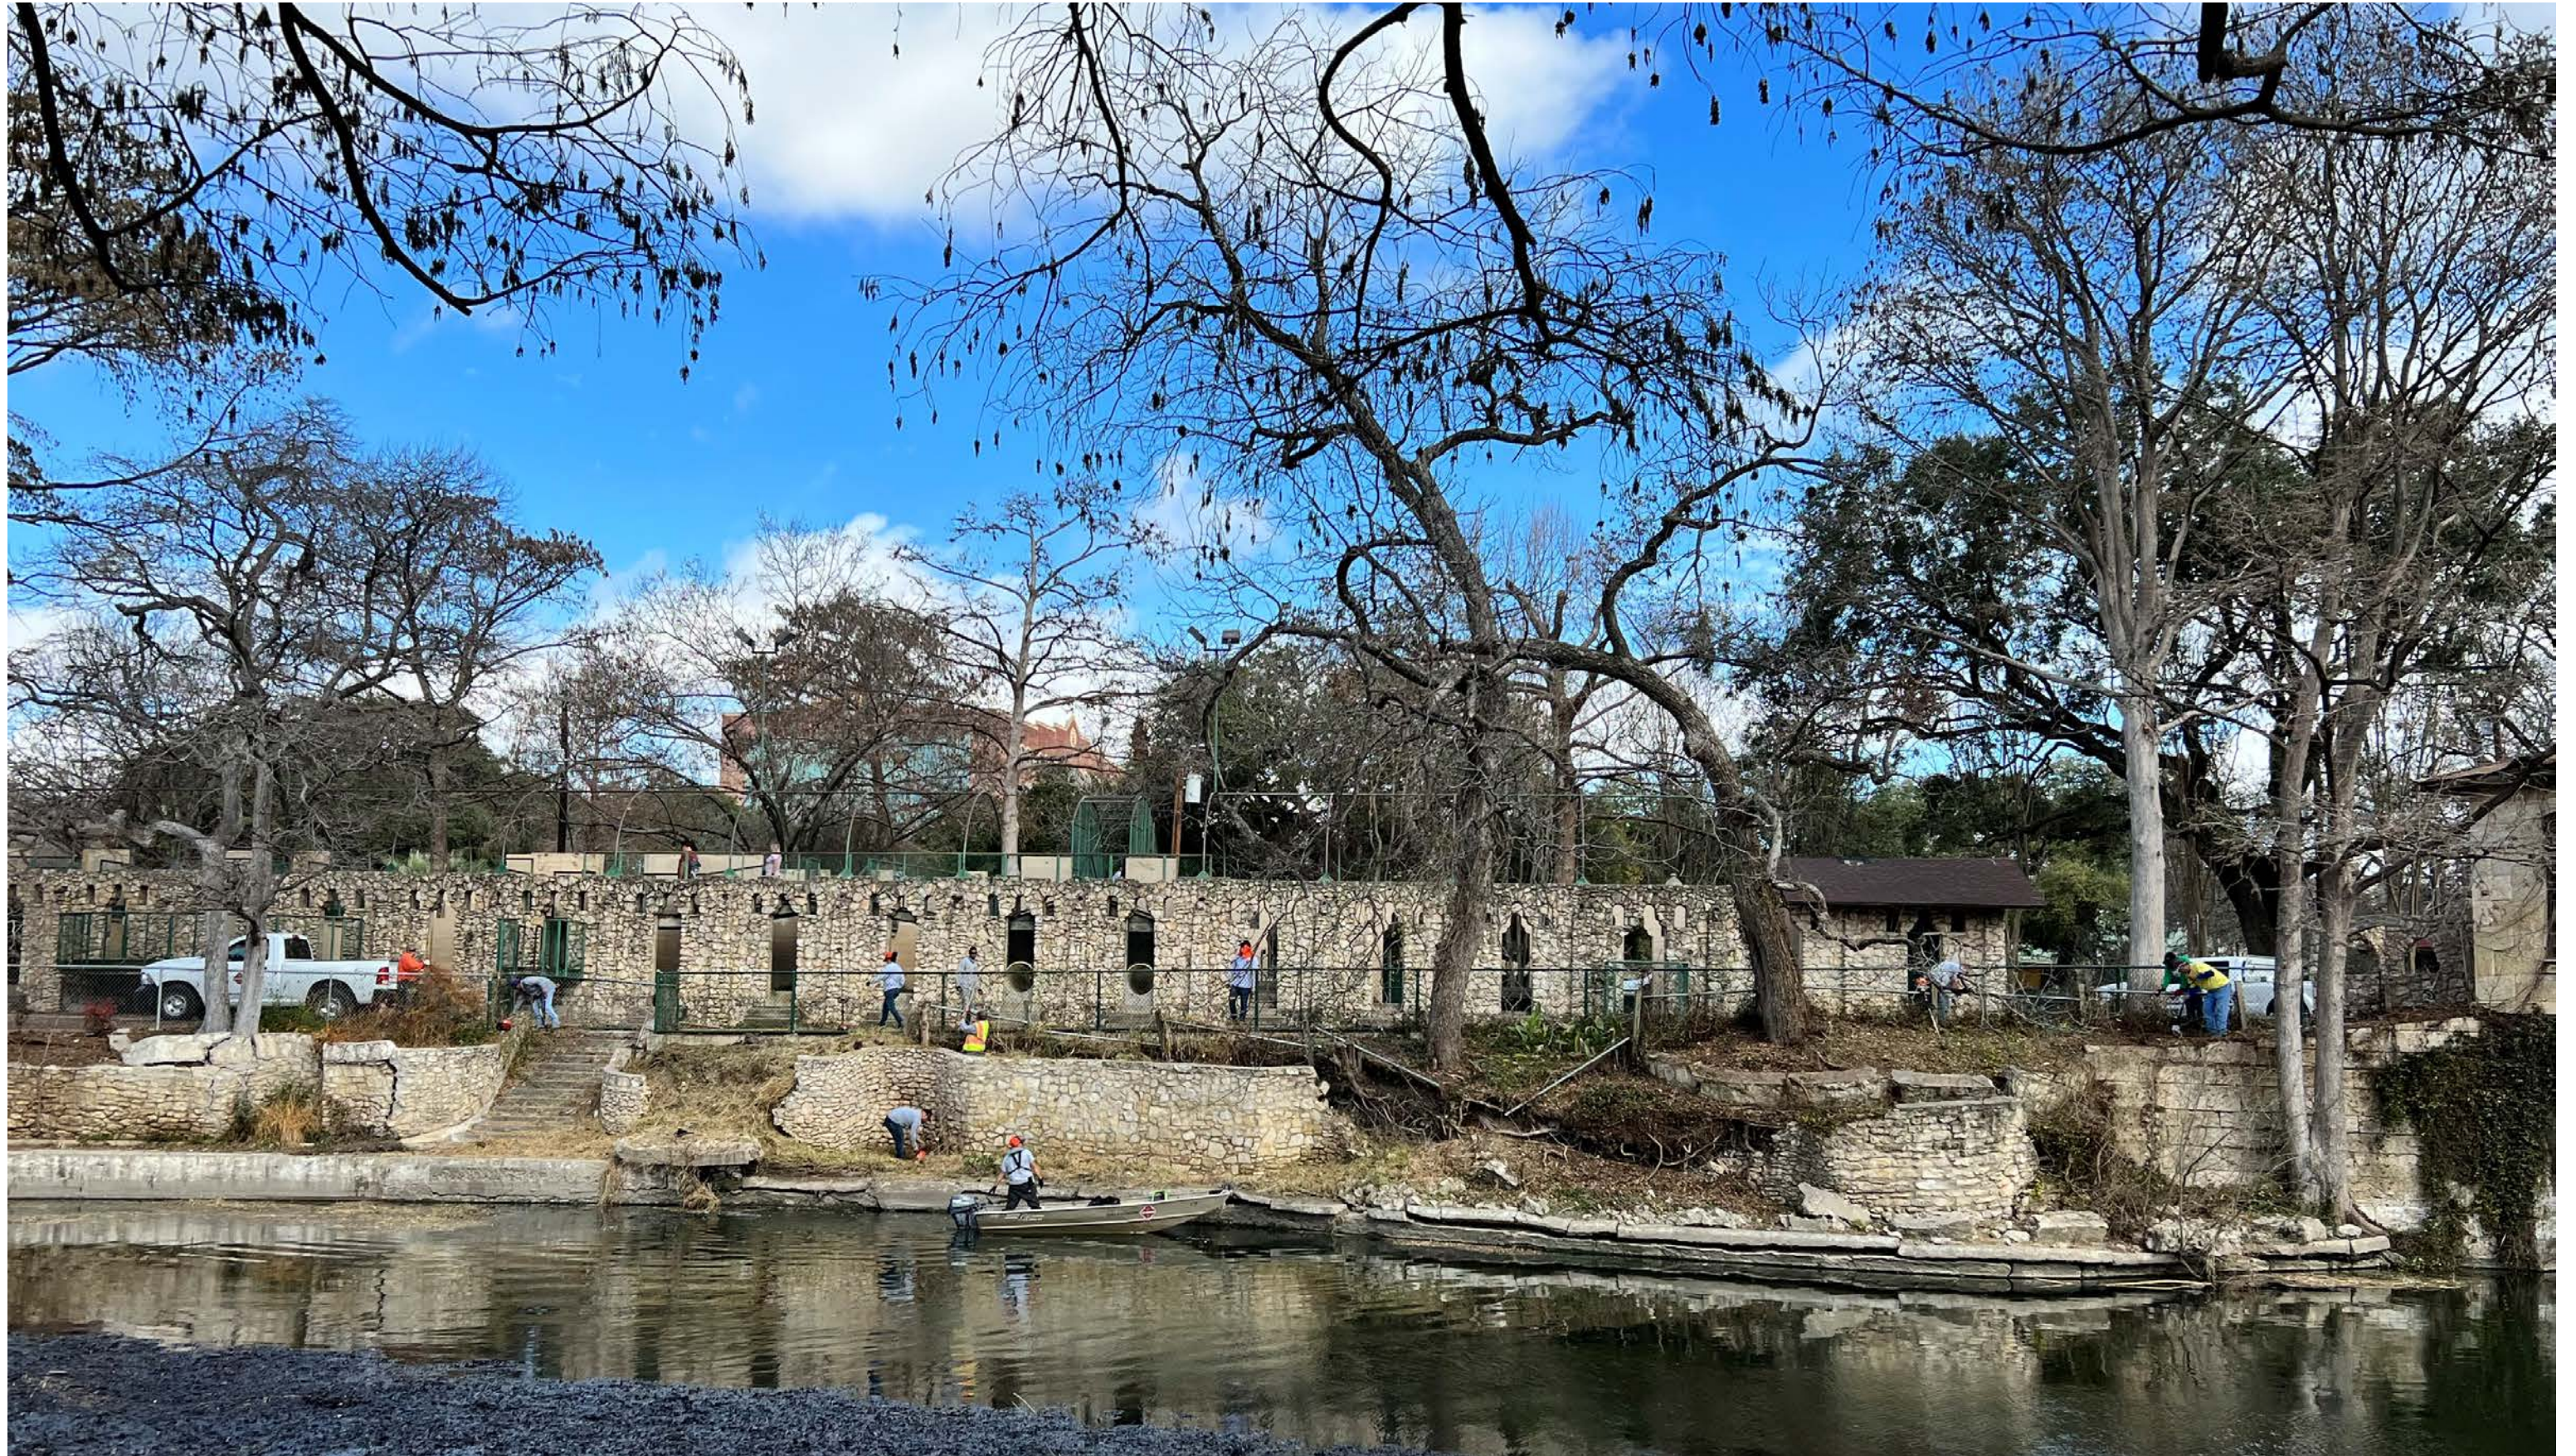
EXISTING CONDITIONS : LAMBERT BEACH NORTH WALLS

EXISTING CONDITIONS : LAMBERT BEACH NORTH WALLS

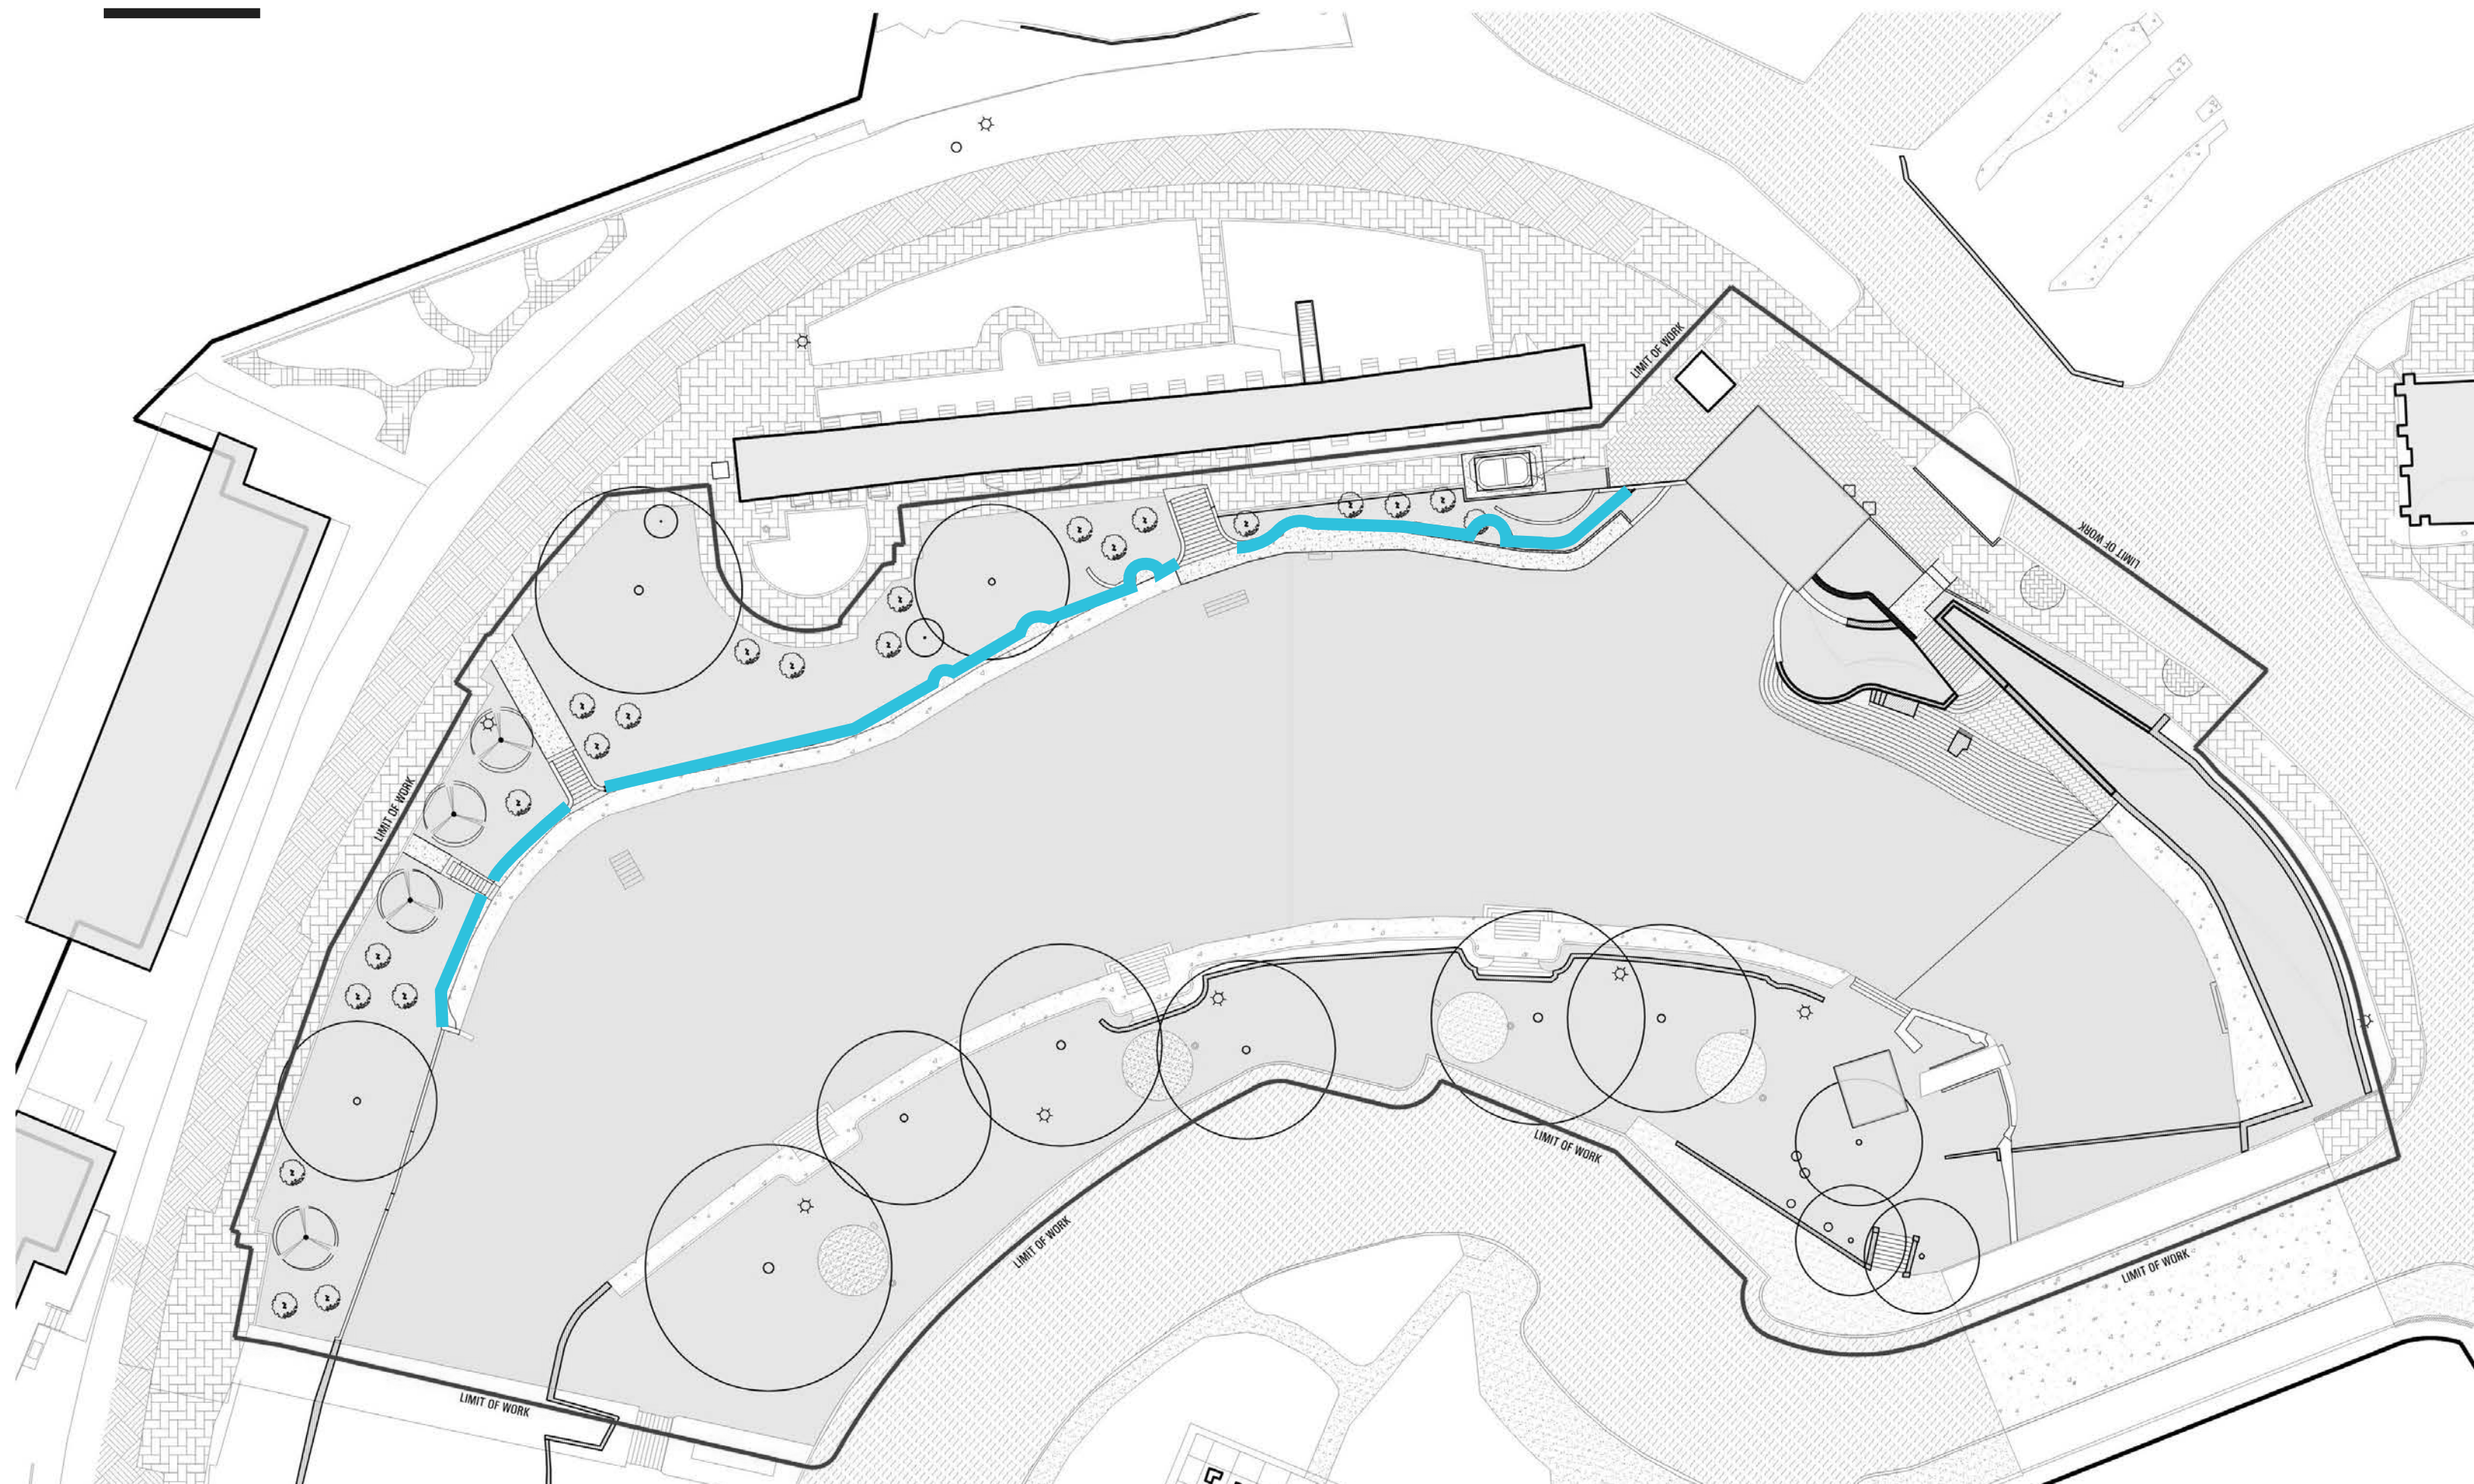
DIAGRAM : EXISTING LAMBERT BEACH WALLS STUDIED FOR RELOCATION

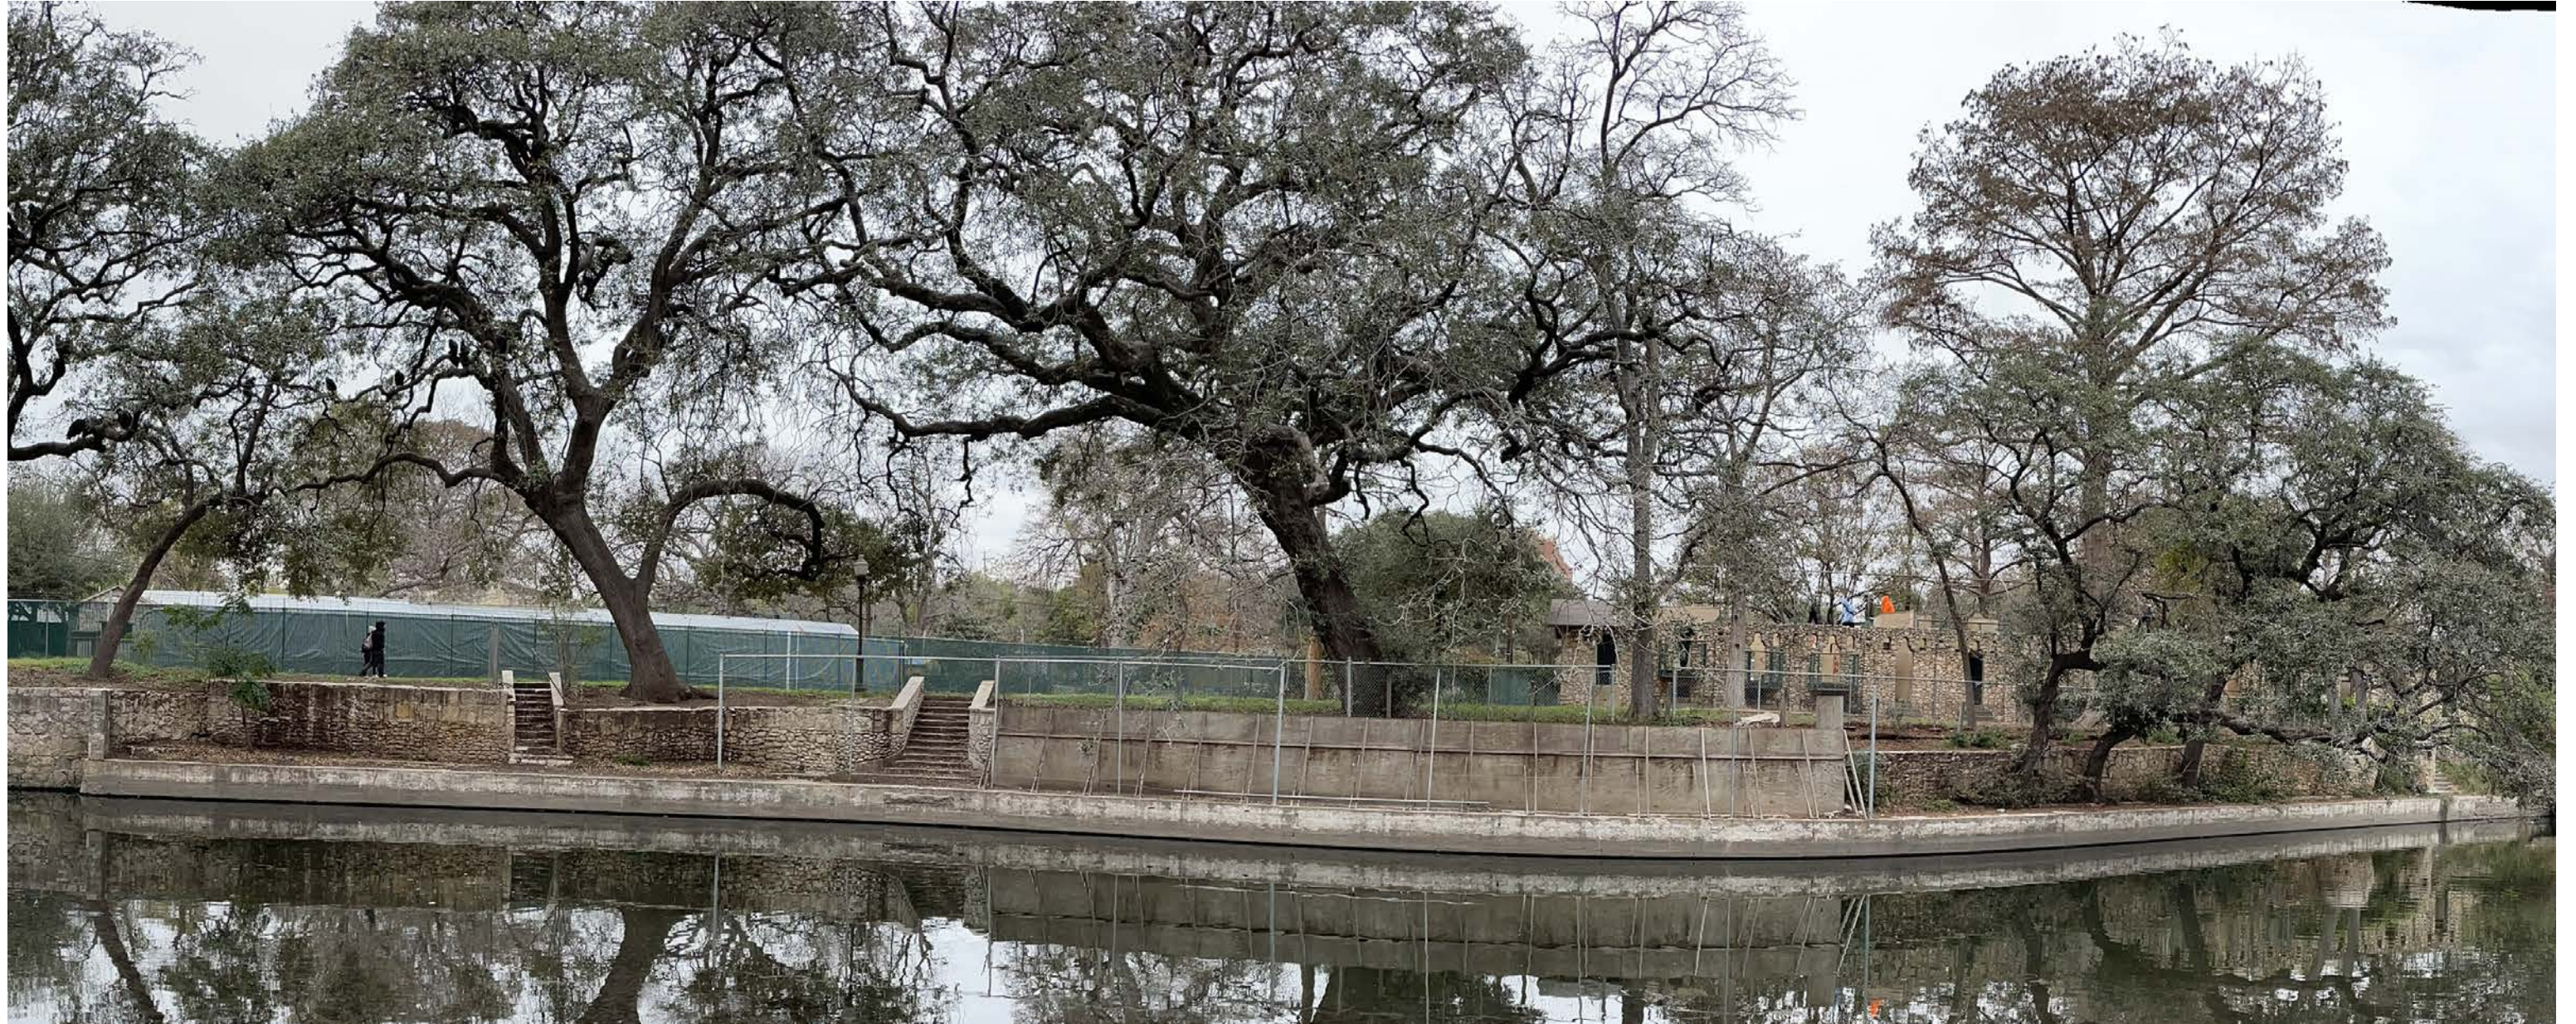
PHOTO : EXISTING LAMBERT BEACH WALLS STUDIED FOR RELOCATION

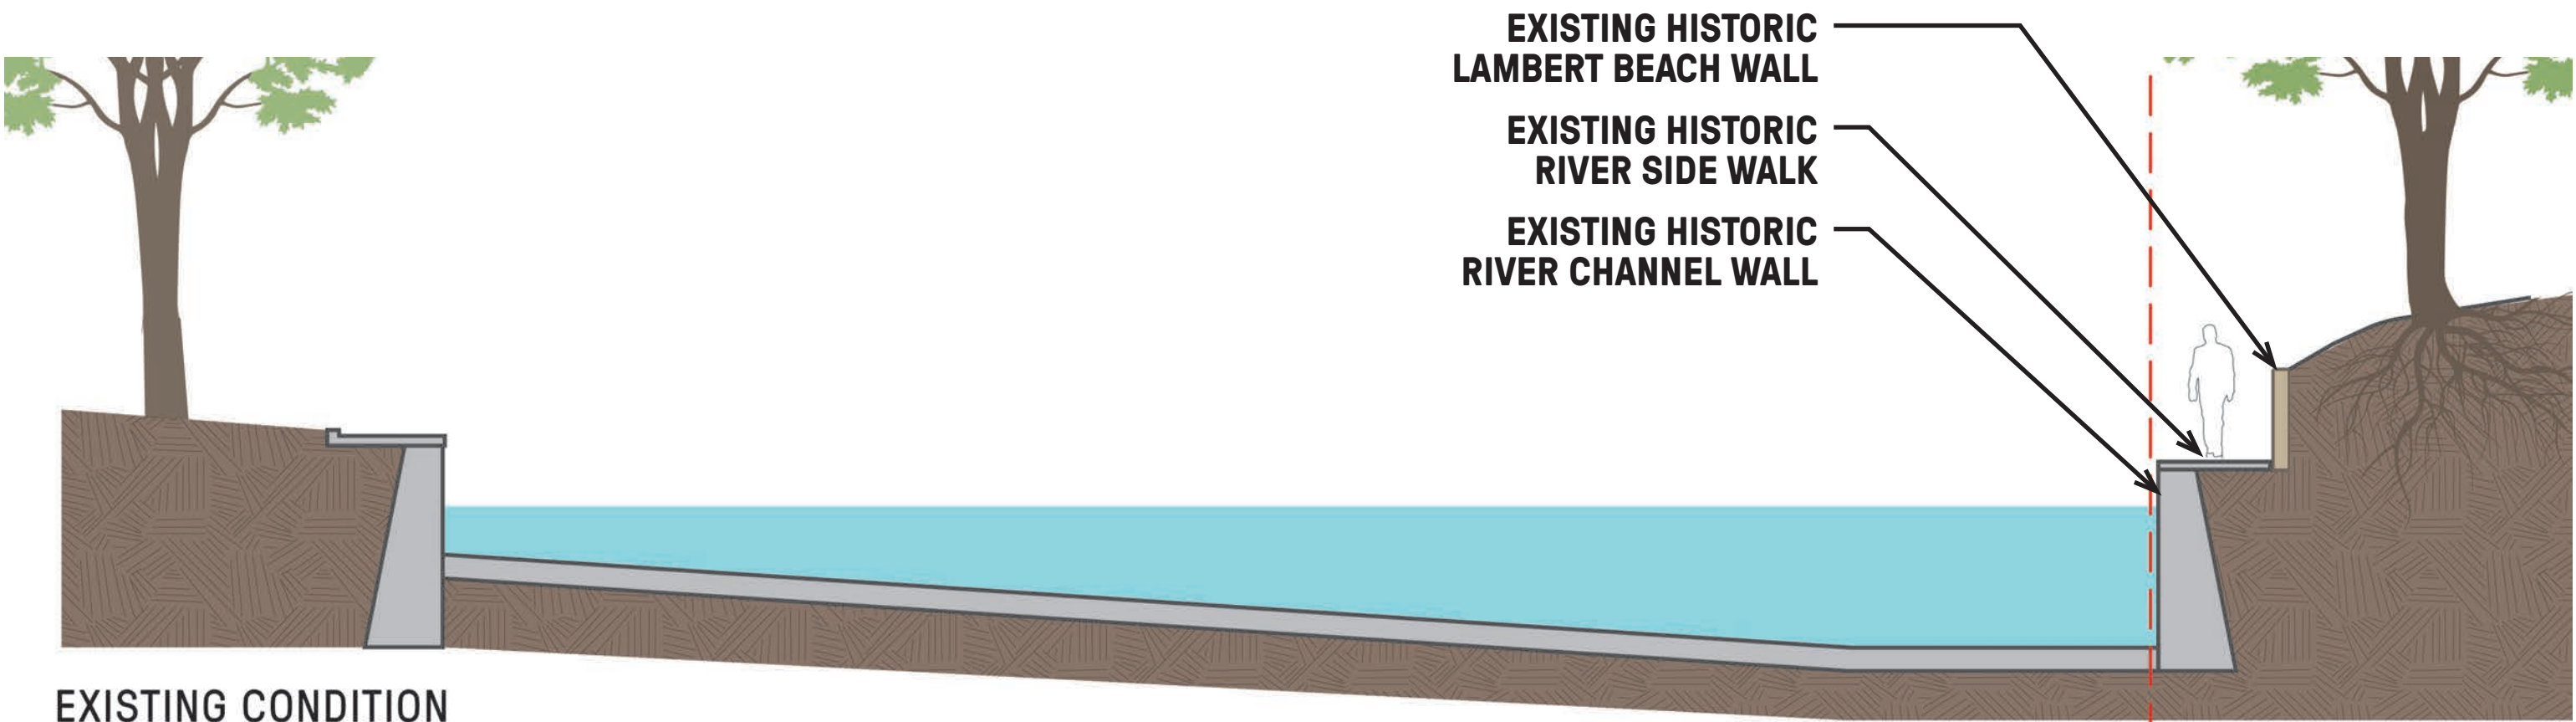
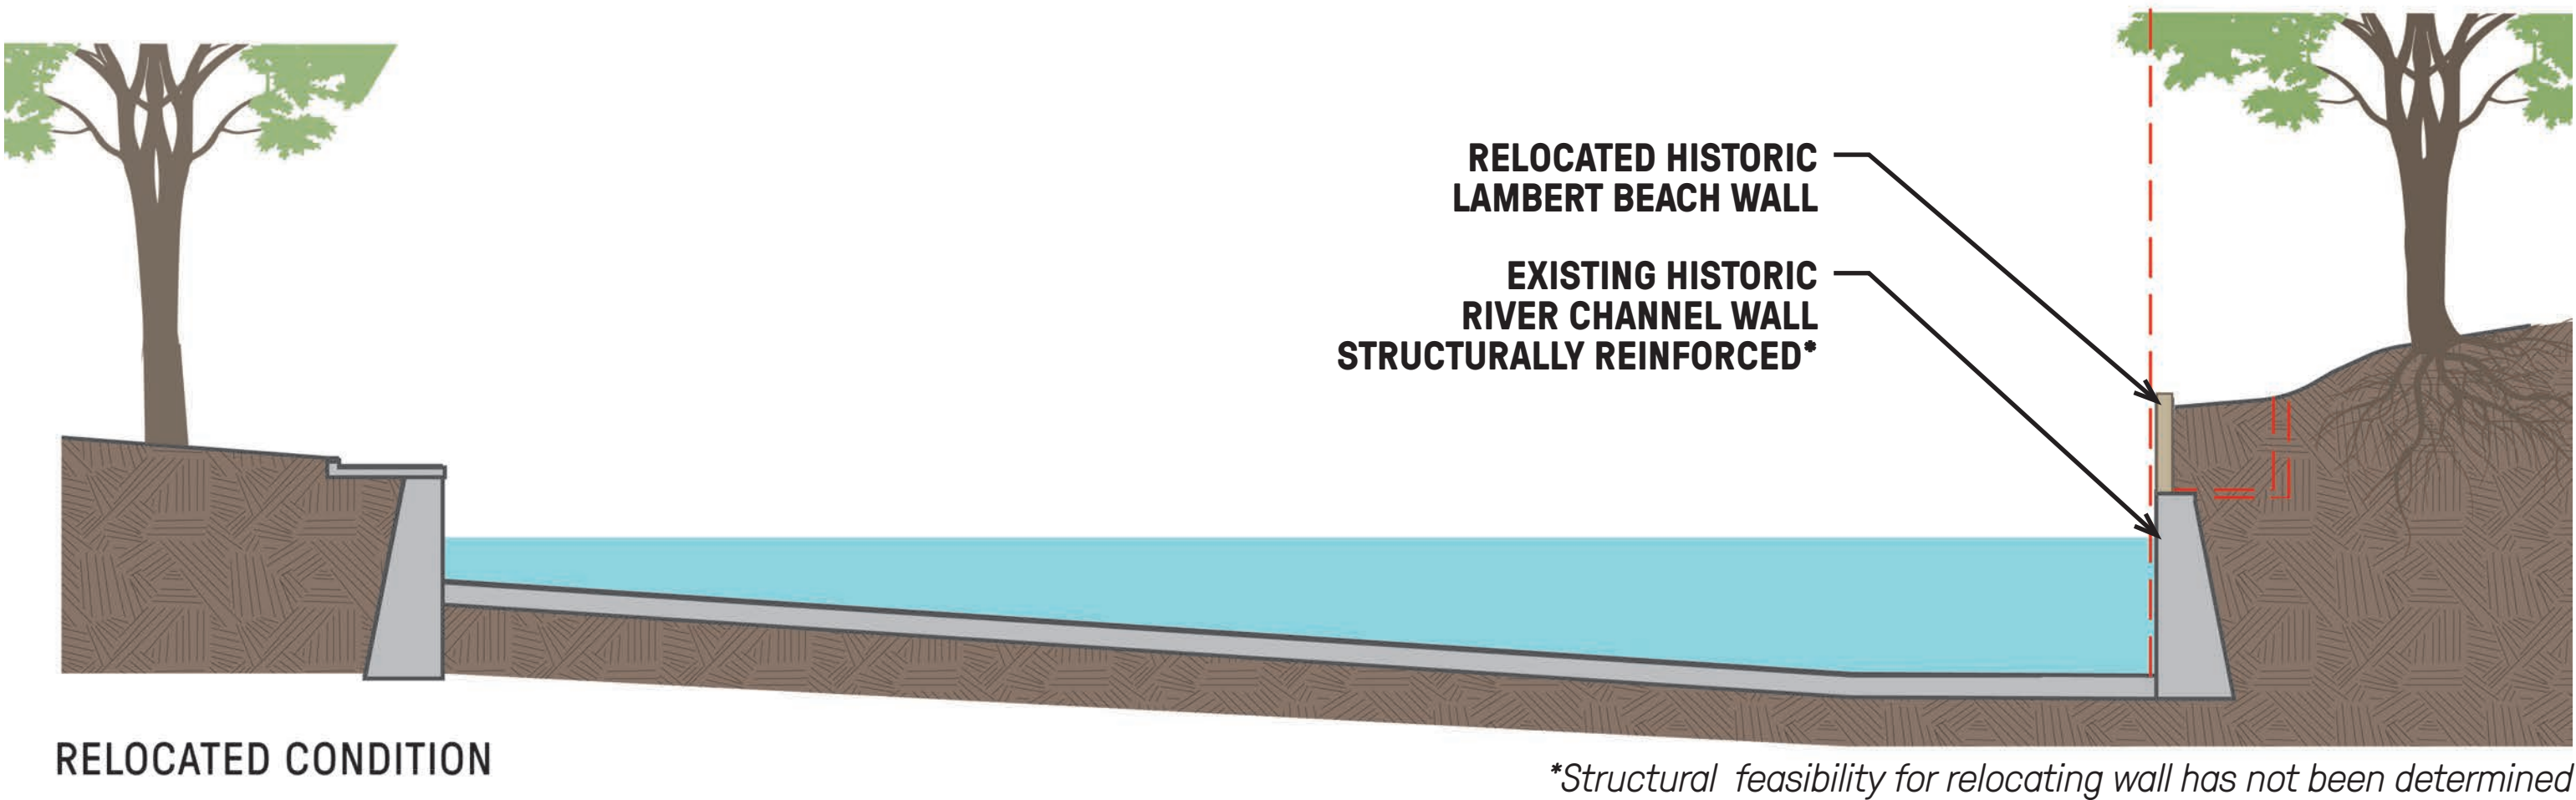
DIAGRAM : PROPOSED WALL RELOCATION AT LAMBERT BEACH

**Structural feasibility for relocating wall has not been determined*

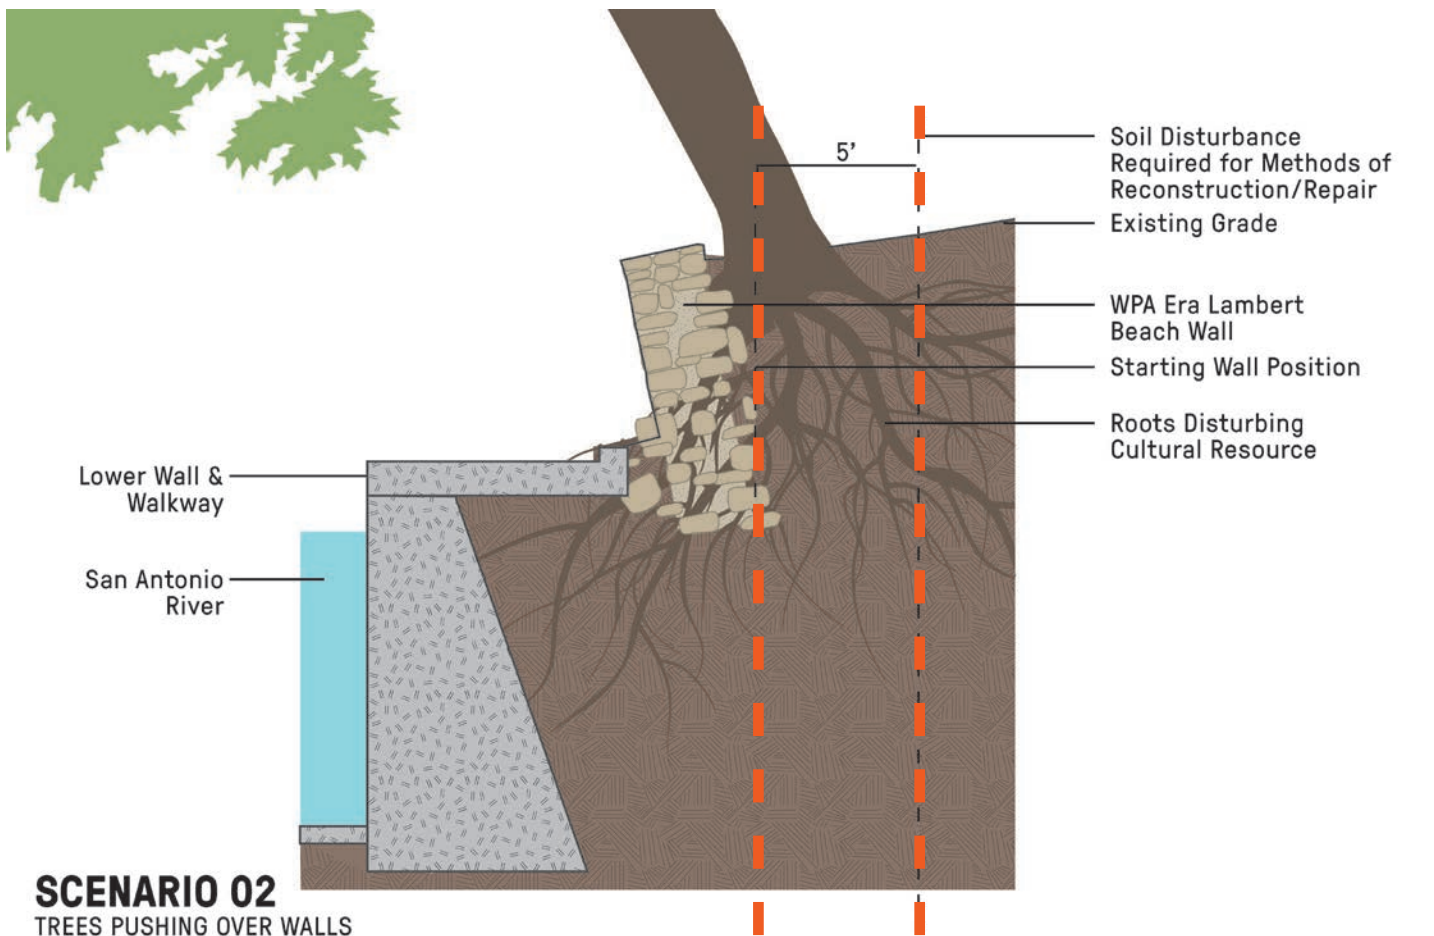
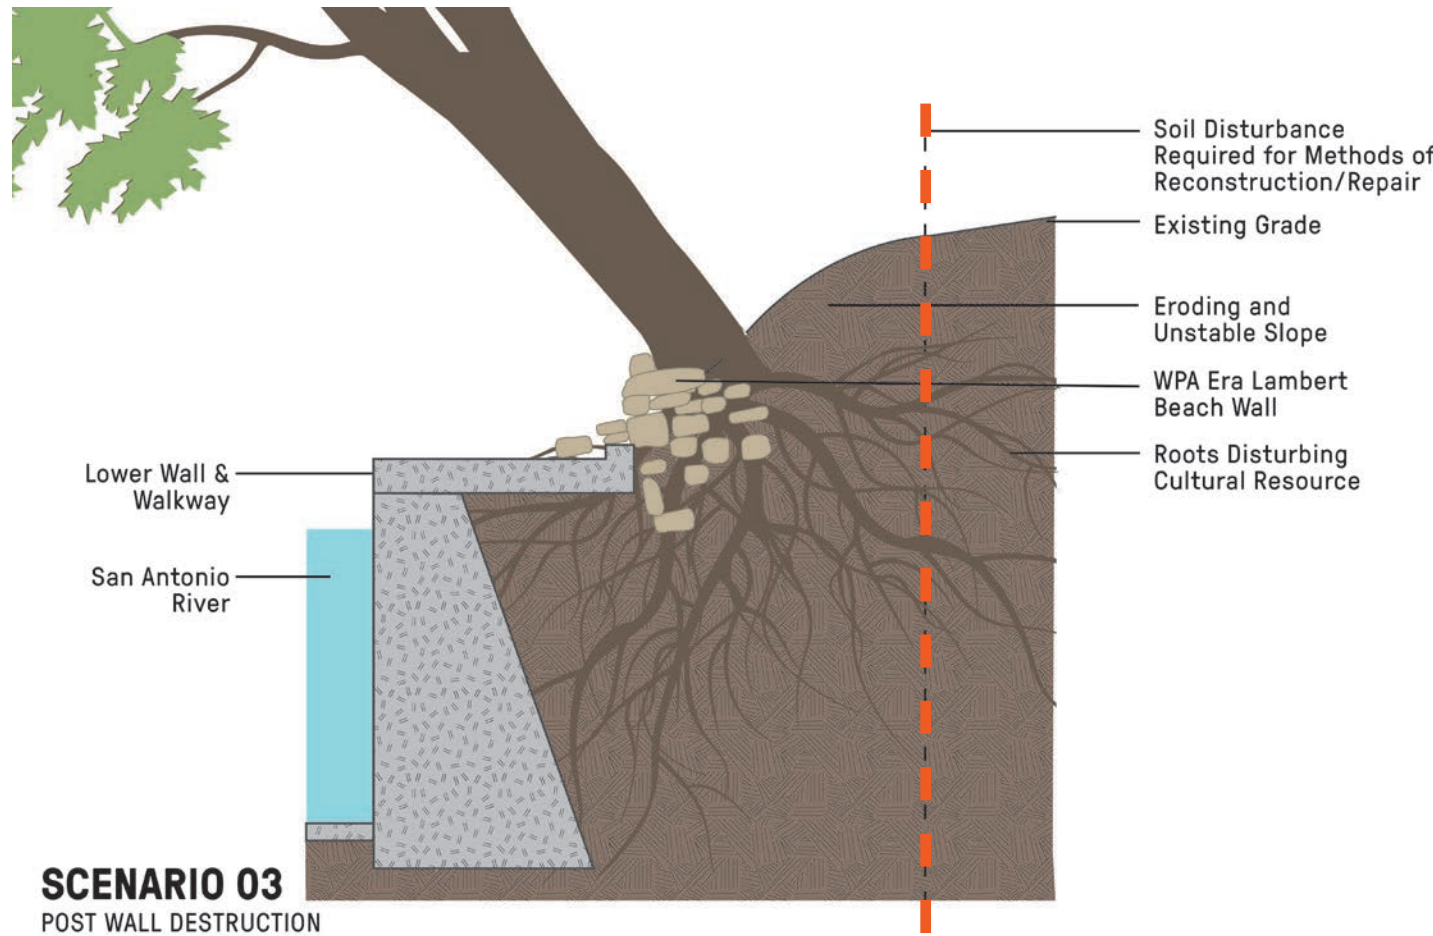
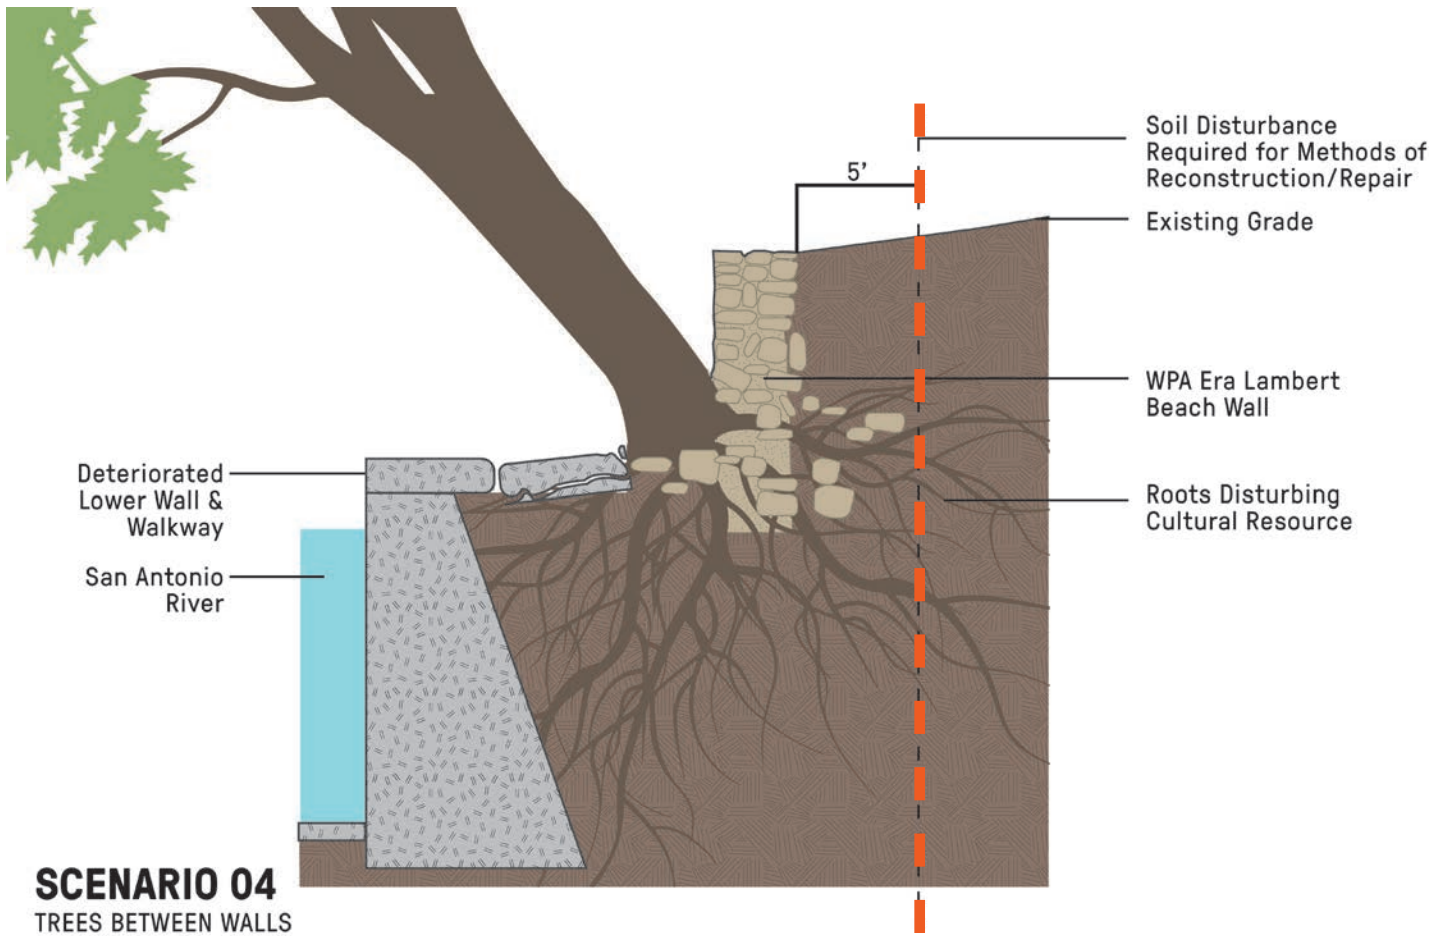
WALL CONDITIONS

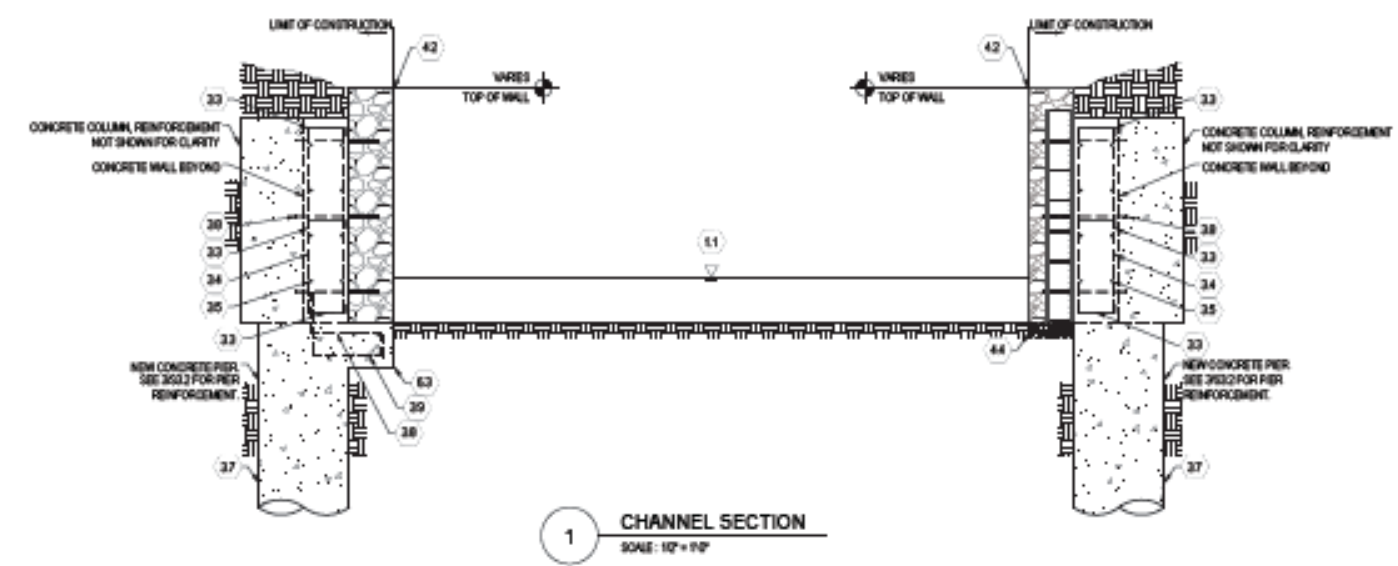
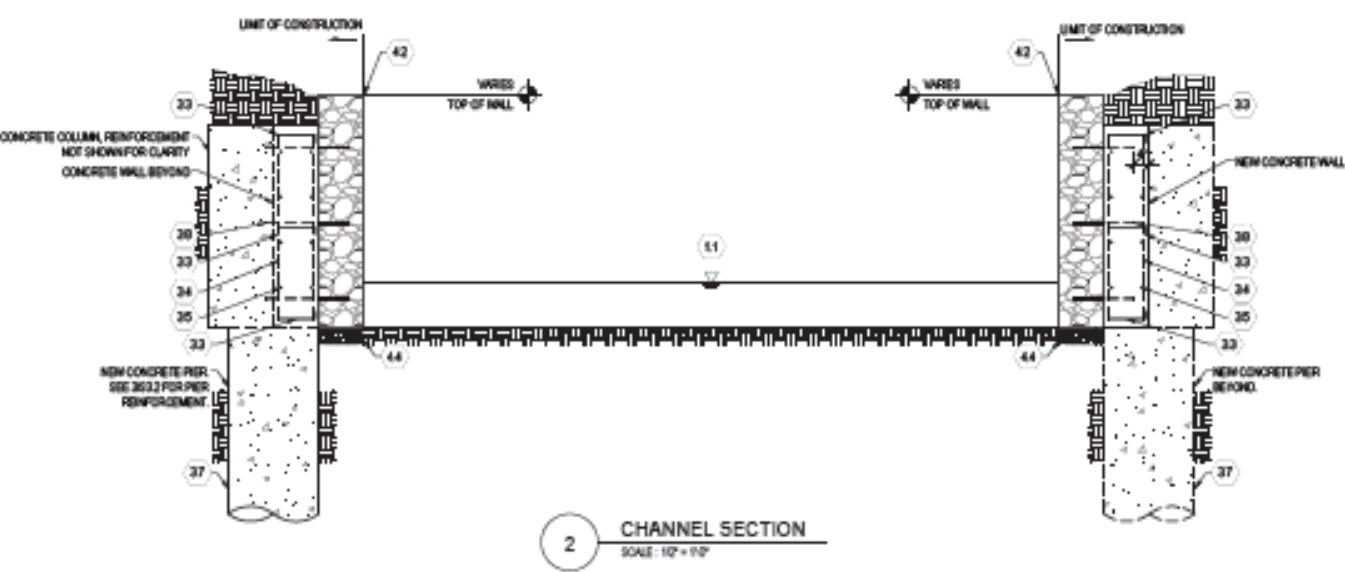
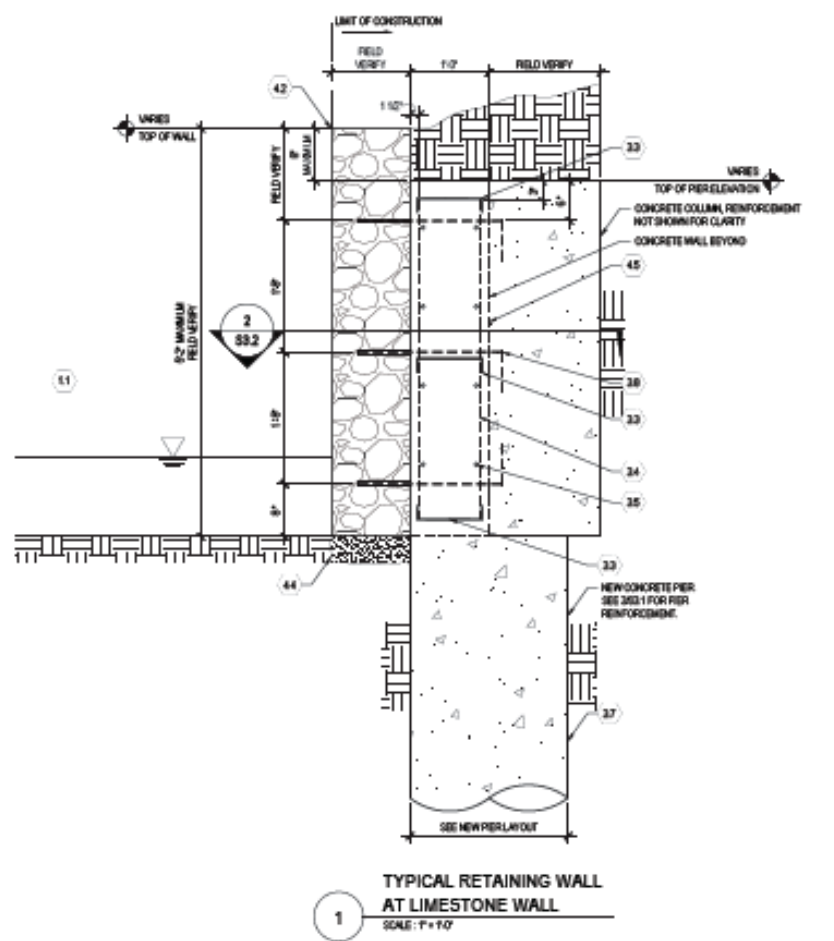
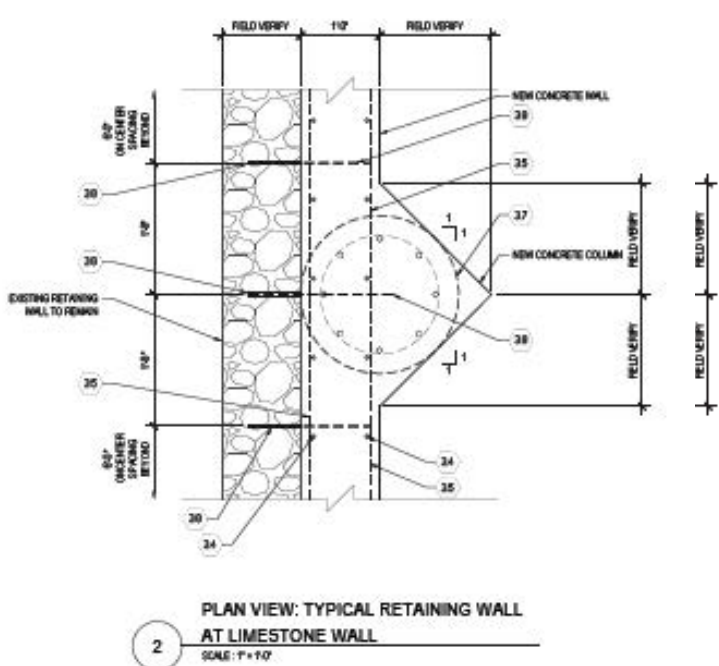
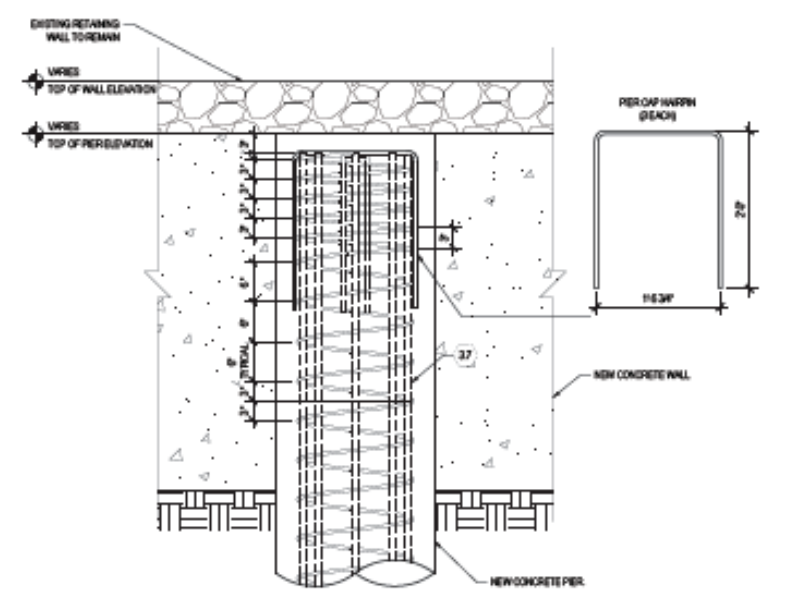
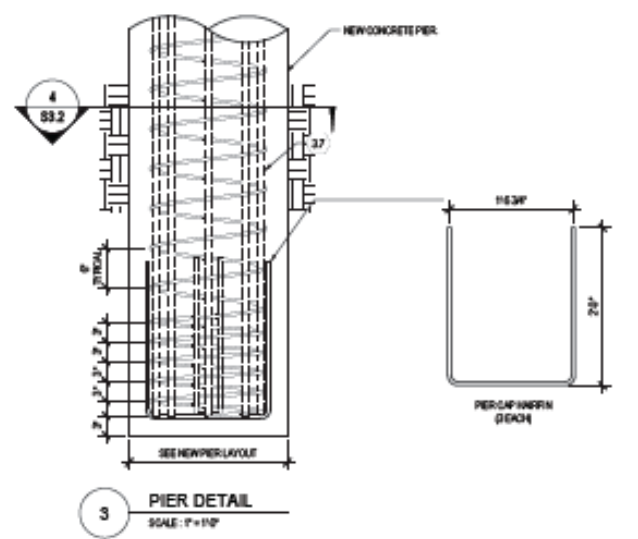
ALTERNATIVE STRUCTURAL STRATEGY : PIER AND SPANDREL SYSTEM

ALTERNATIVE STRUCTURAL STRATEGY : PIER AND SPANDREL SYSTEM

- MORE ROBUST SYSTEM
 - DEEPER FOUNDATION OFFERS GREATER STABILITY
- SIMILAR TIMEFRAME TO EXISTING PROPOSED STRATEGY

- TREE IMPACTS:
 - ROOT SYSTEMS OF TREES WOULD STILL BE DESTROYED DUE TO EXCAVATION REQUIRED
 - EXTENSIVE CANOPY TRIMMING REQUIRED
- CONSTRUCTION ACCESS:
 - HEAVY MACHINE RIG ACCESSIBILITY ISSUES (SLOPES, HISTORIC STRUCTURES, TREES)
 - REQUIRES EXTENSIVE SUPPORT SYSTEM FOR EQUIPMENT WEIGHT
- HISTORIC IMPACTS:
 - ANCHORS THROUGH FRONT OF WALLS DO NOT COMPLY WITH THE SECRETARY OF THE INTERIOR'S STANDARDS FOR REHABILITATION
 - REQUIRES DISMANTLING / REBUILDING OF HISTORIC WALLS AGAINST SECRETARY OF THE INTERIOR'S STANDARDS FOR REHABILITATION
- MORE EXPENSIVE COST
