brackenridge park

A POSTCARD PLACE LOST IN TIME

HDRC MEETING

19 APRIL 2023

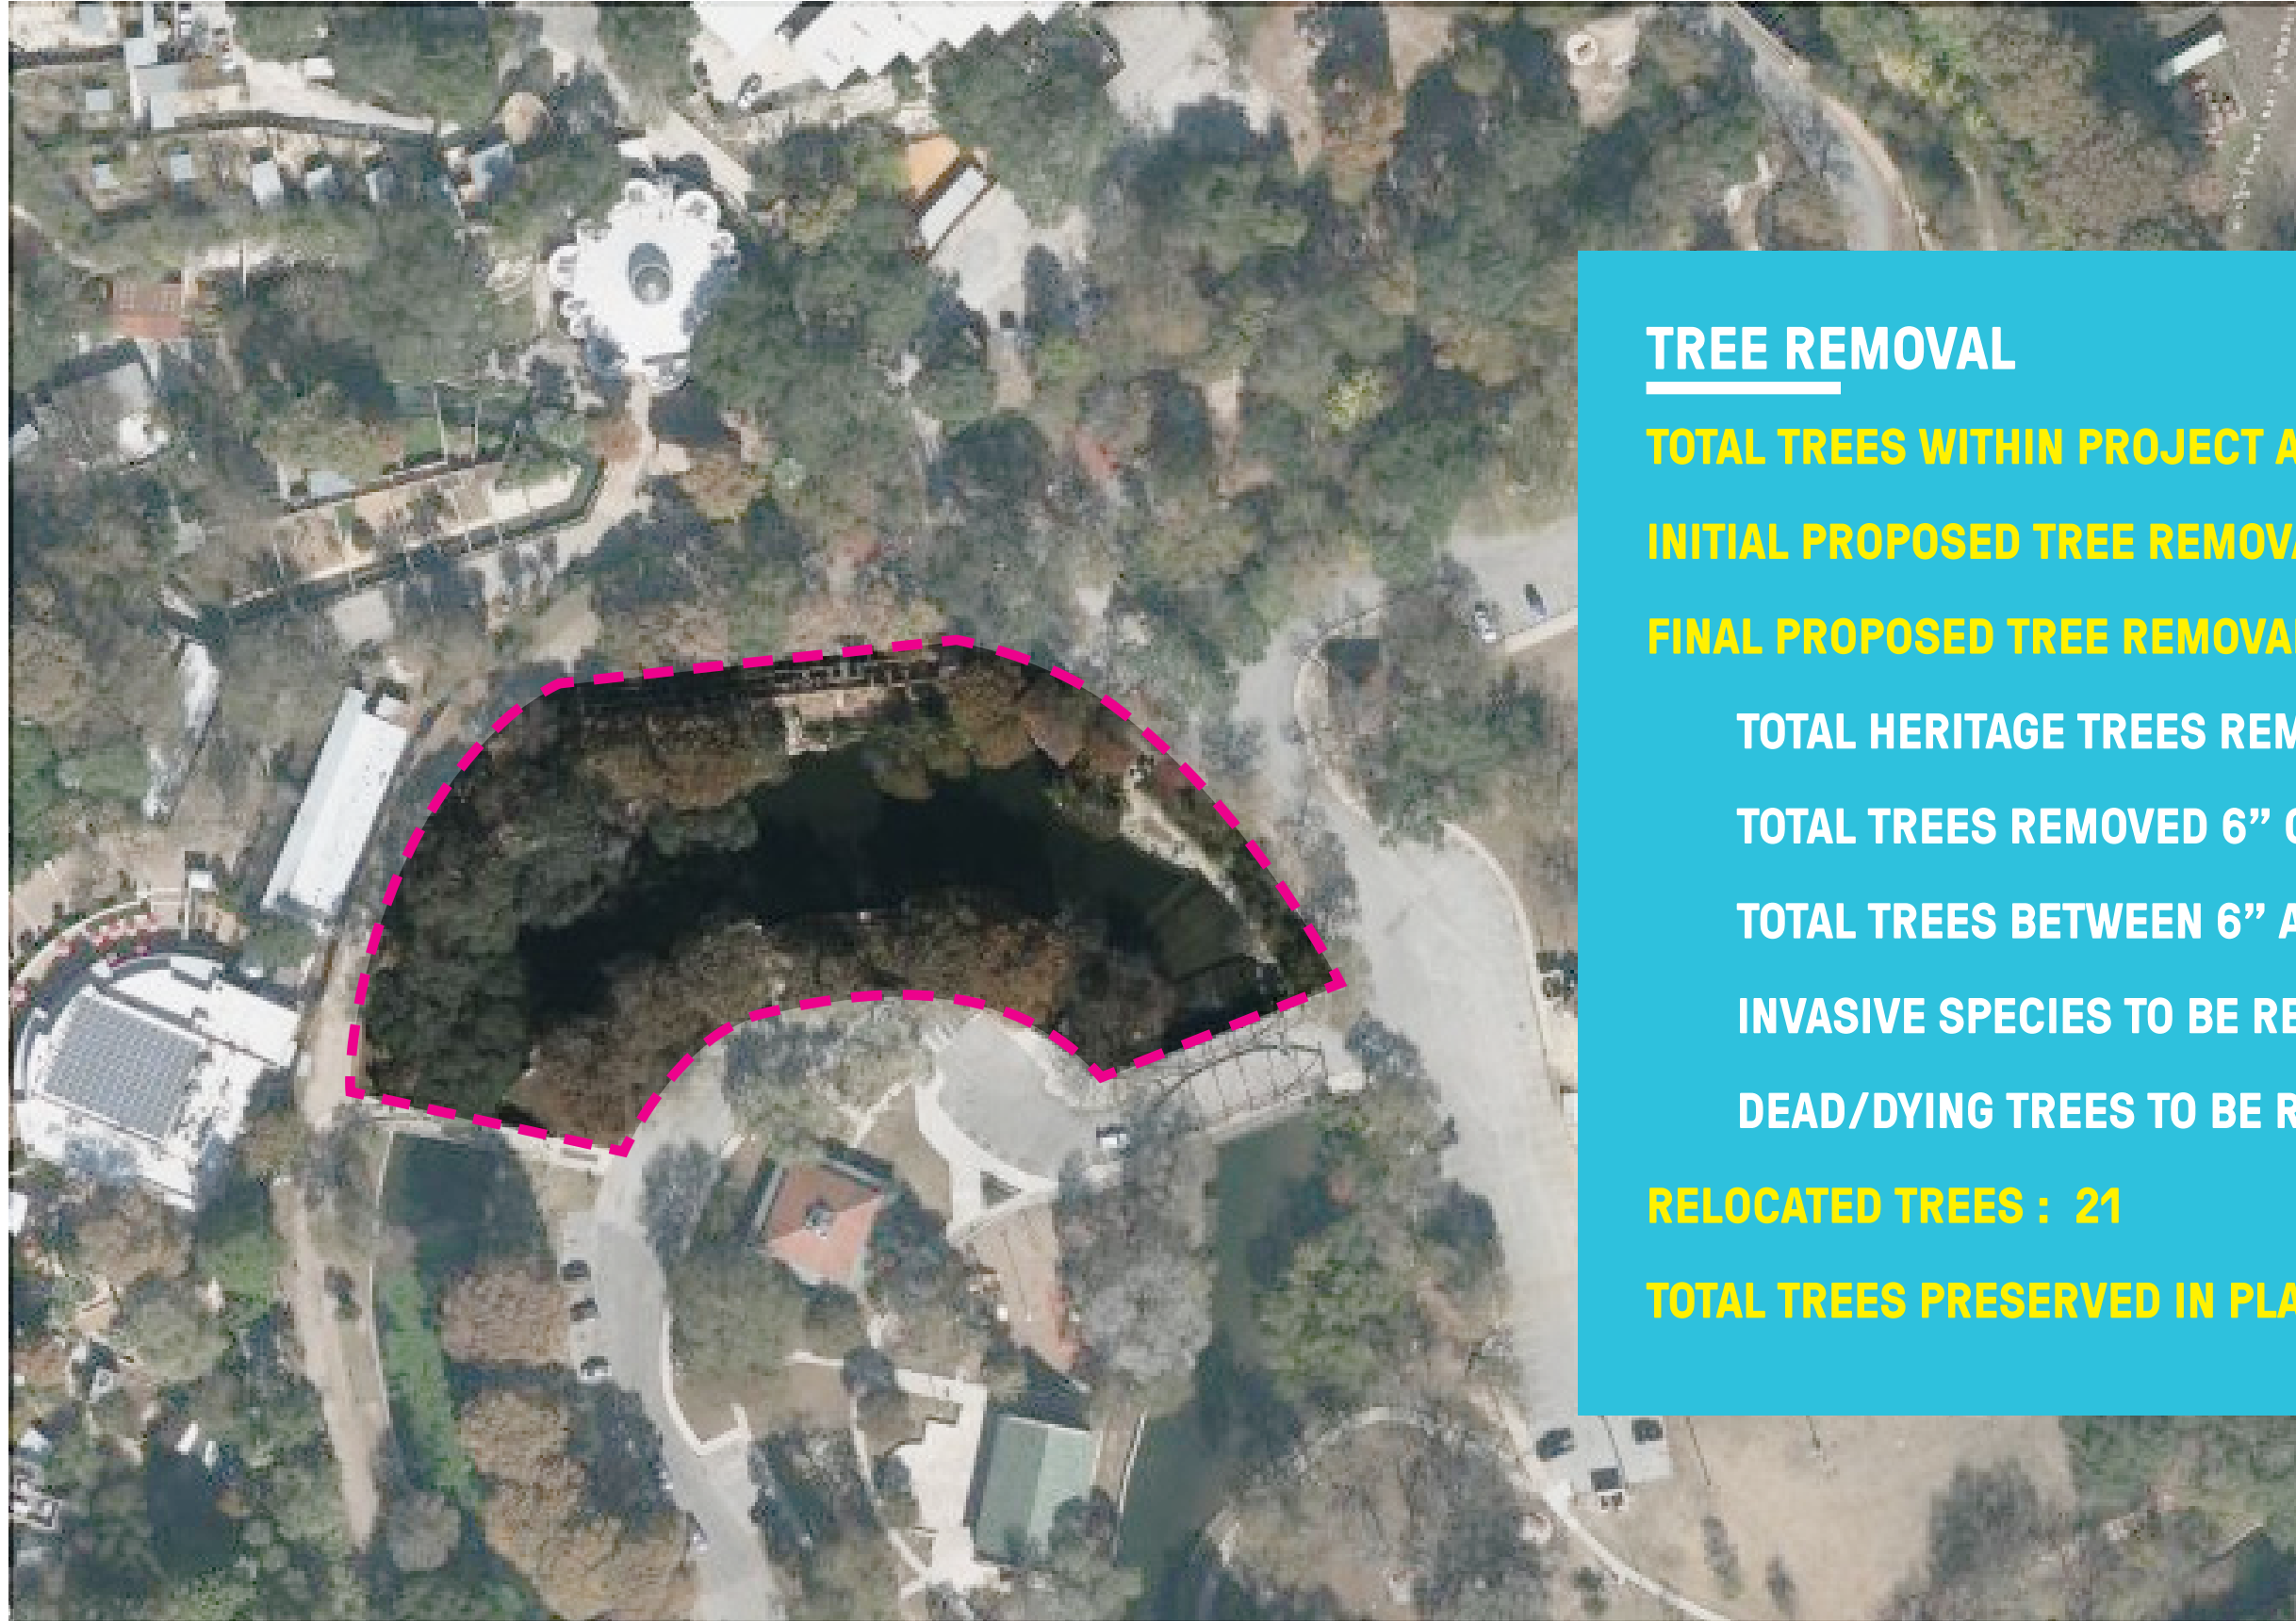
TREE REMOVAL SUMMARY

TOTAL TREES WITHIN PROJECT AREA: 83

INITIAL PROPOSED TREE REMOVAL : 70

FINAL PROPOSED TREE REMOVAL : 48

RELOCATED TREES : 21

TOTAL TREES PRESERVED IN PLACE : 14

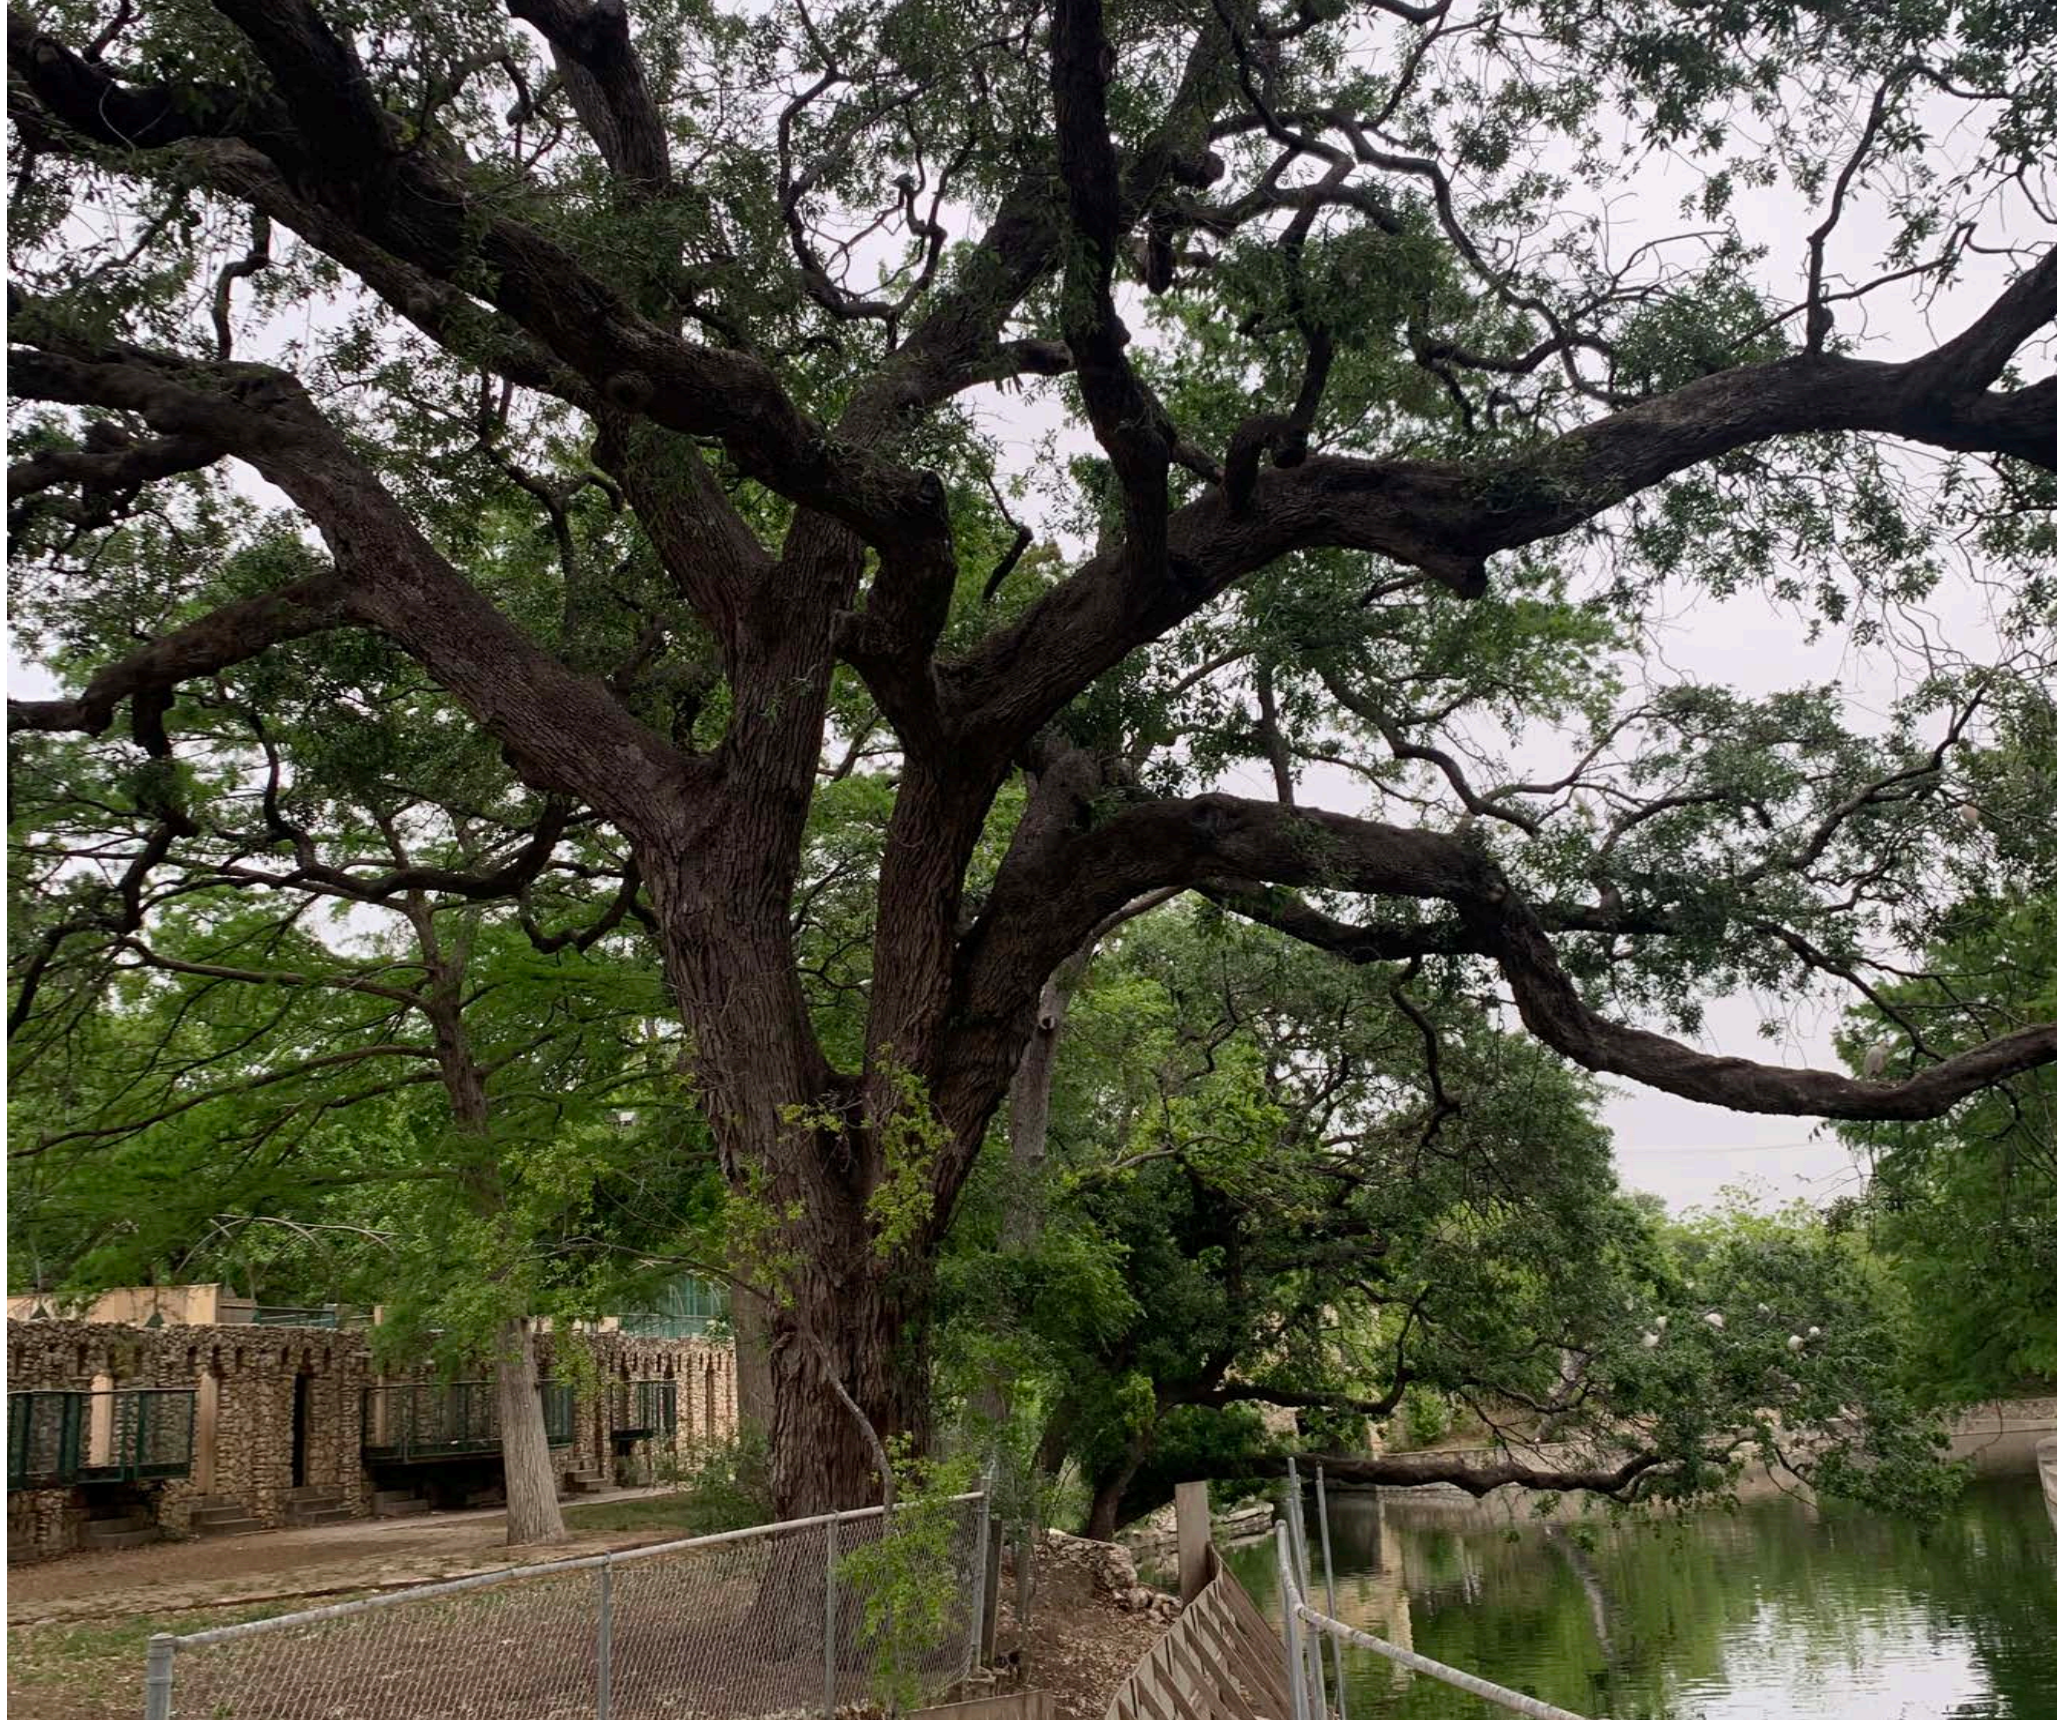
44" LIVE OAK TO BE RELOCATED

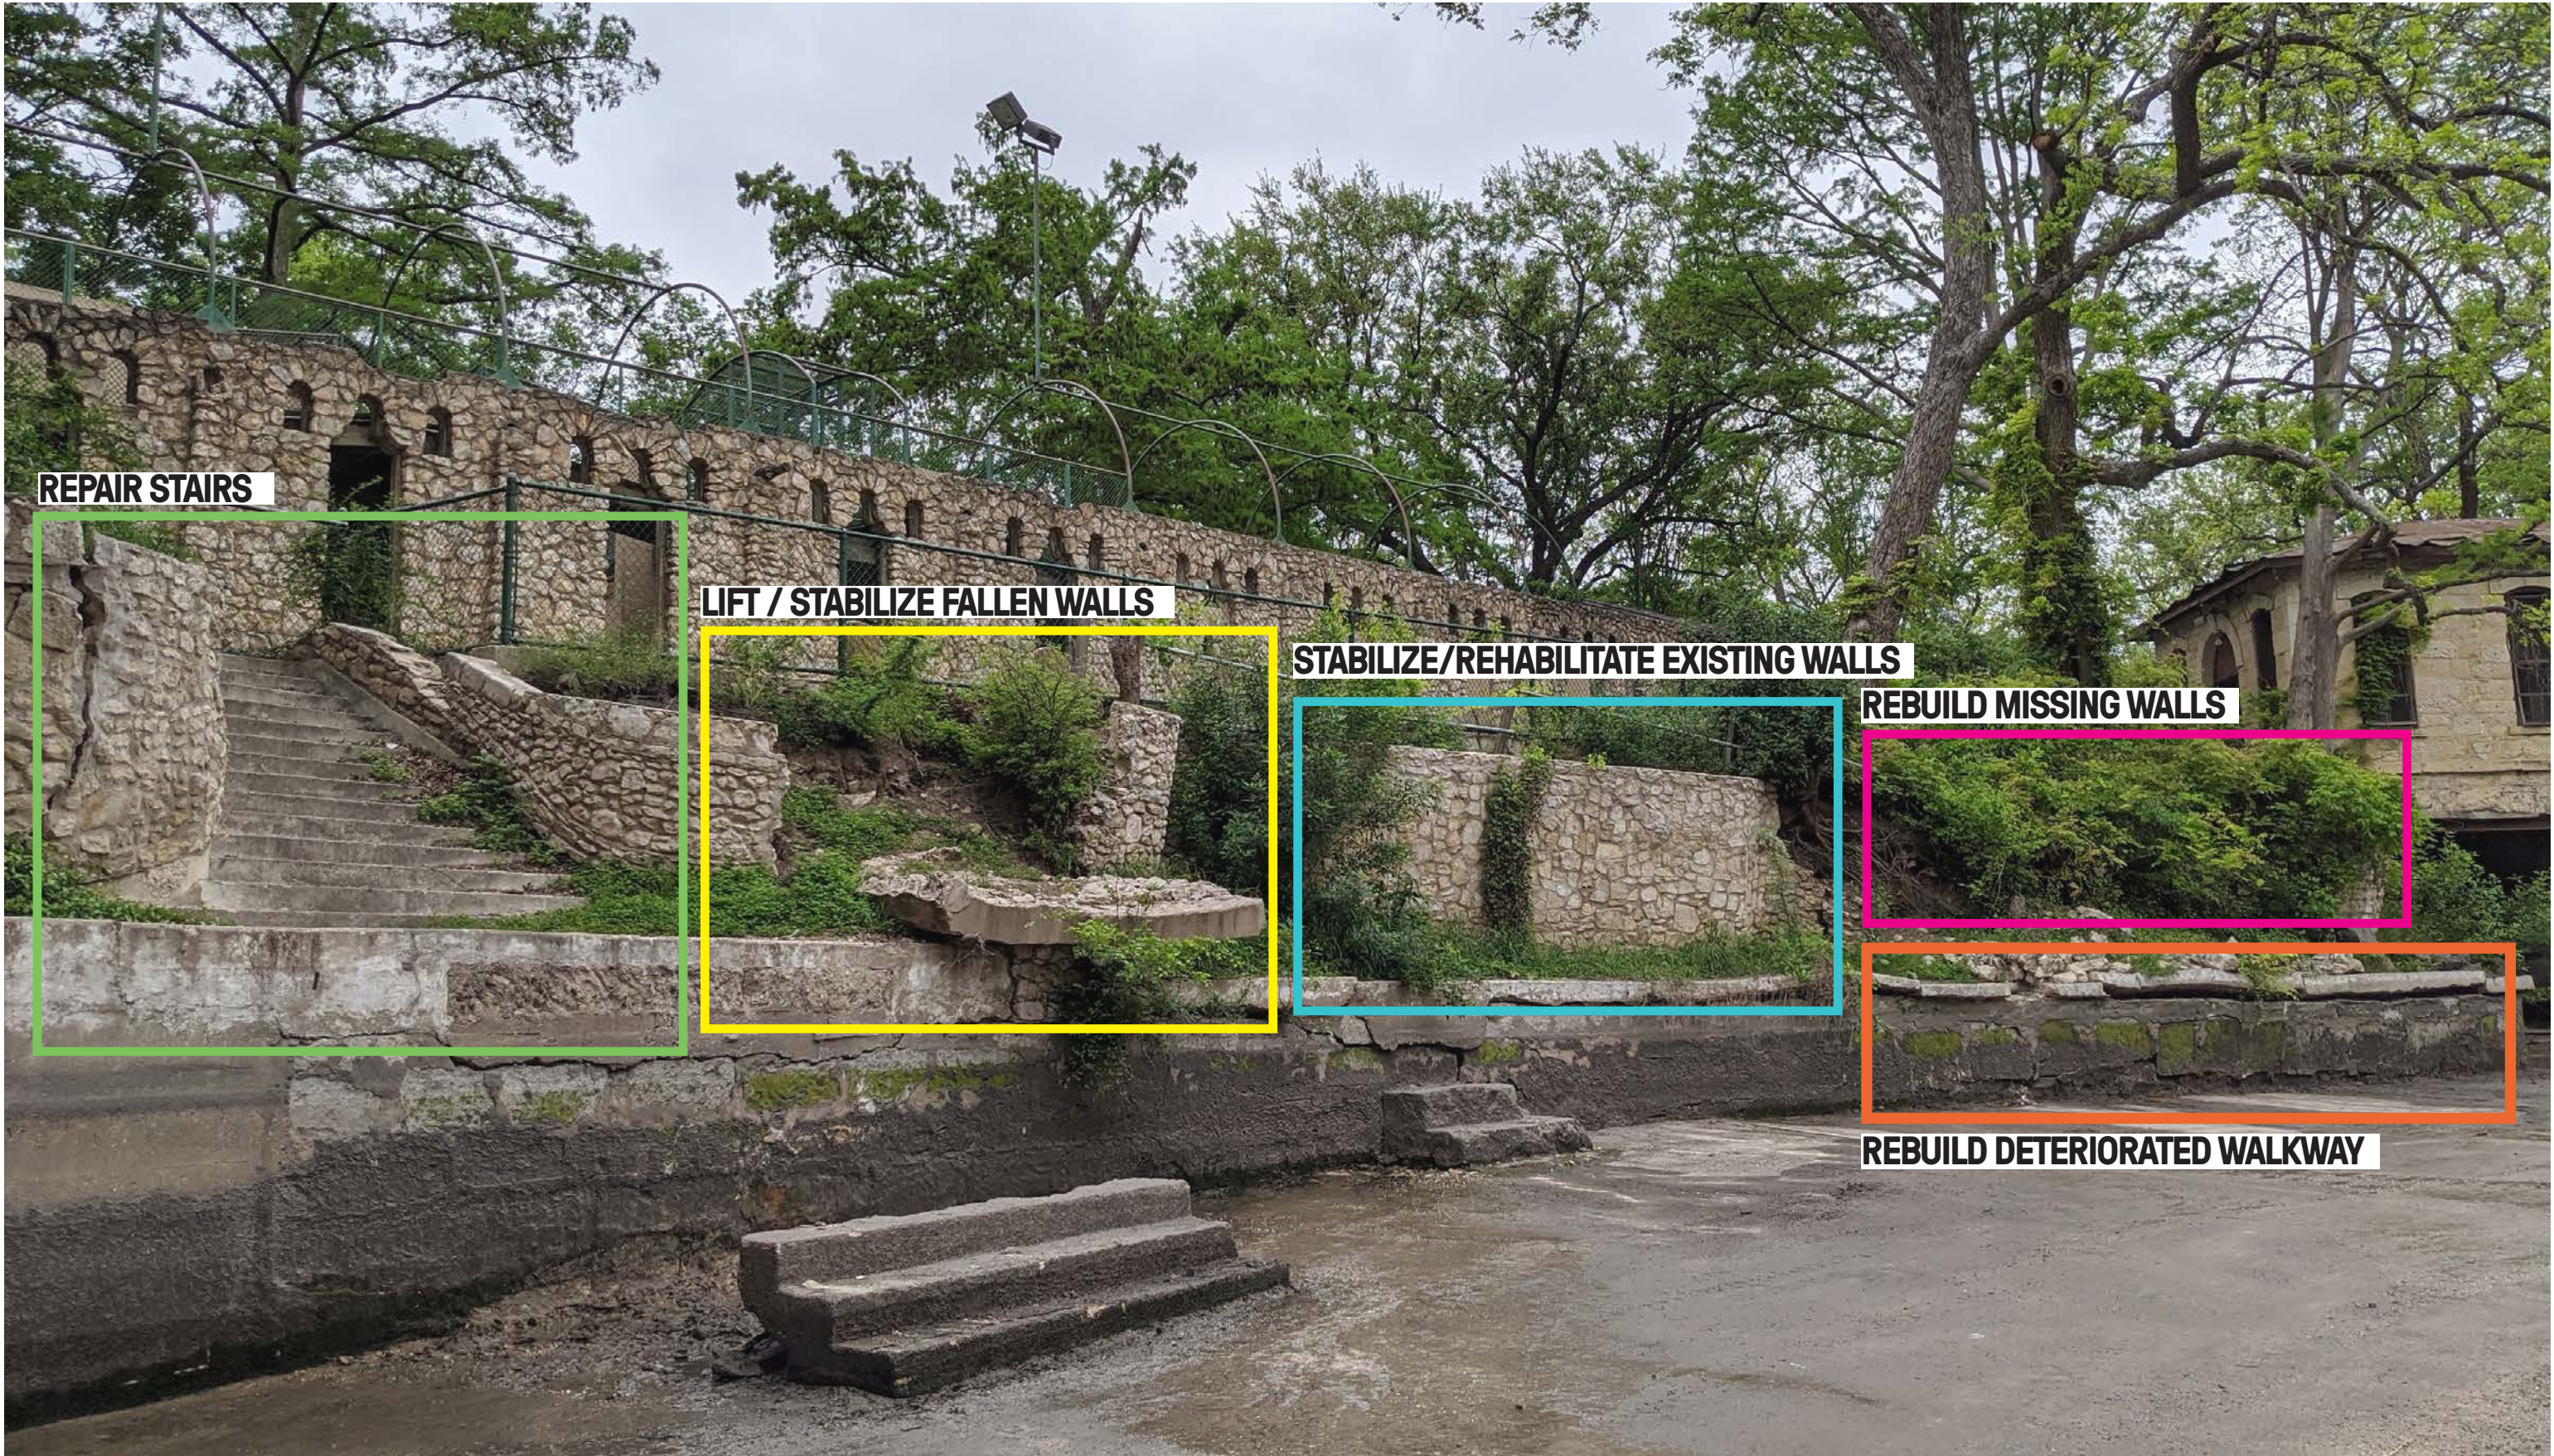
DEWATERED RIVER CHANNEL WALL AND WALK AT PUMP HOUSE

REPAIR STAIRS

LIFT / STABILIZE FALLEN WALLS

STABILIZE/REHABILITATE EXISTING WALLS

REBUILD MISSING WALLS

REBUILD DETERIORATED WALKWAY

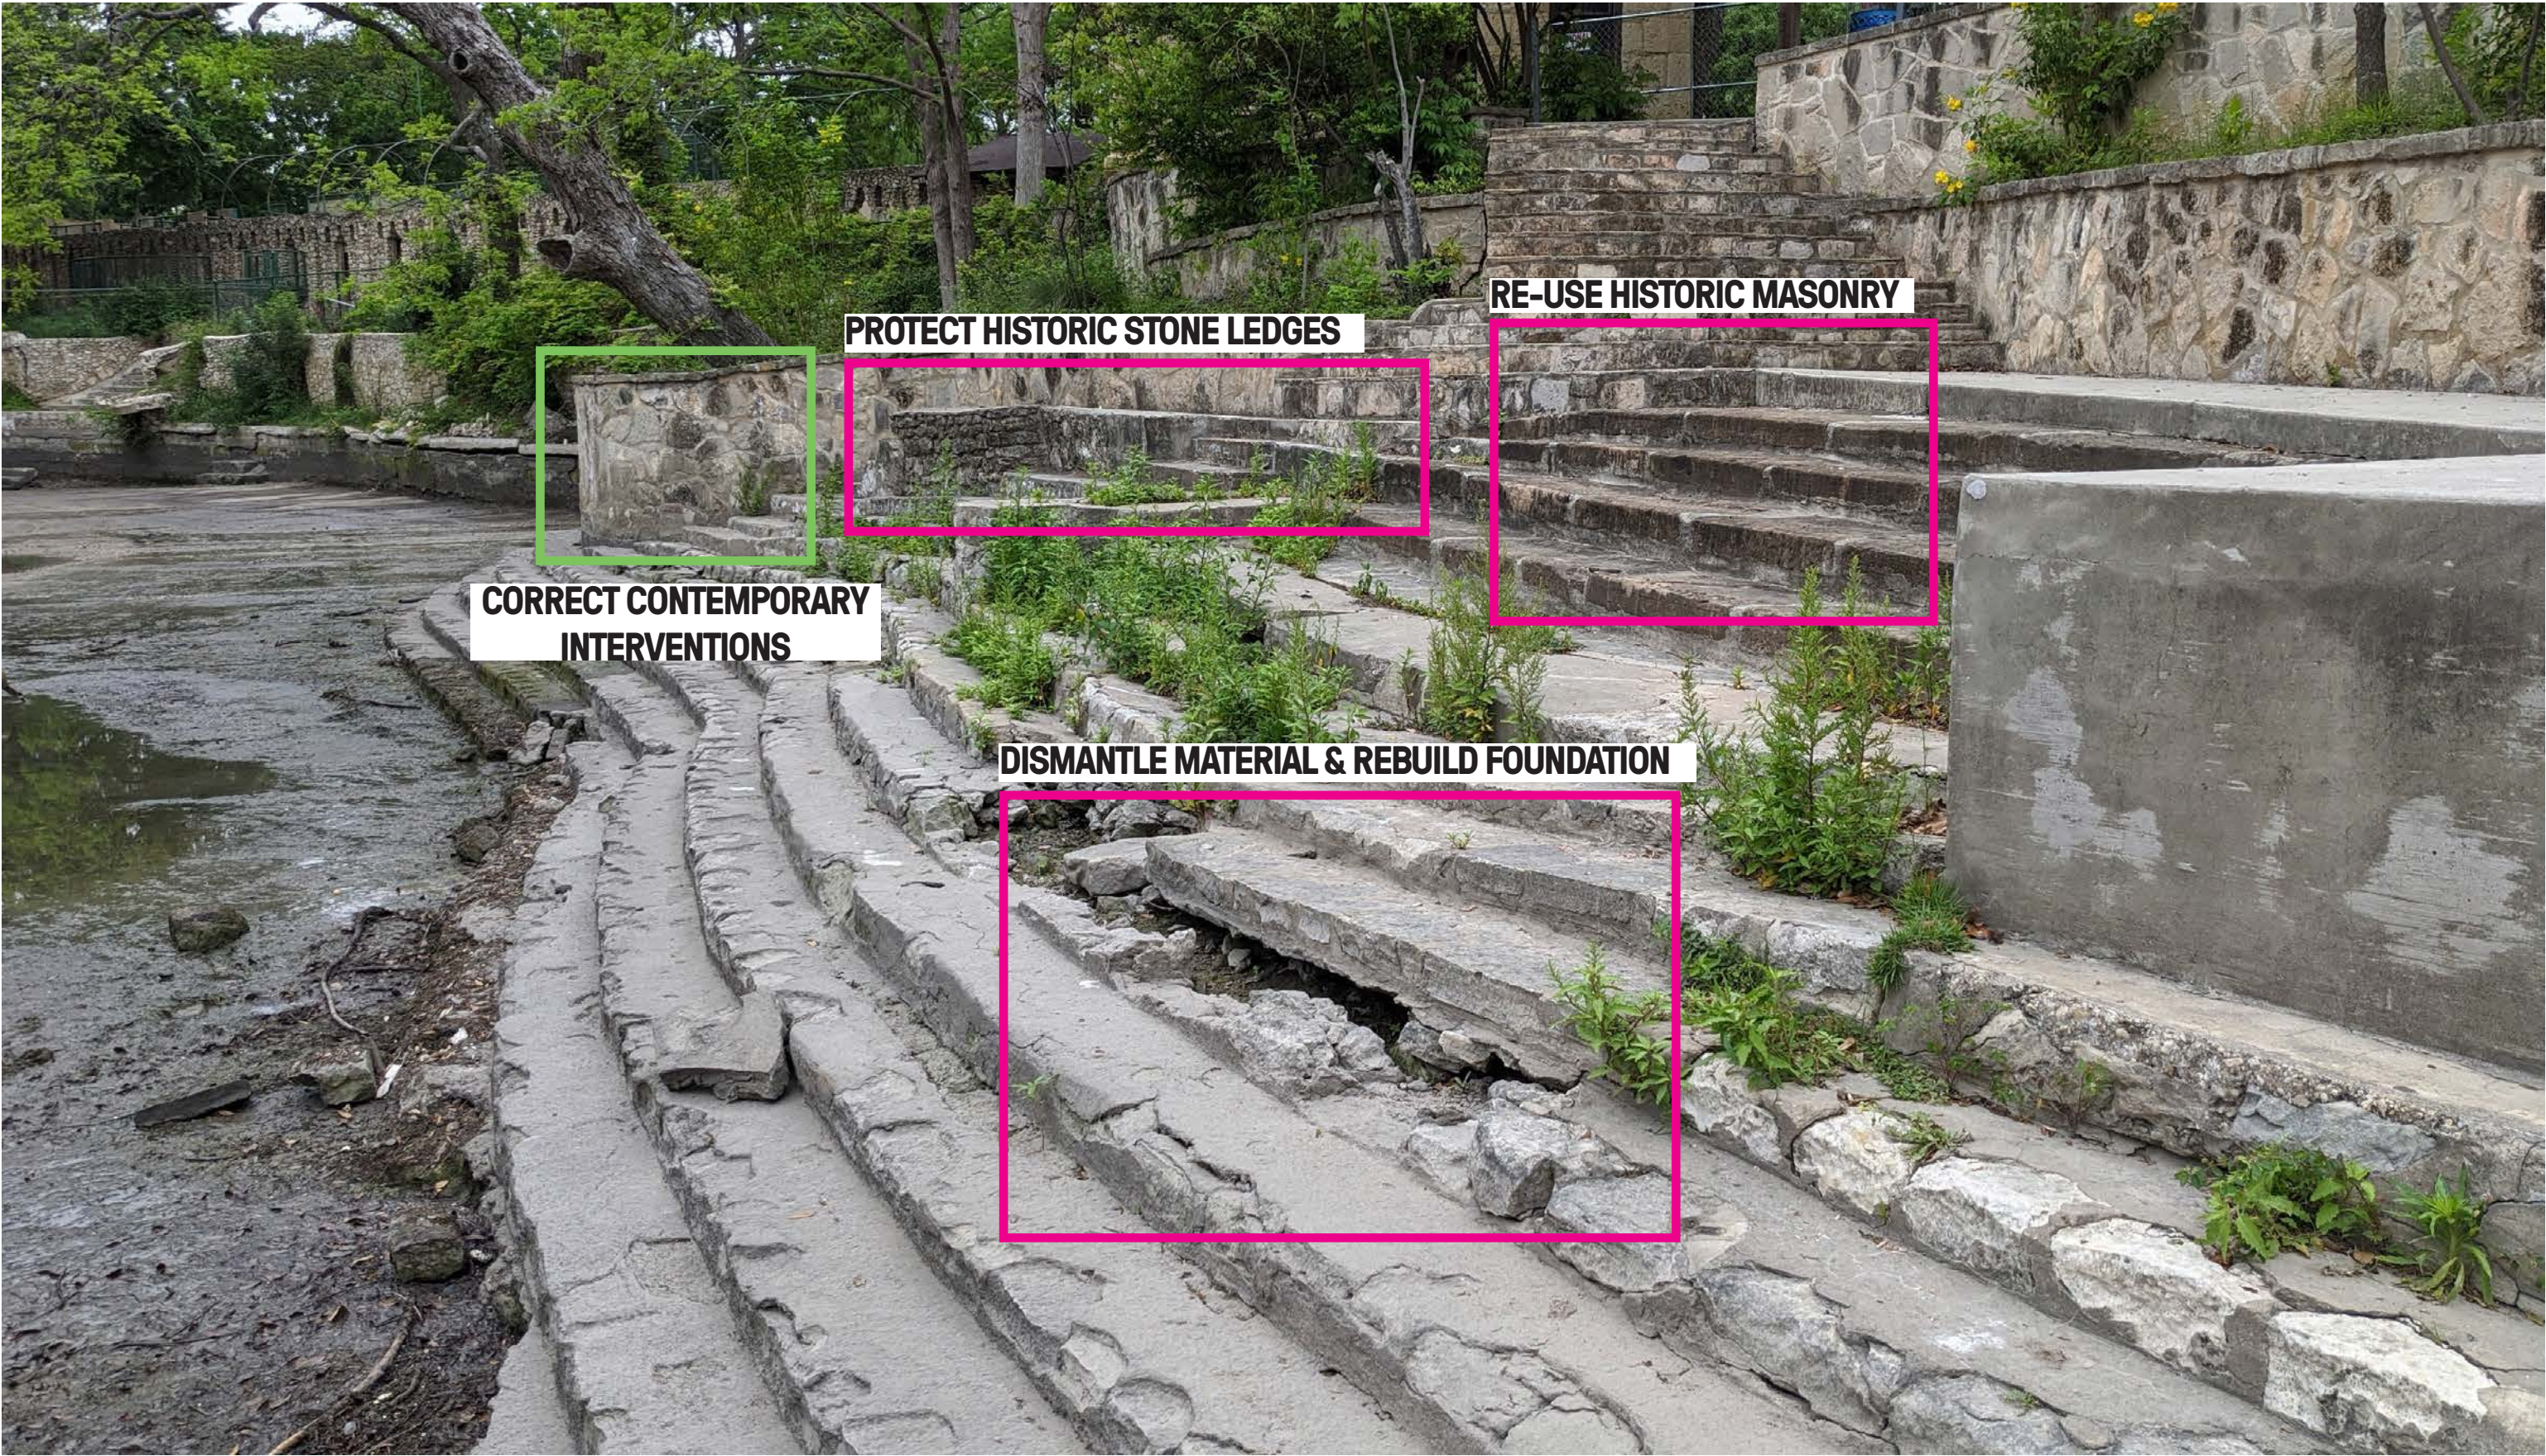
DEWATERED LAMBERT BEACH GRAND STAIR

**CORRECT CONTEMPORARY
INTERVENTIONS**

PROTECT HISTORIC STONE LEDGES

RE-USE HISTORIC MASONRY

DISMANTLE MATERIAL & REBUILD FOUNDATION

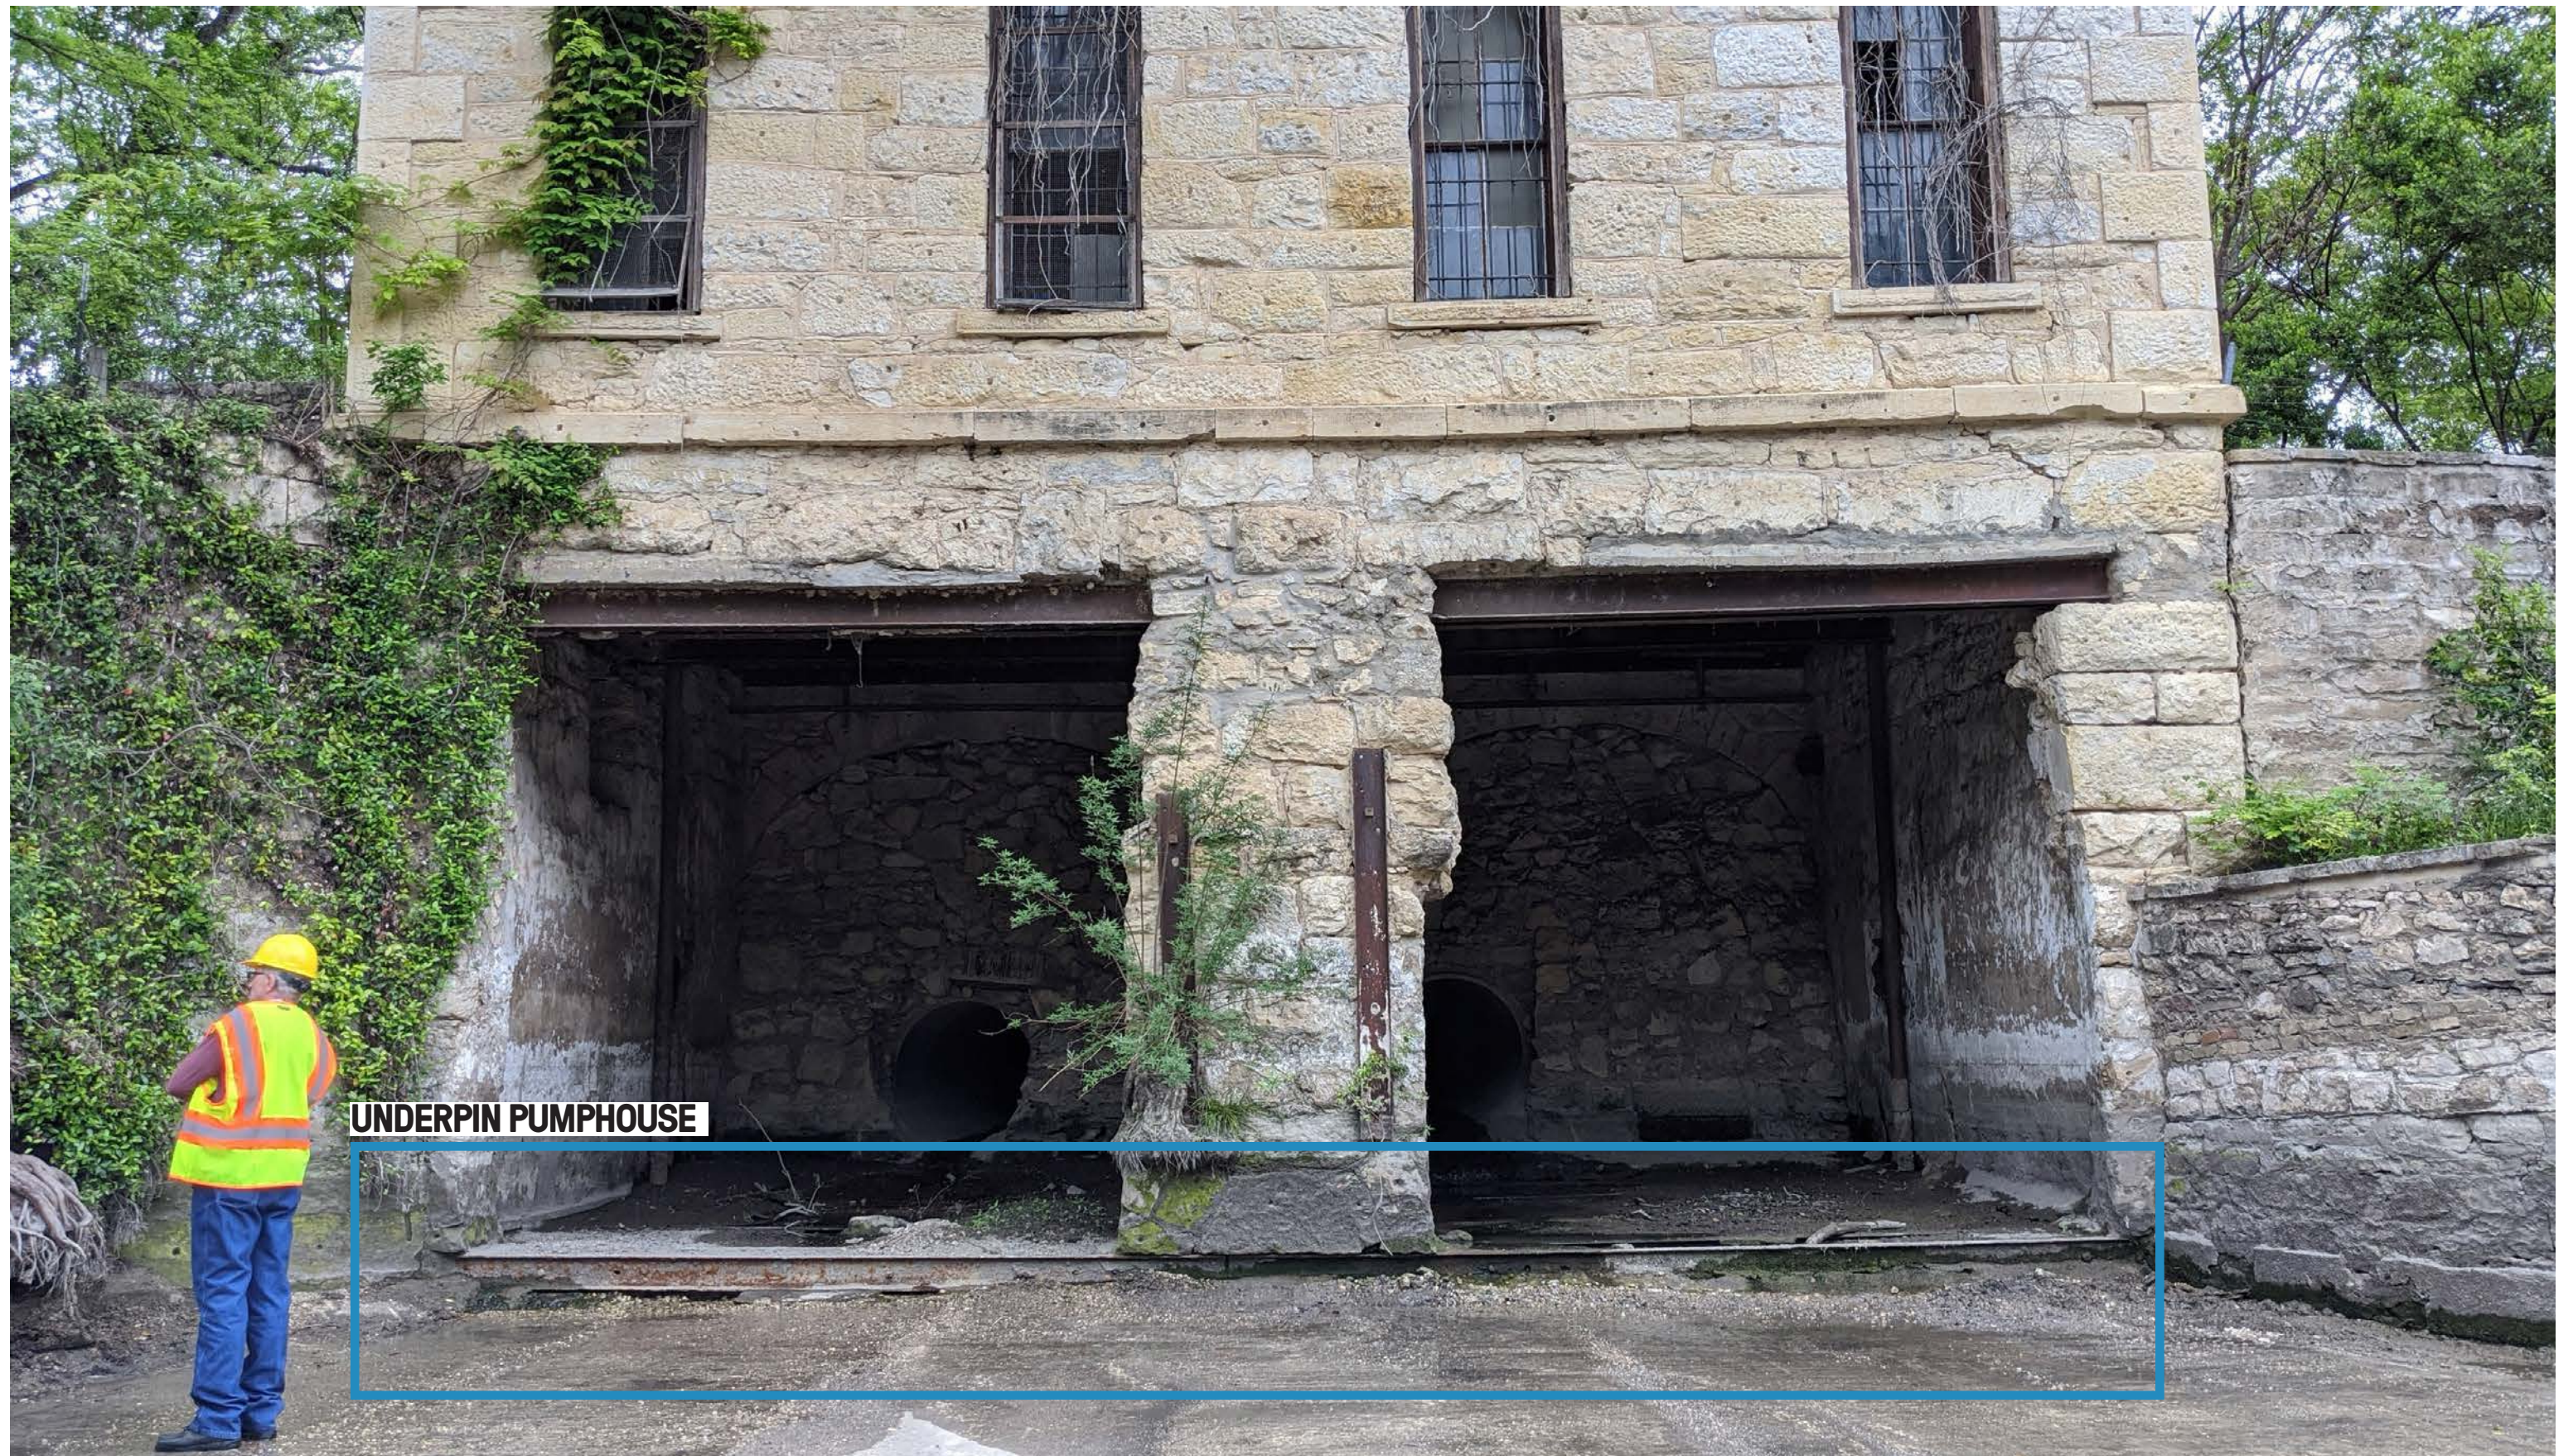
DEWATERED RIVER LEVEL FLOOR OF PUMP HOUSE

UNDERPIN PUMPHOUSE

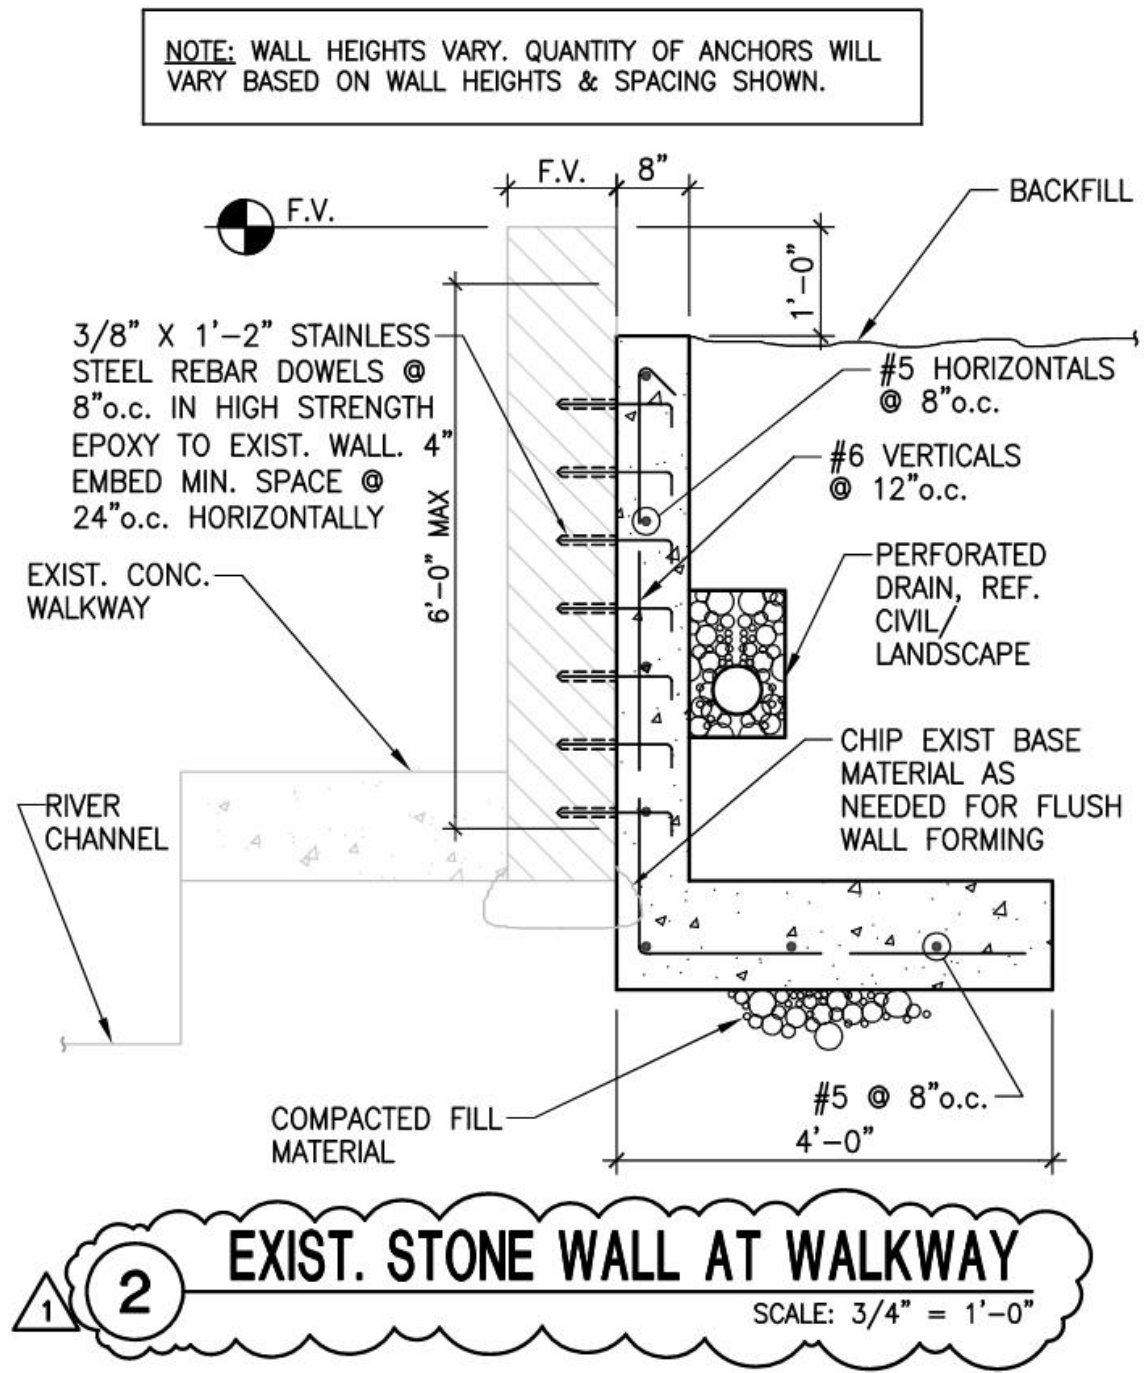
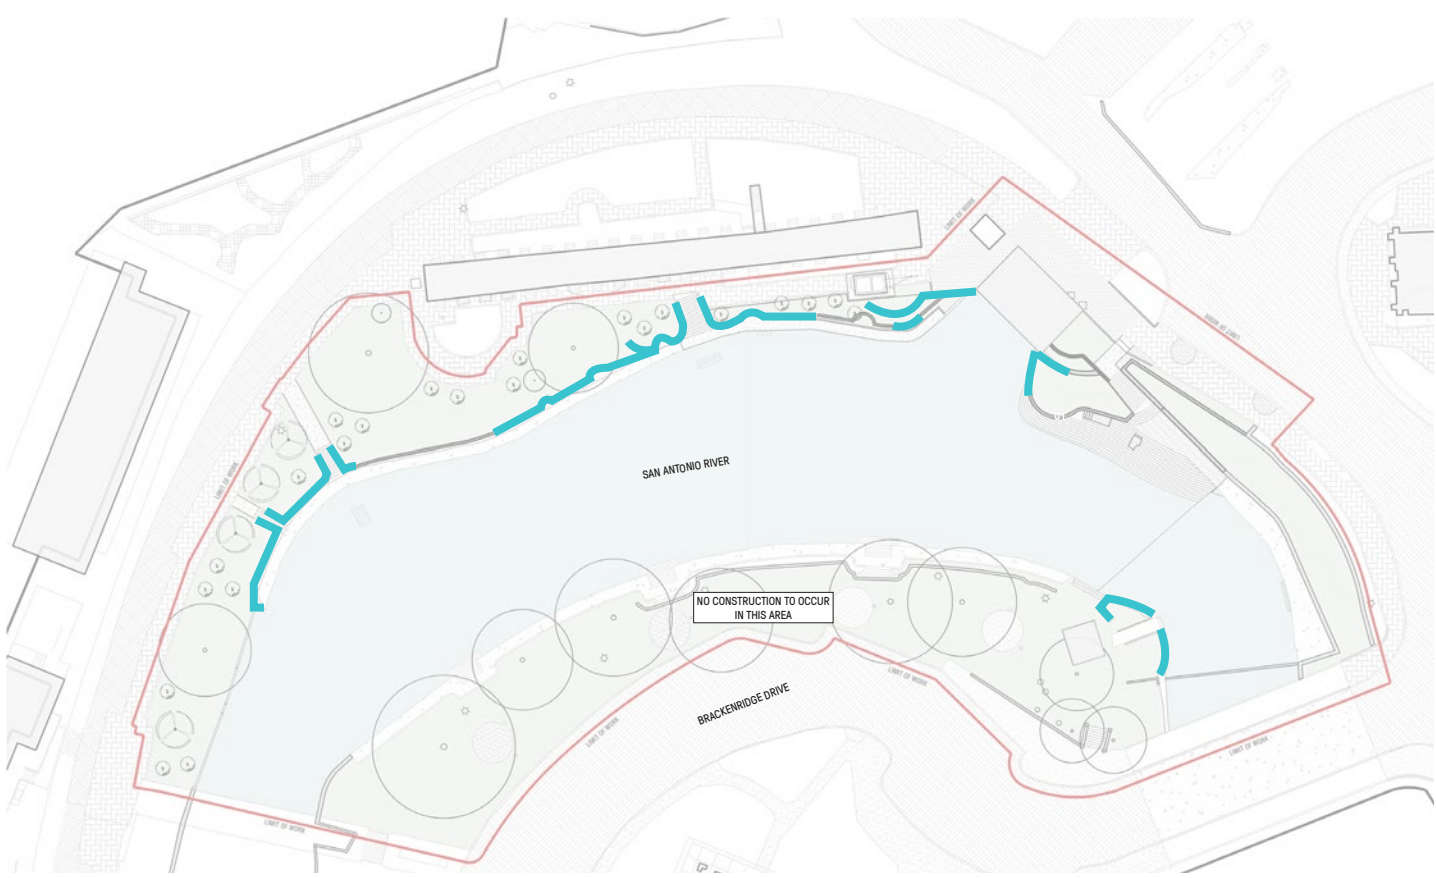
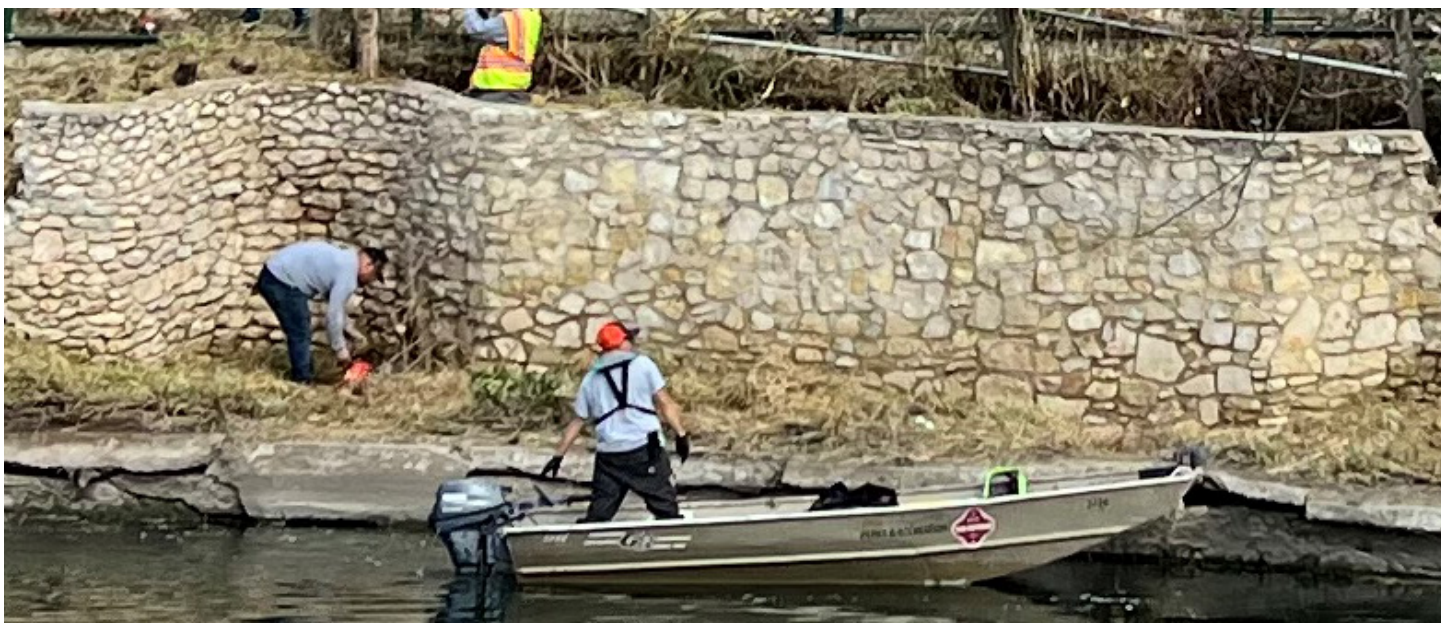
STRUCTURAL DETAILS : LAMBERT BEACH WALLS
