brackenridge park

A POSTCARD PLACE LOST IN TIME

HDRC MEETING

19 APRIL 2023

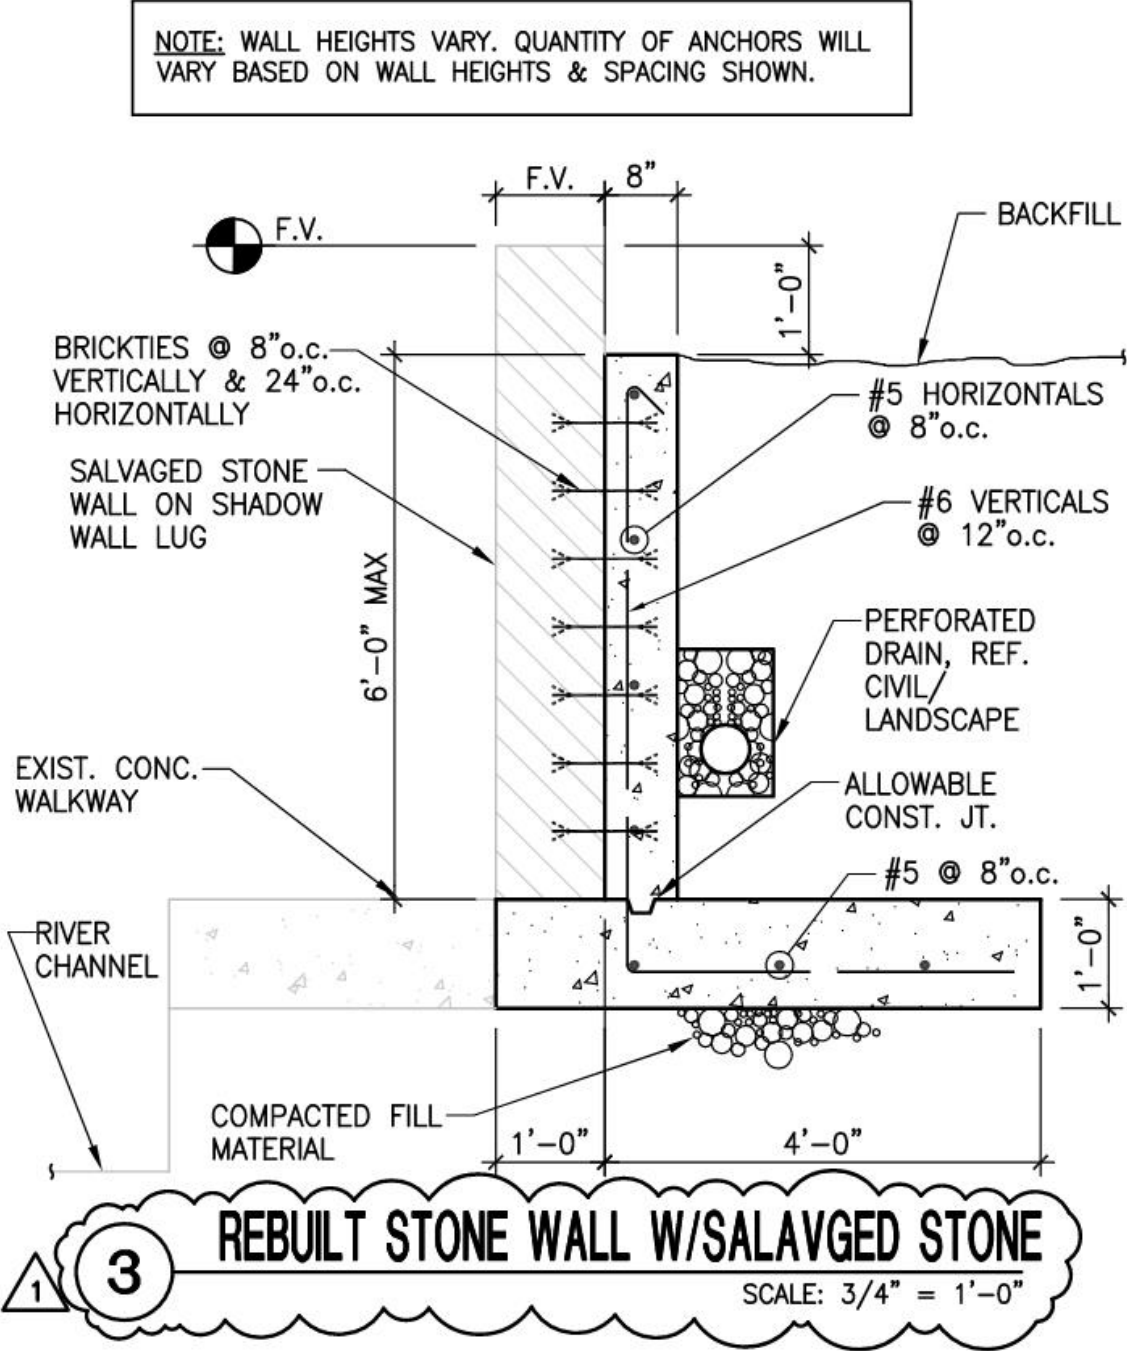
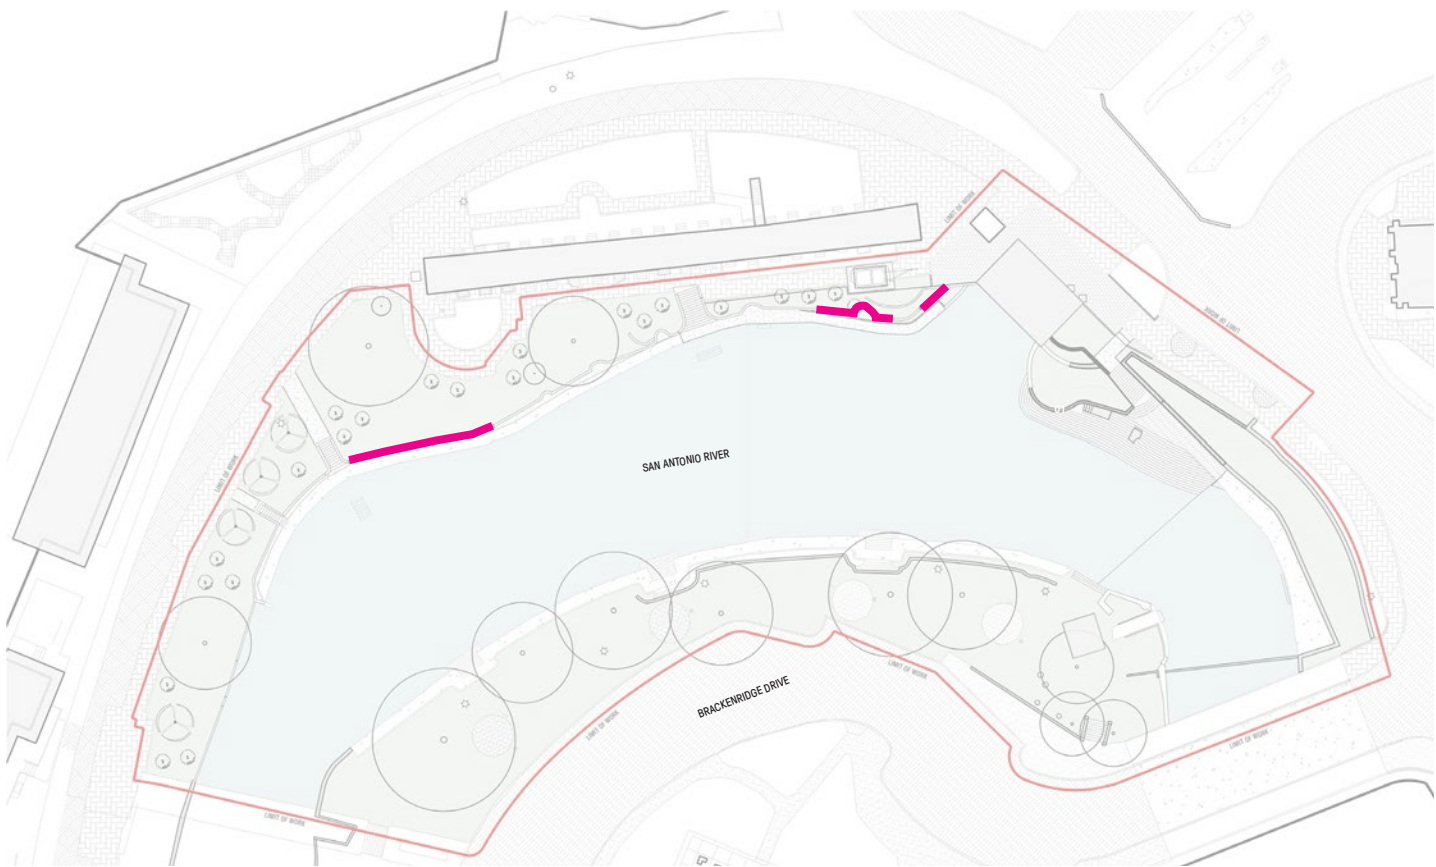
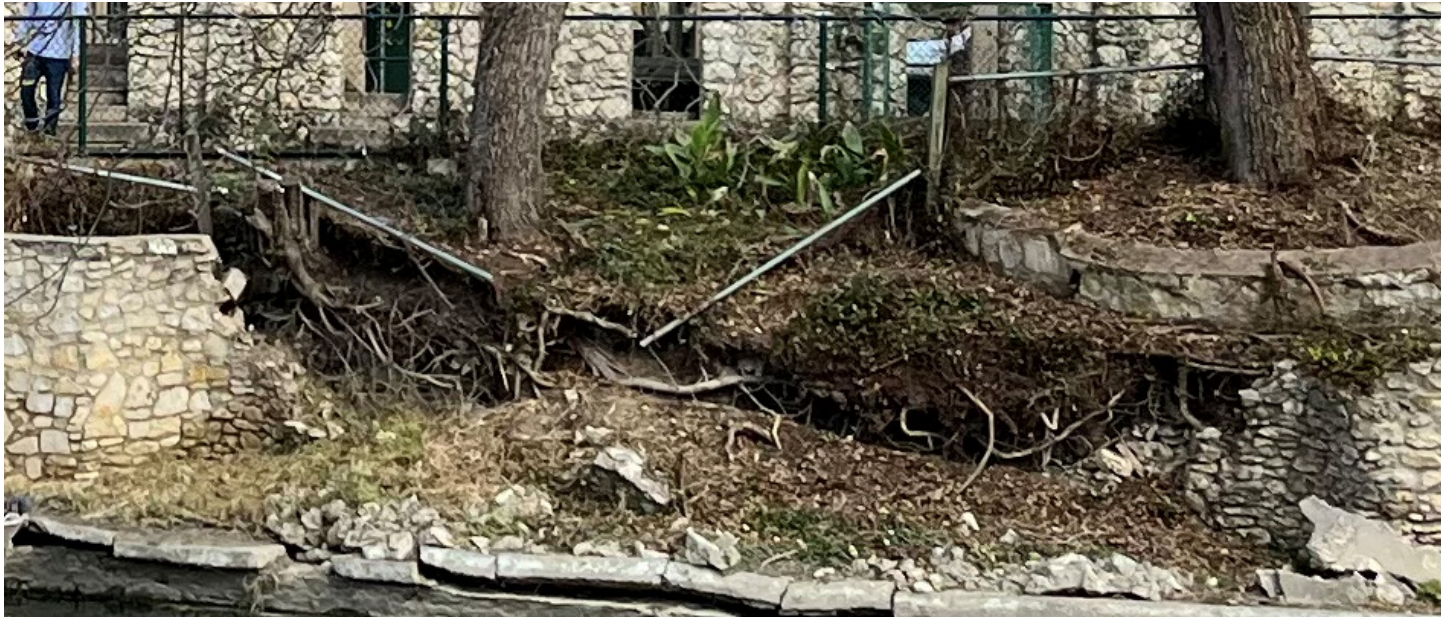
STRUCTURAL DETAILS : LAMBERT BEACH WALLS

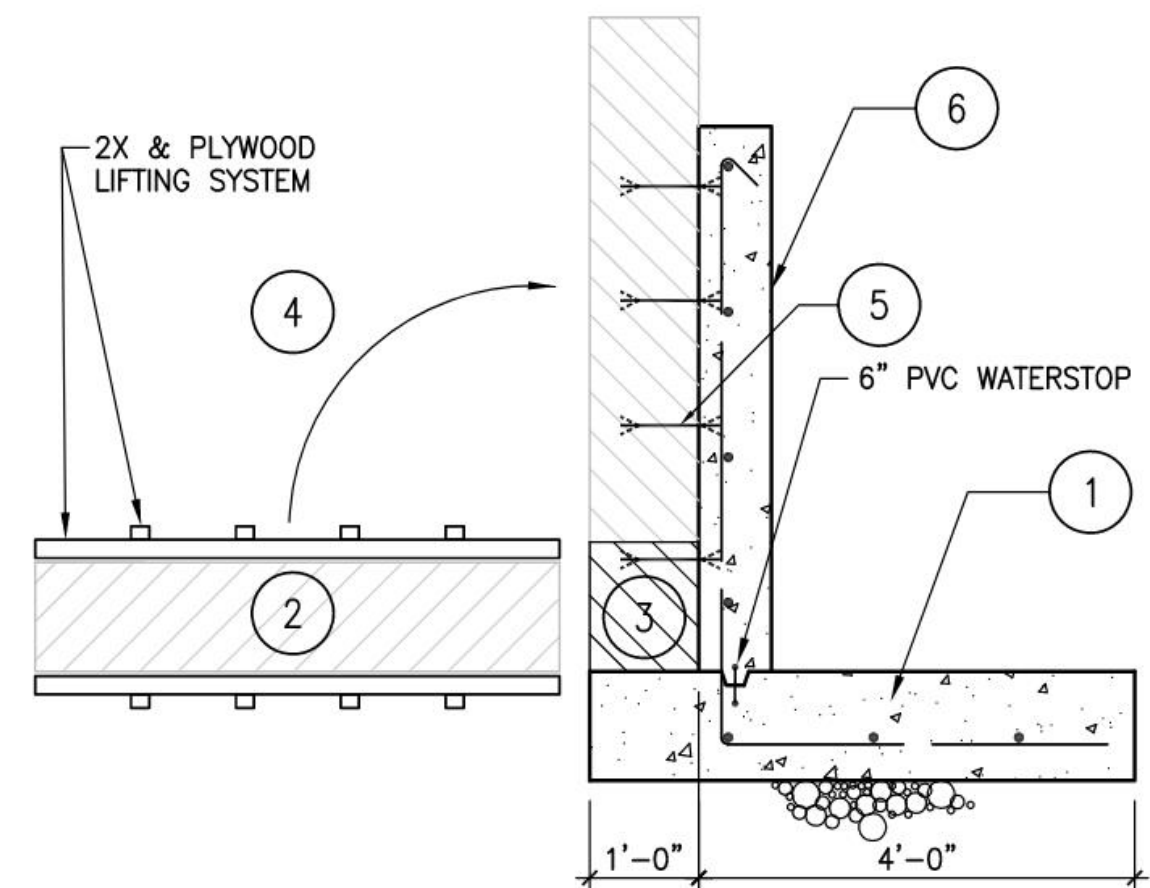
SALAVAGED WALL LIFTING METHOD

- 1. FORM AND POUR NEW SHADOW WALL FOOTING.
- 2. SECURE EXISTING WALL IN LIFTING FRAMEWORK.
- 3. REBUILD BASE FOR EXISTING WALL USING RECLAIMED EXISTING MATERIALS
- 4. LIFT EXISTING WALL INTO PLACE.
- 5. SET ANCHORS PER DETAIL 3/S3.00
- 6. FORM & POUR SHADOW WALL REF.3/S3.00

SCALE: 3/4" = 1'-0"
