# HISTORIC AND DESIGN REVIEW COMMISSION

August 02, 2023

**HDRC CASE NO:** 2023-289  
**ADDRESS:** 211 WICKES  
**LEGAL DESCRIPTION:** NCB 938 BLK 1 LOT 4  
**ZONING:** RM-4, H  
**CITY COUNCIL DIST.:** 1  
**DISTRICT:** King William Historic District  
**APPLICANT:** Elaine Lutton/Lutton Properties LLC  
**OWNER:** LUTTON PROPERTIES LLC  
**TYPE OF WORK:** Standing seam metal roof installation, Historic Tax Certification  
**APPLICATION RECEIVED:** July 20, 2023  
**60-DAY REVIEW:** September 11, 2023  
**CASE MANAGER:** Claudia Espinosa

1. Replace the existing composition shingle roof with a standing seam metal roof.
2. Receive Historic Tax Certification.

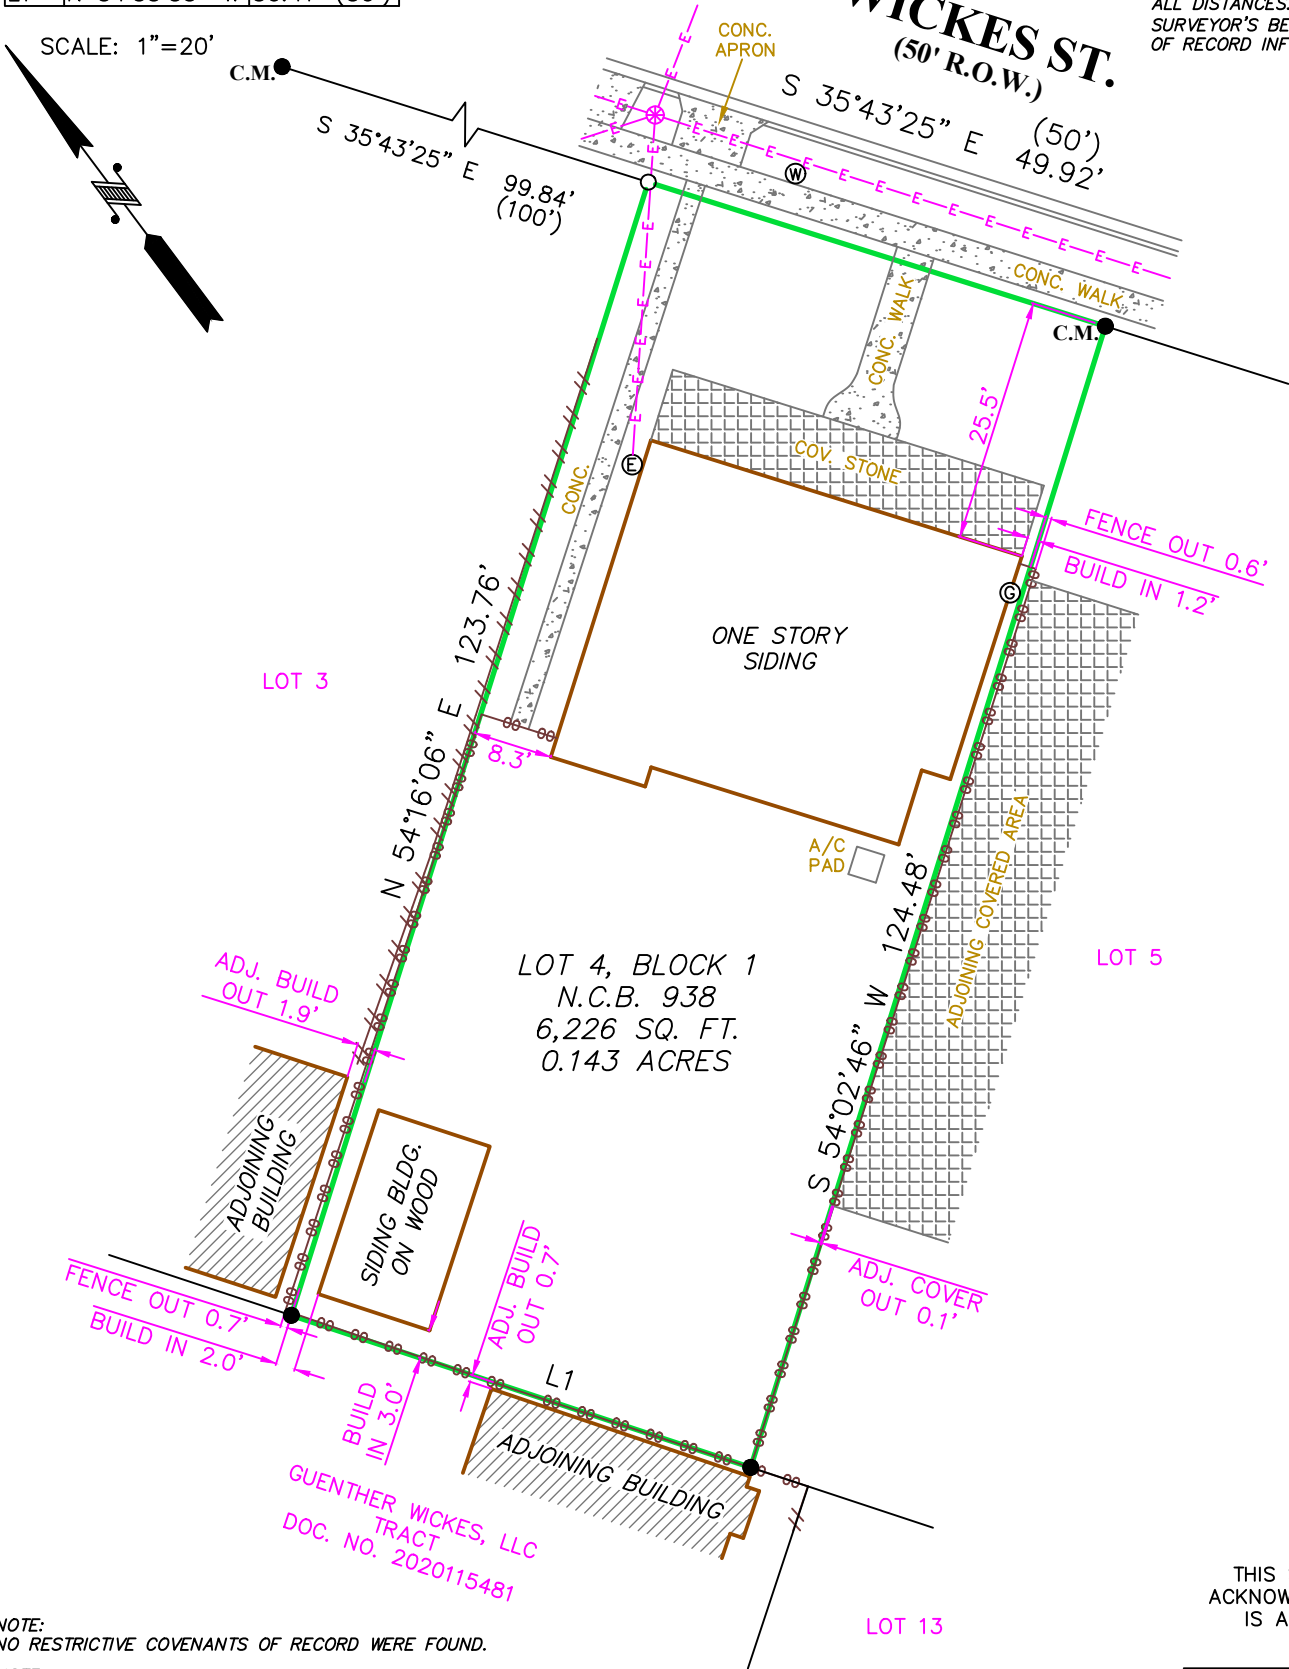
LINE	BEARING	DISTANCE
L1	N 34°53'55" W	50.41' (50')

SCALE: 1"=20'

NOTE:  
THE ORIGINAL MAP OR PLAT OF  
RECORD IS WITHOUT BEARINGS AND  
ALL DISTANCES. THIS IS THE  
SURVEYOR'S BEST INTERPRETATION  
OF RECORD INFORMATION.

NOTE:  
BEARINGS SHOWN HEREON ARE BASED ON ACTUAL GPS OBSERVATIONS,  
TEXAS STATE PLANE COORDINATES, SOUTH CENTRAL ZONE, GRID.

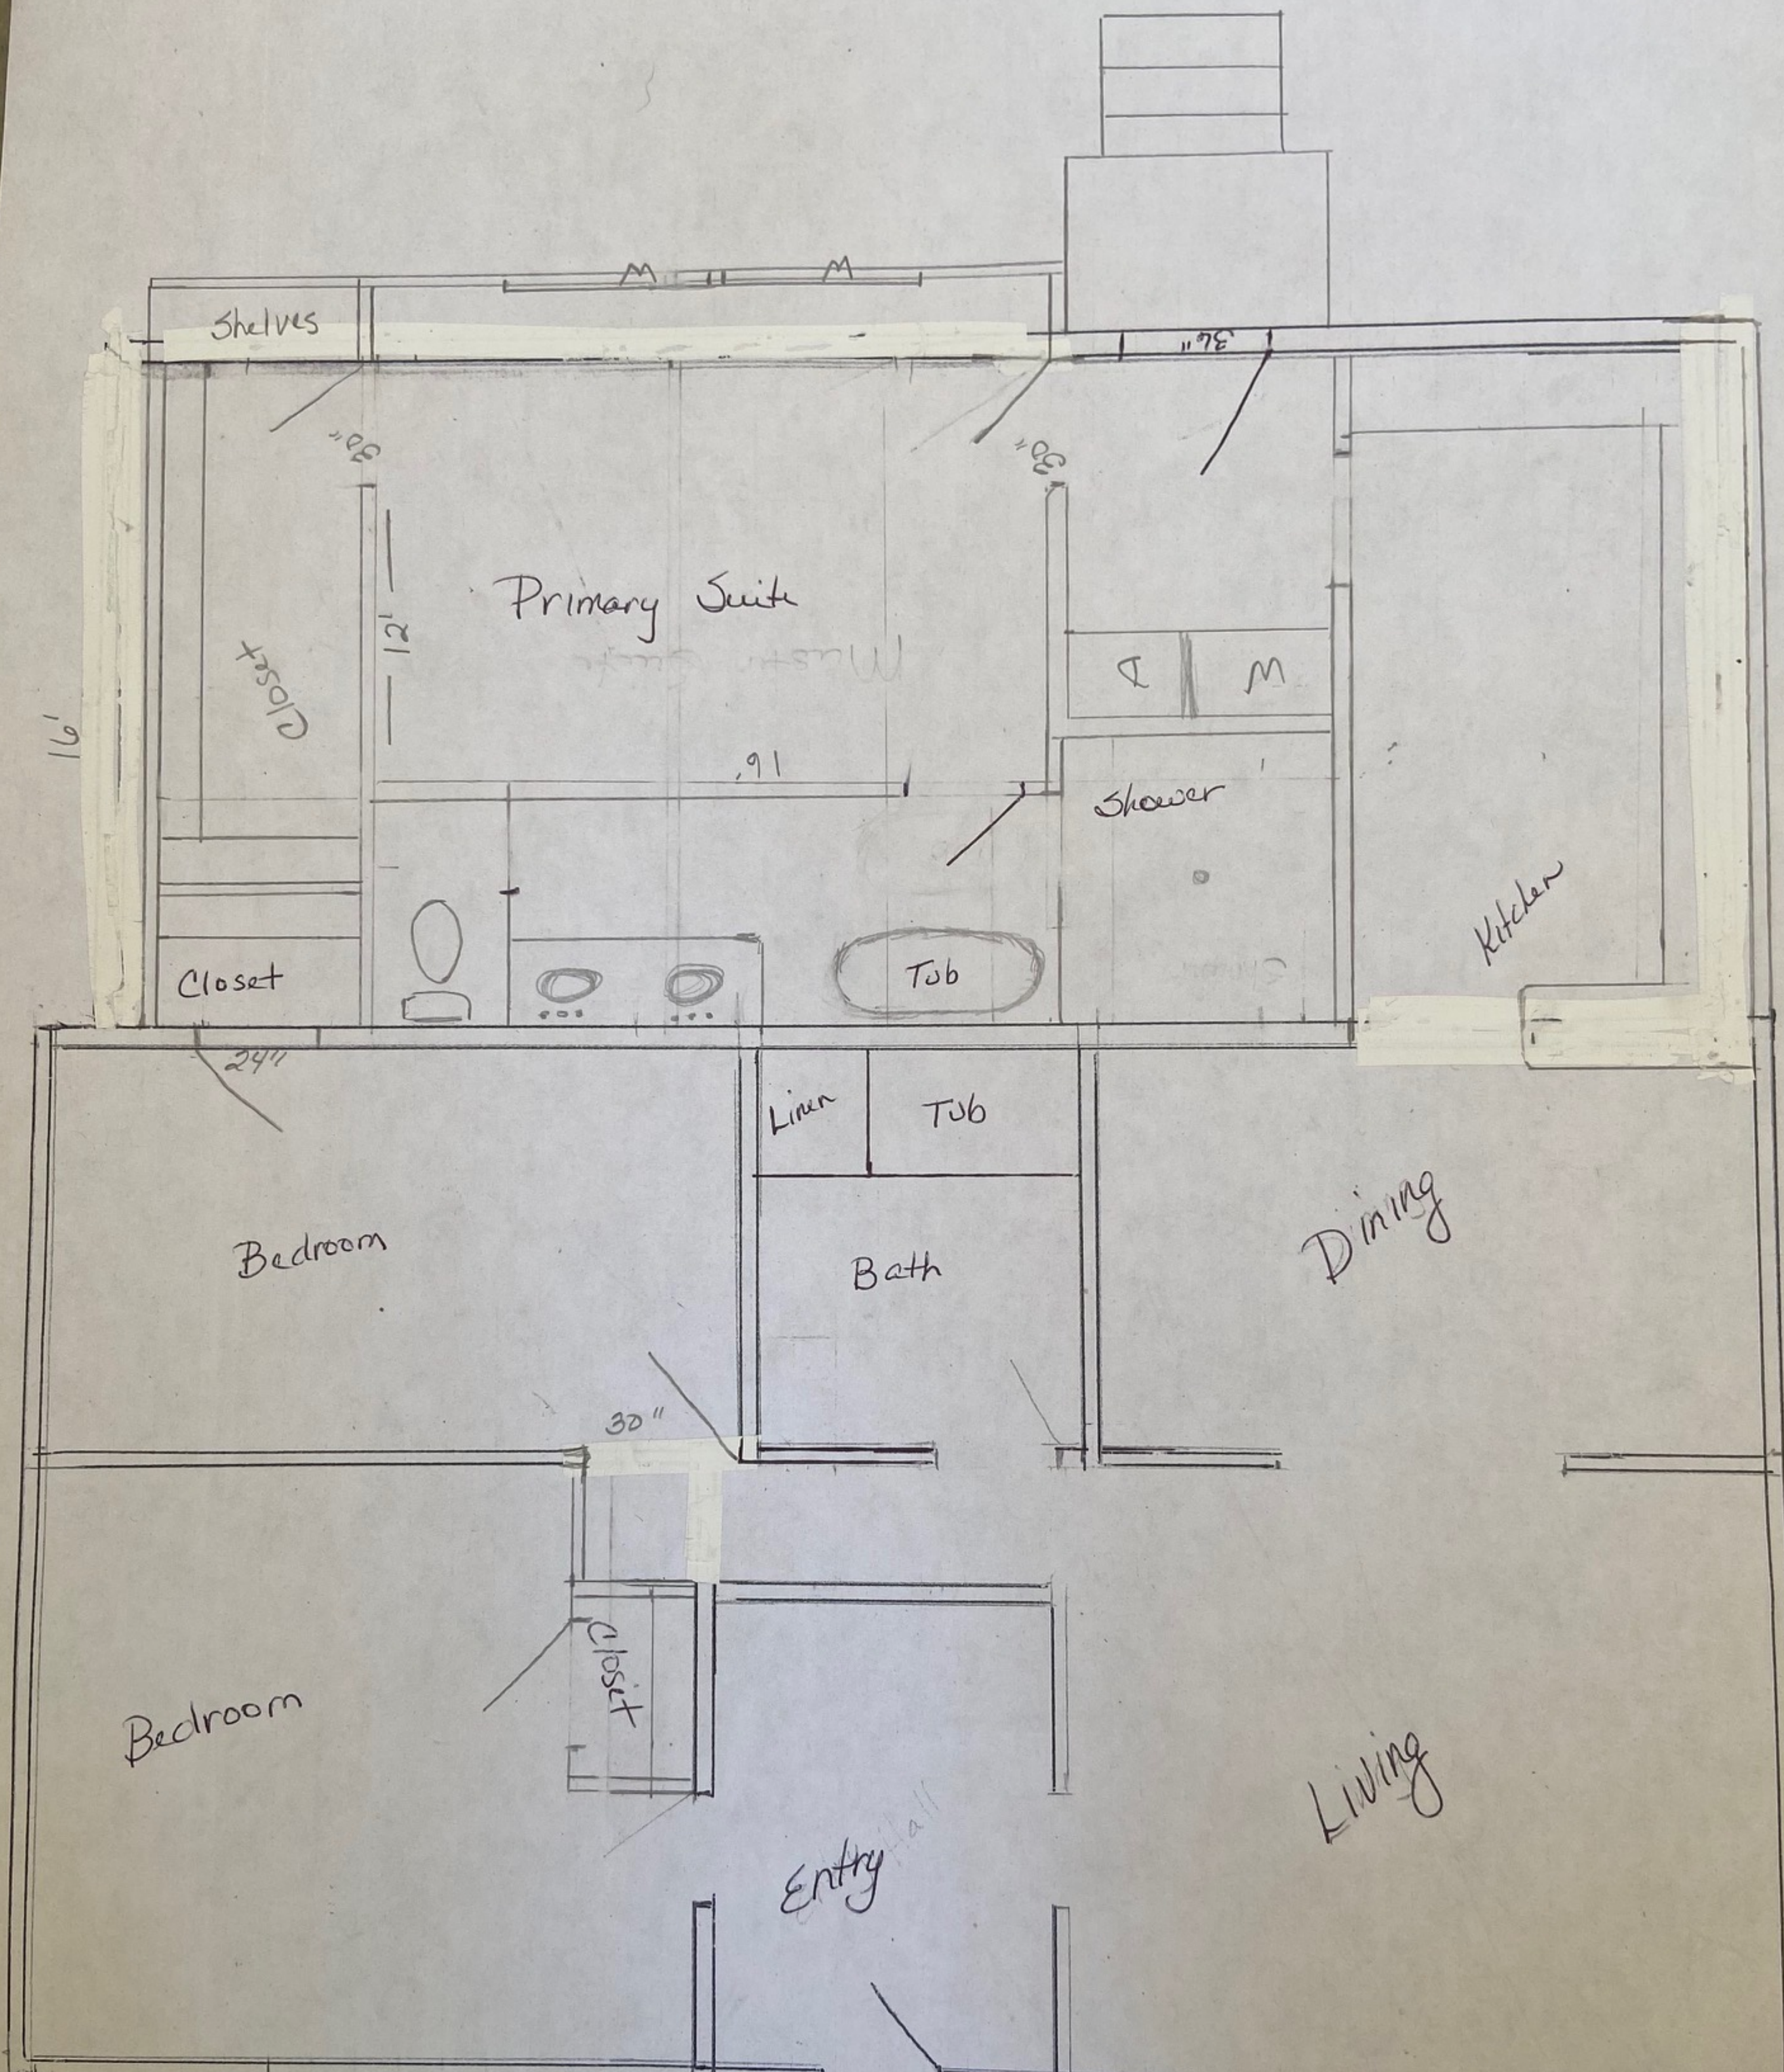
Front -

211 Wickes
