HISTORIC AND DESIGN REVIEW COMMISSION

HDRC CASE NO: 2023-337
ADDRESS: 419 WICKES
LEGAL DESCRIPTION: NCB 2881 BLK 6 LOT 11
ZONING: RM-4, H
CITY COUNCIL DIST.: 1
DISTRICT: King William Historic District
APPLICANT: Jacob Williams/WILLIAMS JACOB CHARLES & CHEVALIER KARINA
OWNER: Jacob Williams/WILLIAMS JACOB CHARLES & CHEVALIER KARINA
TYPE OF WORK: Front porch post installation, handrail installation, removal of porch plinths
APPLICATION RECEIVED: August 14, 2023
60-DAY REVIEW: October 13, 2023
CASE MANAGER: Jessica Anderson
REQUEST:

The applicant is requesting a Certificate of Appropriateness for approval to:

1. Remove the plinths found on each side of the front steps.
2. Install a handrail and posts on the front porch.

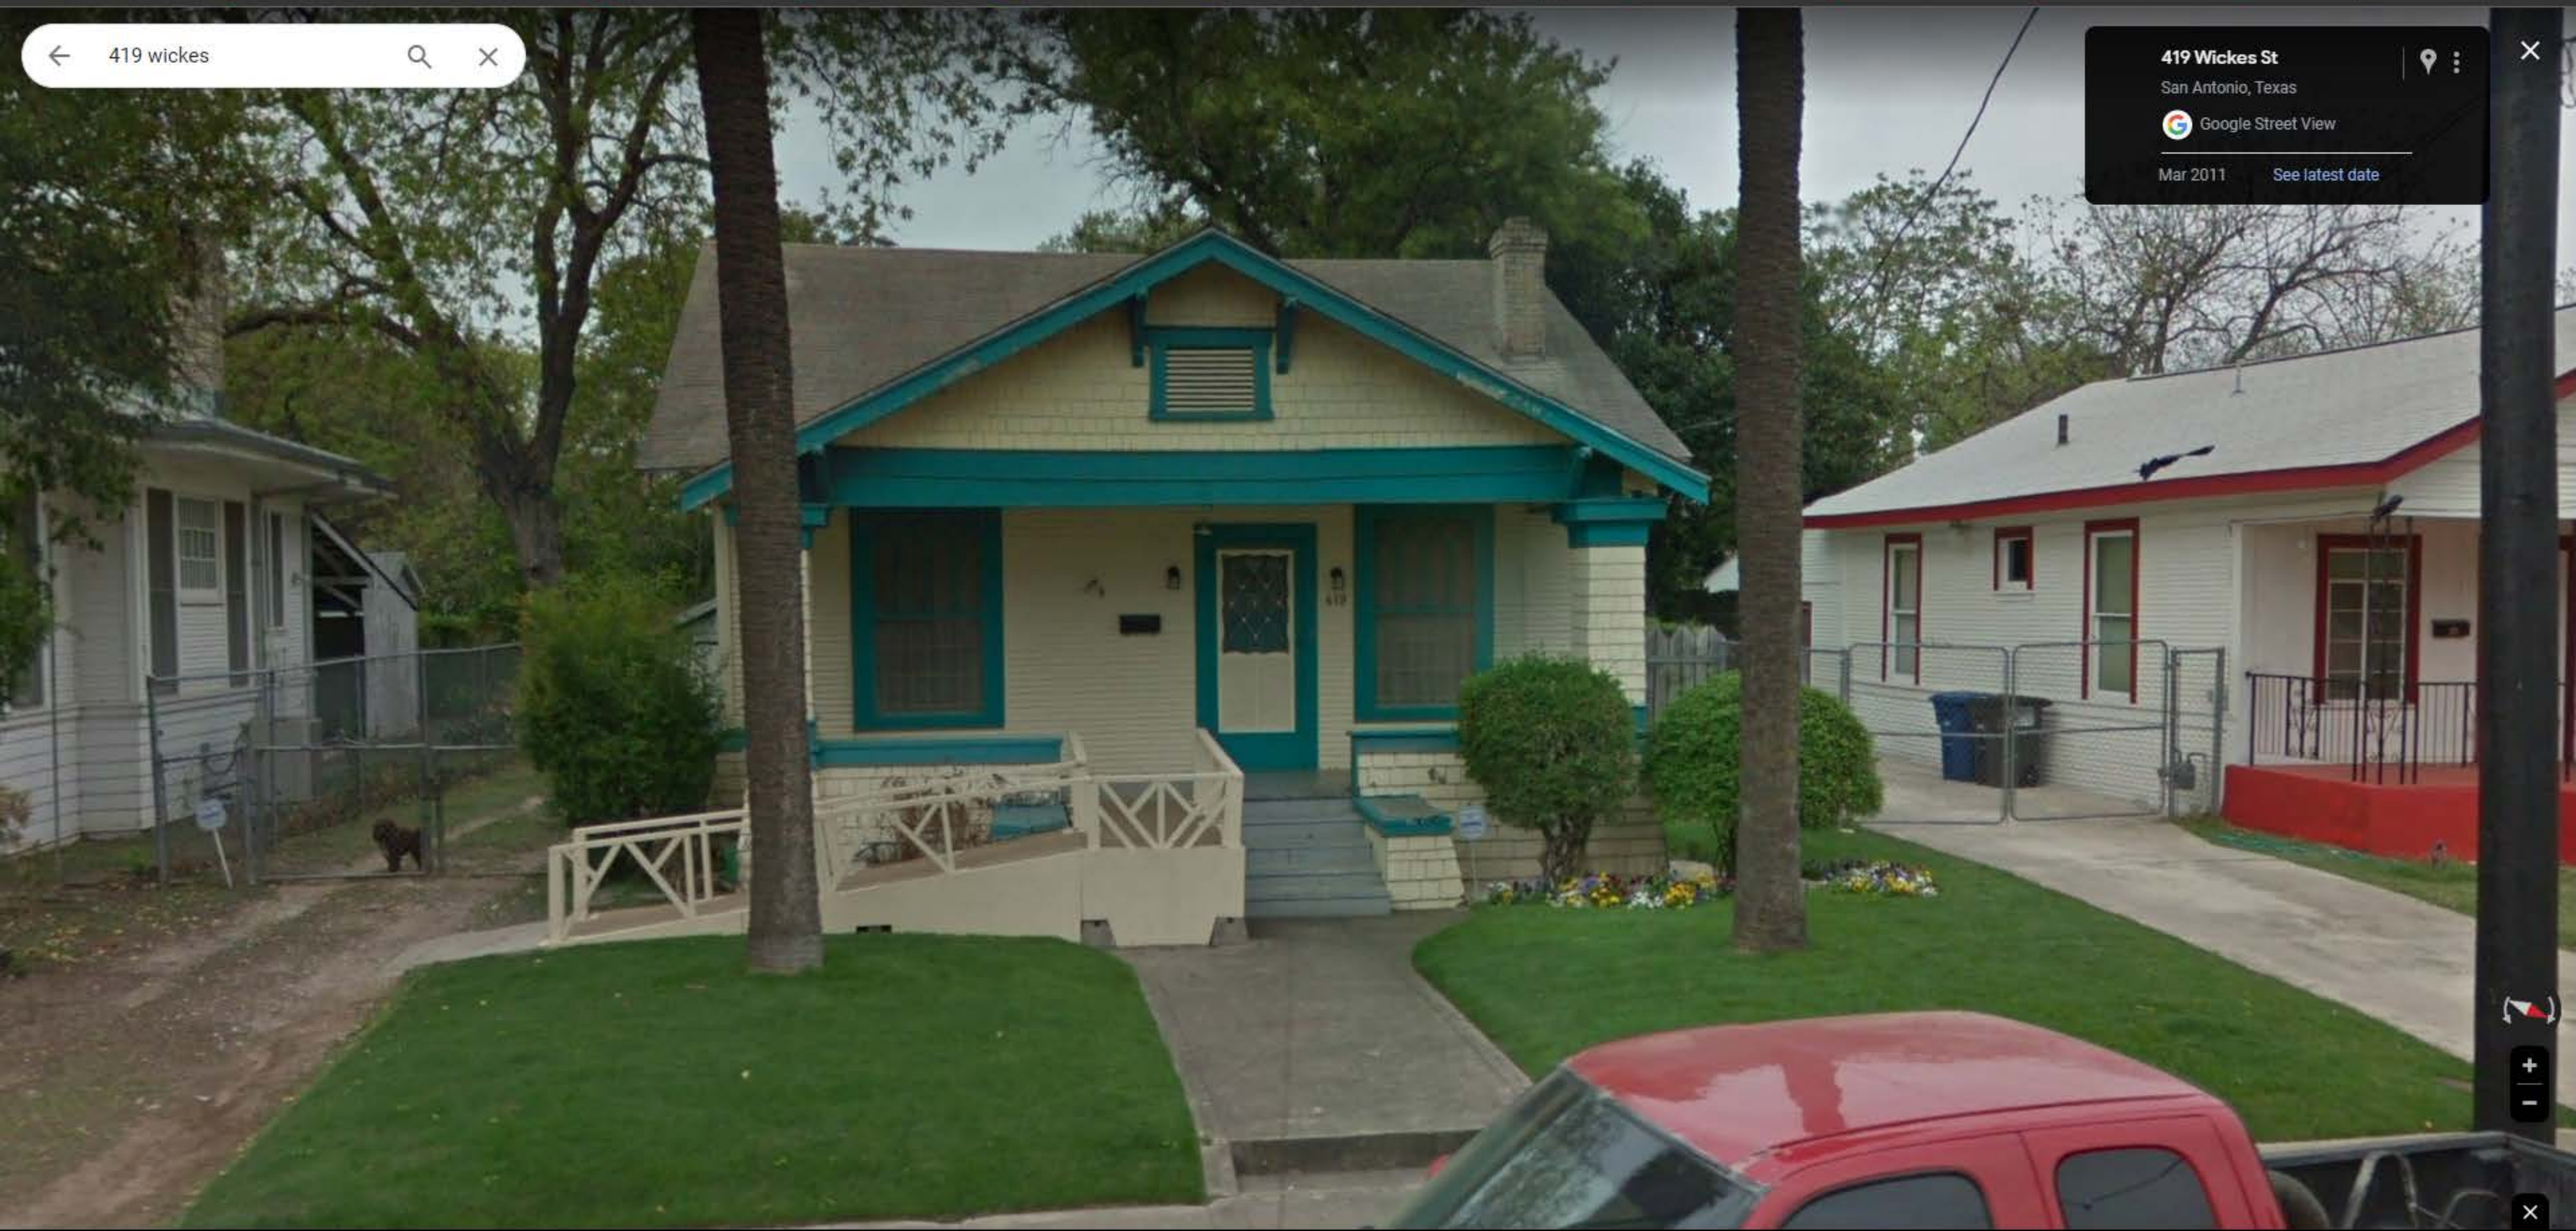
419 Wickes St
San Antonio, Texas

Mar 2011 [See latest date](#)

Staff does not recommend approval of item 1, removal of the plinths found on each side of the front steps, based on finding c. Staff recommends the plinths be reconstructed based on images available of the house from c. Oct 2007 until c. July 2014.
