HISTORIC AND DESIGN REVIEW COMMISSION

HDRC CASE NO: 2023-346
ADDRESS: 1407 FULTON AVE
LEGAL DESCRIPTION: NCB 2755 BLK 61 LOT 23 24
ZONING: R-4,H
CITY COUNCIL DIST.: 1
DISTRICT: Fulton Historic District
APPLICANT: Blanca Tellez /1 SHARPE OPPORTUNITY INTERMEDIATE TRUST
OWNER: Blanca Tellez /1 SHARPE OPPORTUNITY INTERMEDIATE TRUST
TYPE OF WORK: Wholesale window replacement, garage door removal, exterior door replacement
APPLICATION RECEIVED: August 04, 2023
60-DAY REVIEW: October 3, 2023
CASE MANAGER: Claudia Espinosa

1. Replace the existing wood windows with Croft Aluminum Windows.
2. Remove the existing garage doors leaving open bays.
3. Replace the exterior wooden doors with an aluminum door product.

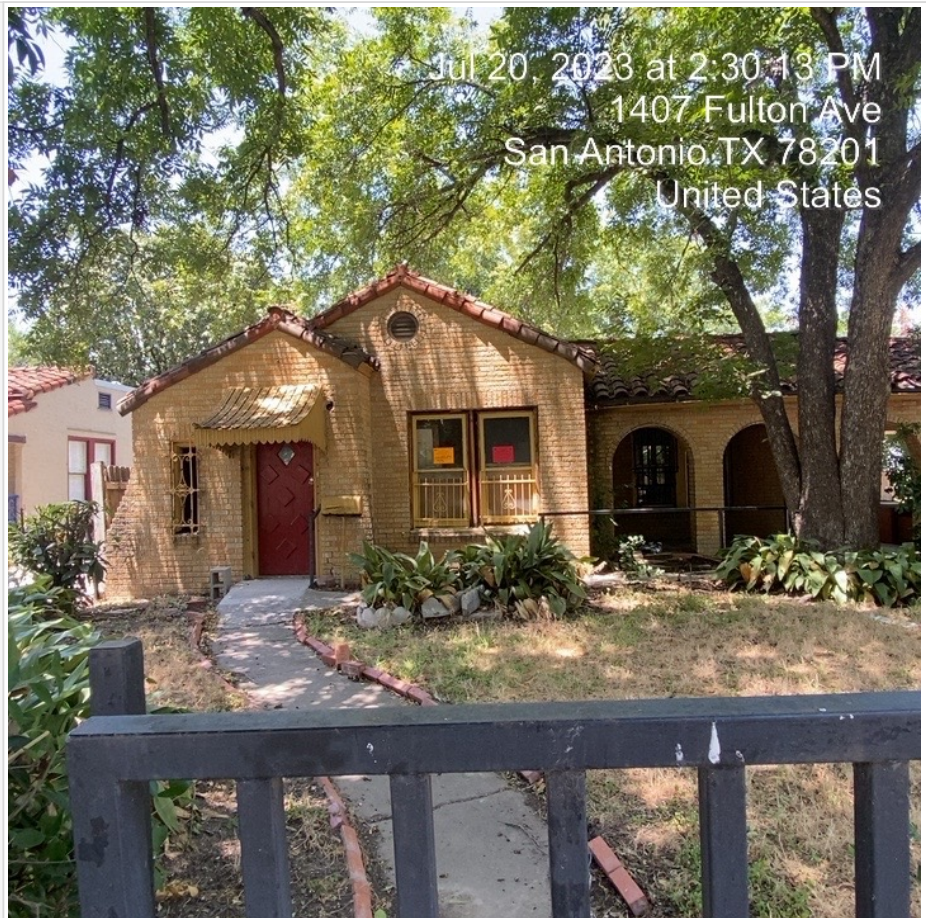
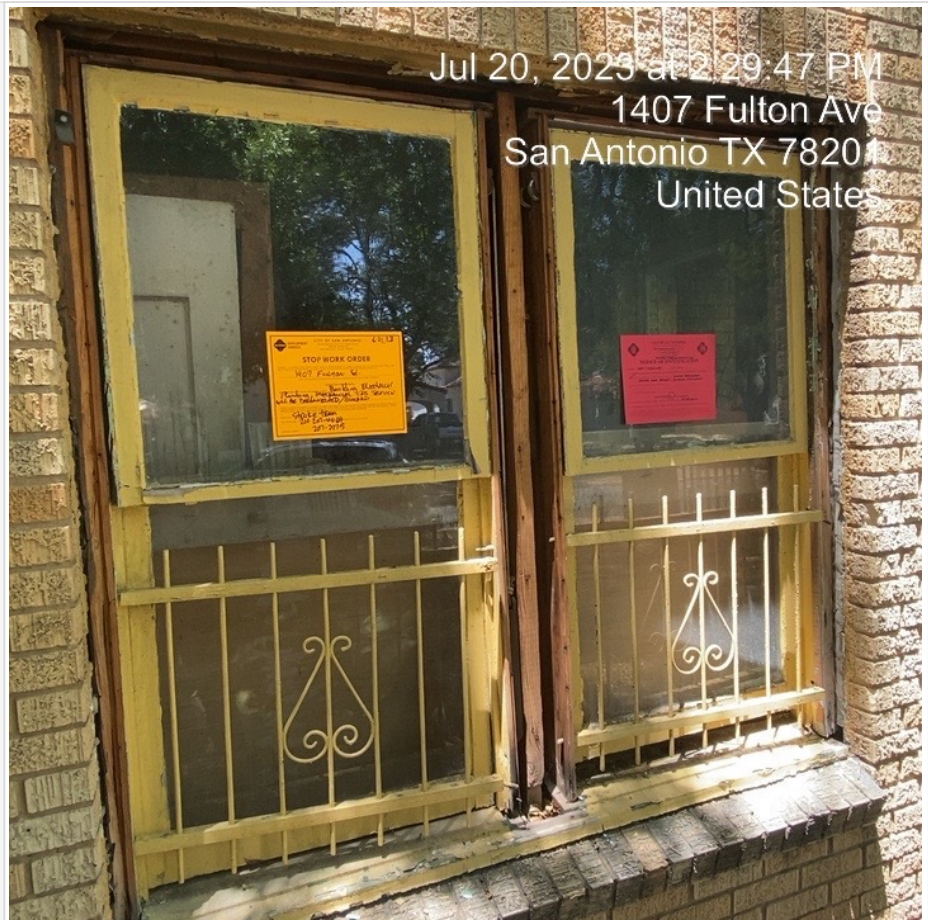
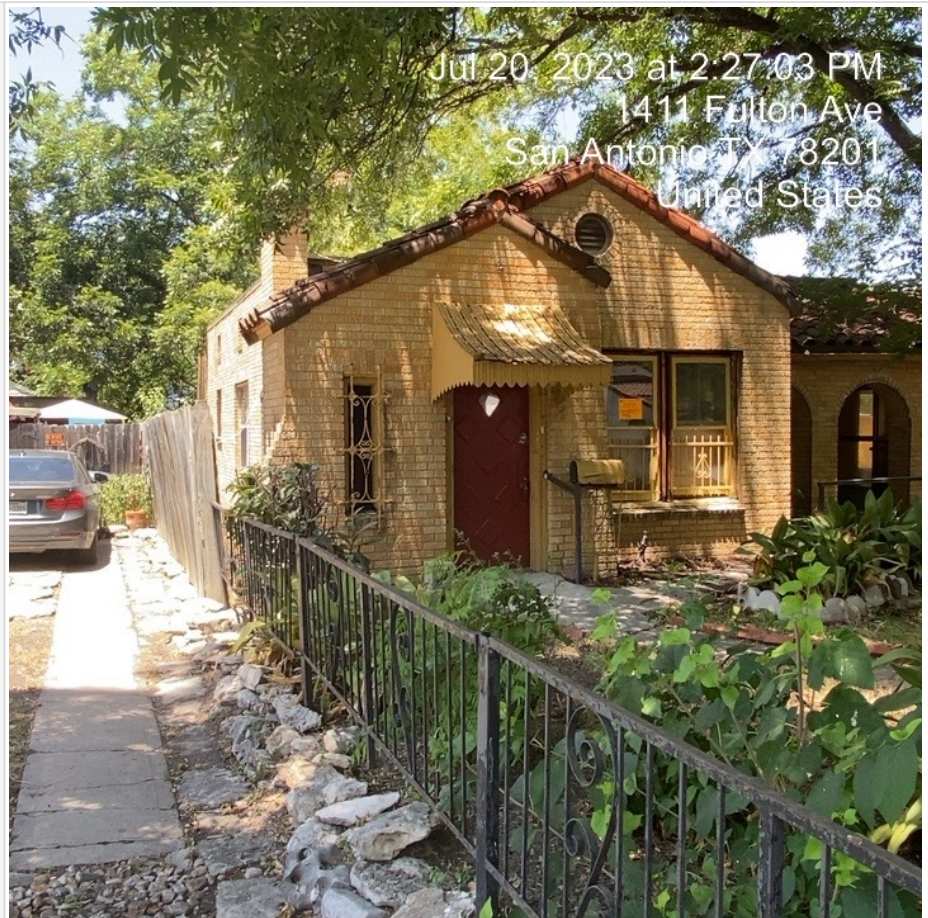
Photographs

Date	07/20/2023
Time	02:31 PM (-5 GMT)
Context	citizen report
Present Staff	Rachel Rettaliata
Present Individuals	None
Types of Work Observed	Exterior Maintenance and Alterations
Amount of Work Completed	25%
Description of work	Window replacement, garage door removal
Description of interaction	No one on site

b. CASE HISTORY – Staff received a report of work being done without a Certificate of Appropriateness on July 18, 2023. Staff was able to conduct a site visit on July 20, 2023, and issued a Stop Work Order for the removal and replacement of the wood windows and metal garage doors.

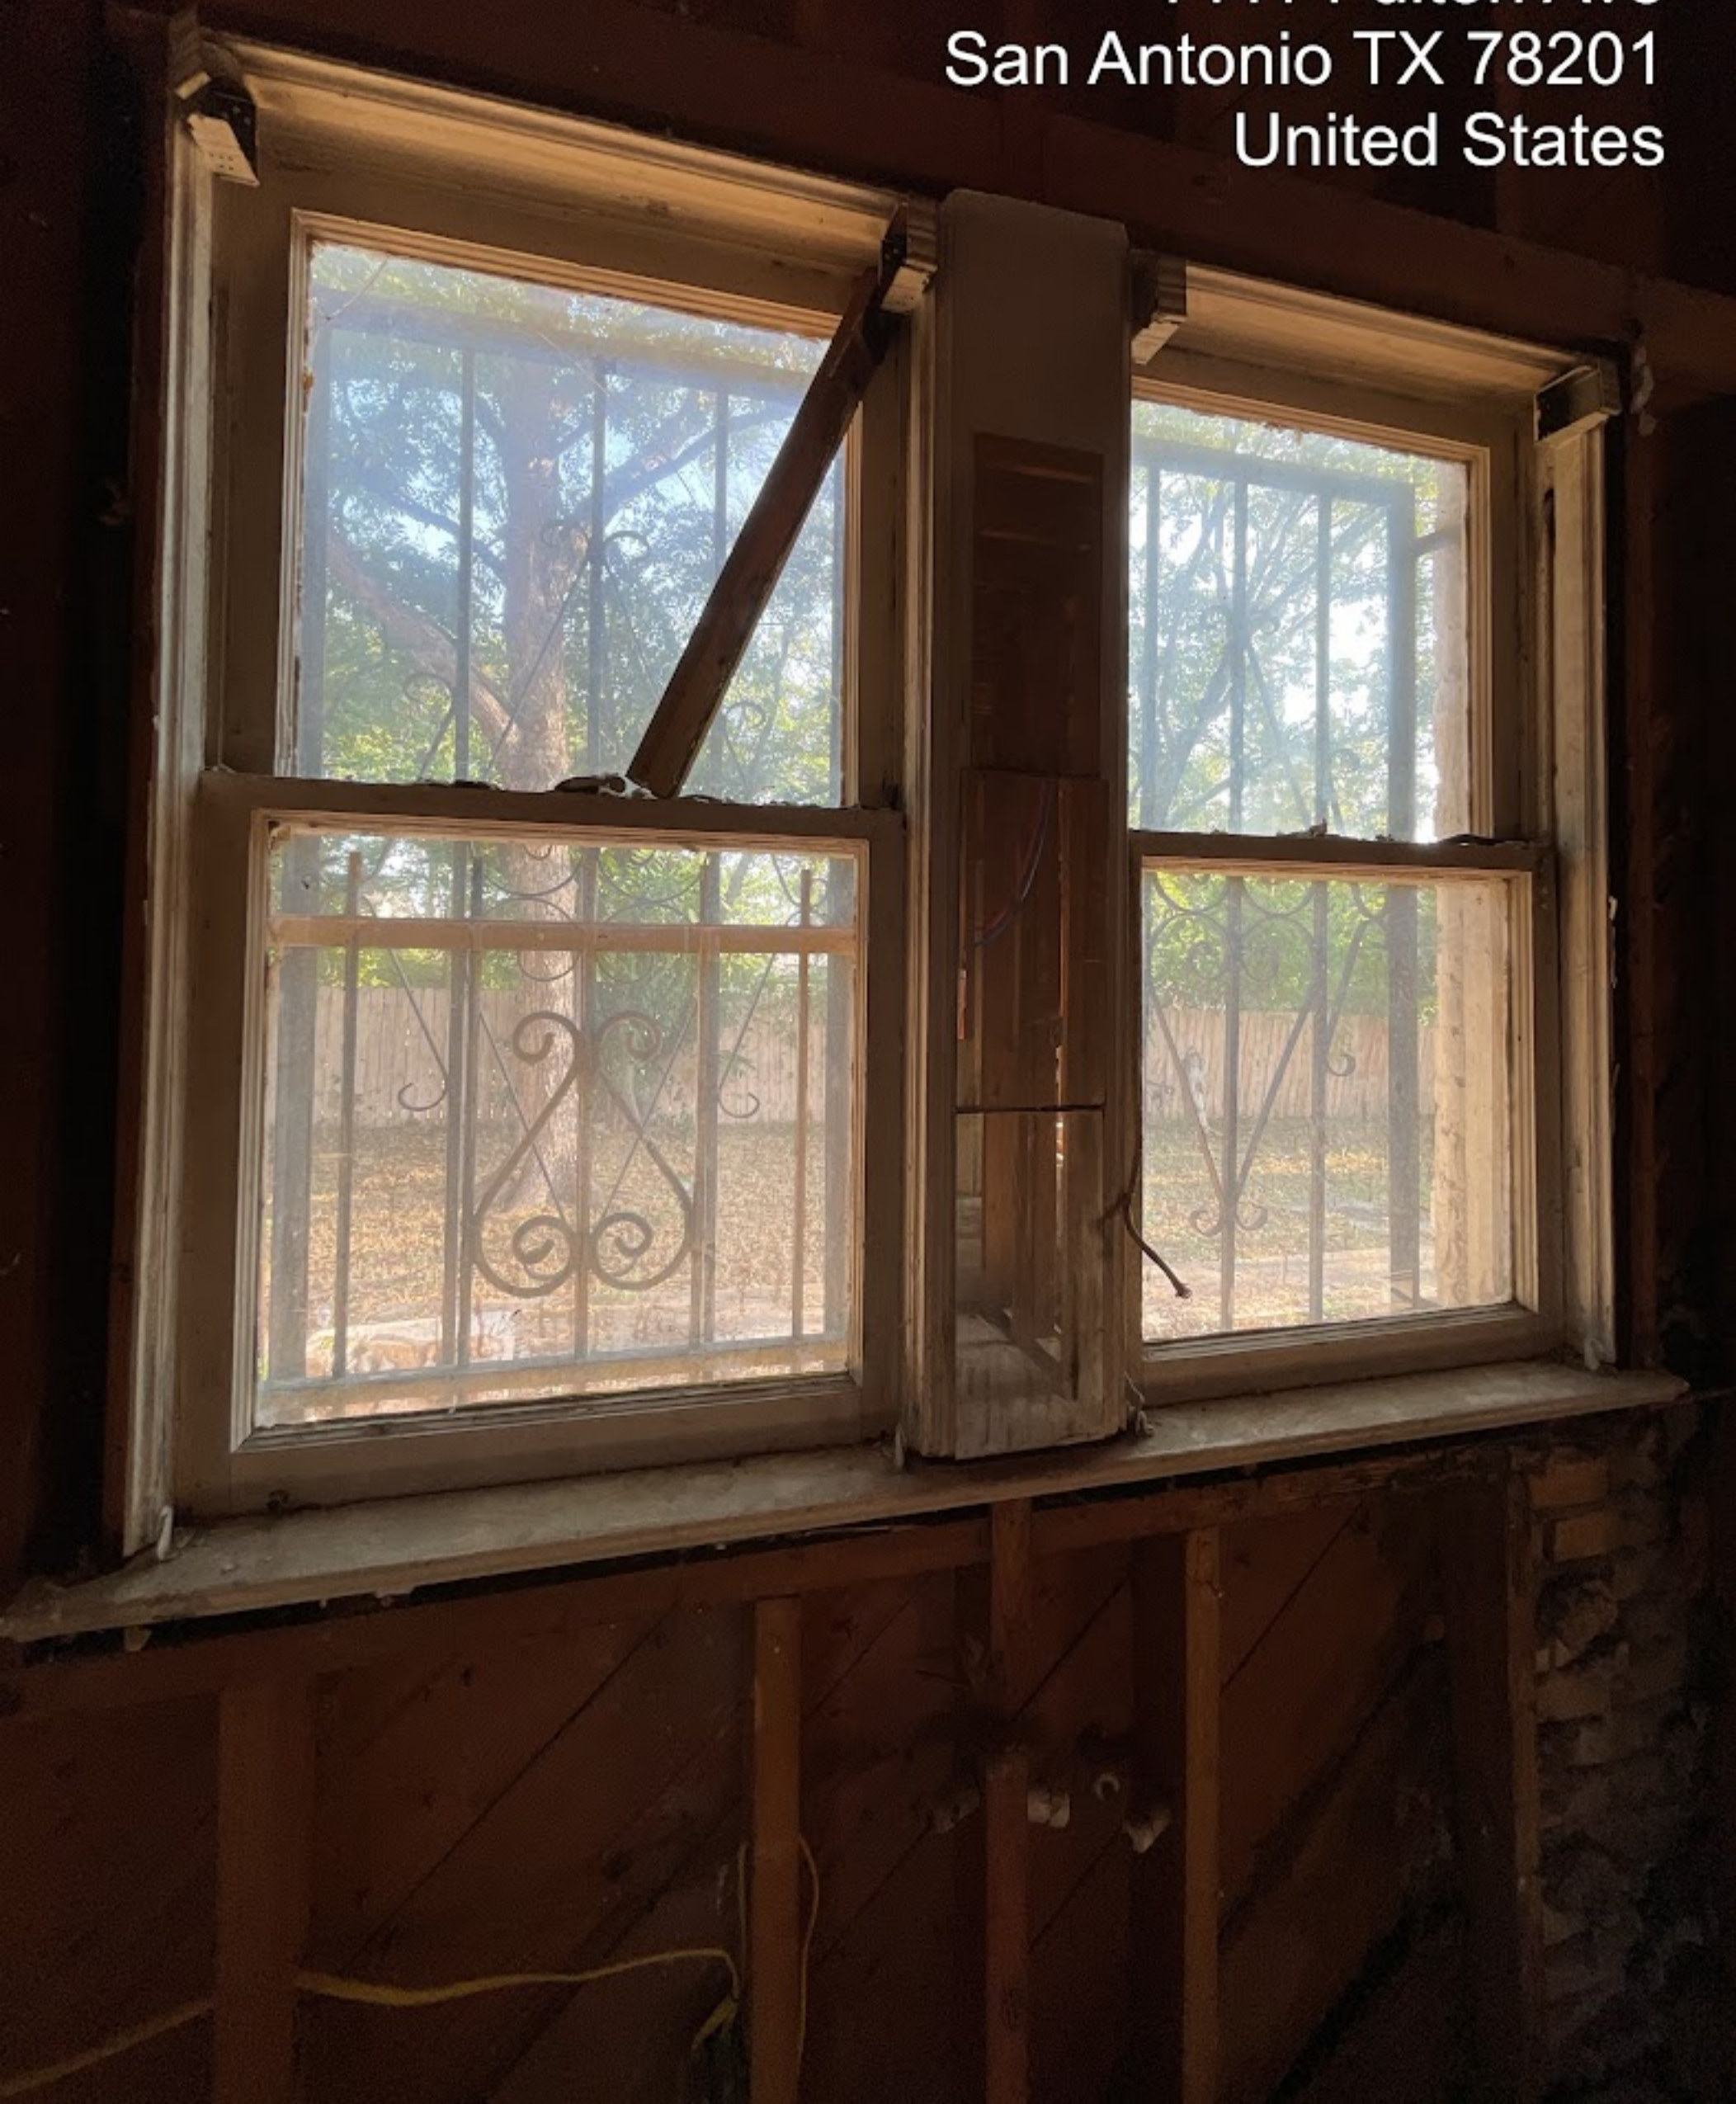
Aug 28, 2023 at 8:46:11 AM
1411 Fulton Ave
San Antonio TX 78201
United States

A photograph of a broken window with a wooden frame and a metal grate. The window is shattered, with a large piece of the frame missing. The text "United States" is visible in the top right corner.
