HISTORIC AND DESIGN REVIEW COMMISSION

HDRC CASE NO: 2024-122
ADDRESS: 221 LOSOYA ST
LEGAL DESCRIPTION: NCB 914 LOT W IRR 90 OF A5 & W IRR 100 FT OF A4 PASEO DEL RIO CONDO **MASTER FILE AND COMMON ELEMENTS**
ZONING: D, H, RIO-3
CITY COUNCIL DIST.: 1
DISTRICT: Alamo Plaza Historic District
APPLICANT: Kyle Tostenson/kyle tostenson architects
OWNER: Jessica Elliot-Middleton/PASEO DEL RIO CONDOMINIUM
TYPE OF WORK: Fifth level balcony installation, fifth level window replacement, fenestration modifications at the fifth level
APPLICATION RECEIVED: March 01, 2024
60-DAY REVIEW: April 30, 2024
CASE MANAGER: Edward Hall
REQUEST:

Penthouse Condo Renovations @ Losoya Street Condos

221 Losoya Street, 5th Floor
San Antonio, Texas 78205

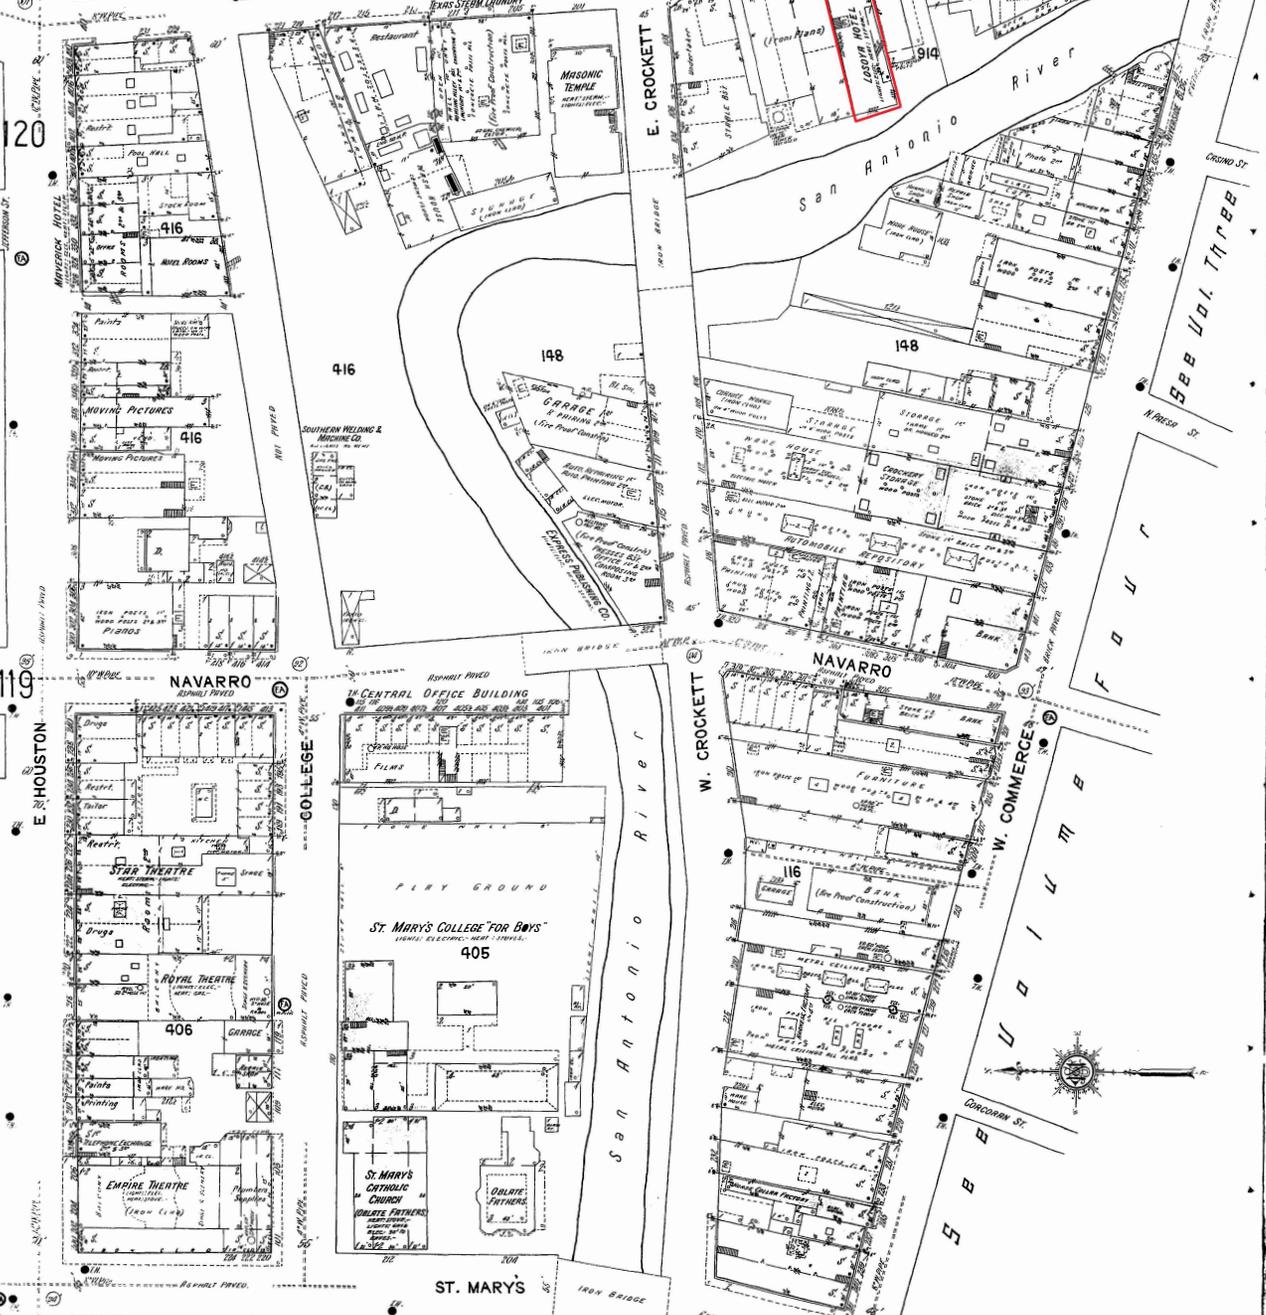
1912 SANBORN MAP

Map labels include: MASONIC TEMPLE, GARAGE, MOVING PICTURES, STAR THEATRE, ROYAL THEATRE, EMPIRE THEATRE, ST. MARYS COLLEGE FOR BOYS, ST. MARYS CATHOLIC CHURCH, OLBRIE FATHERS, LOSoya, Navarro, E. Crockett, W. Crockett, W. Commerce, San Antonio River, and various street names like Houston, College, and Commerce.

- a. The historic structure at 221 Losoya was constructed circa 1910 and is found on the 1912 Sanborn Map. The structure features five (5) stories in height and a brick façade. The structure is contributing to the Alamo Plaza Historic District.

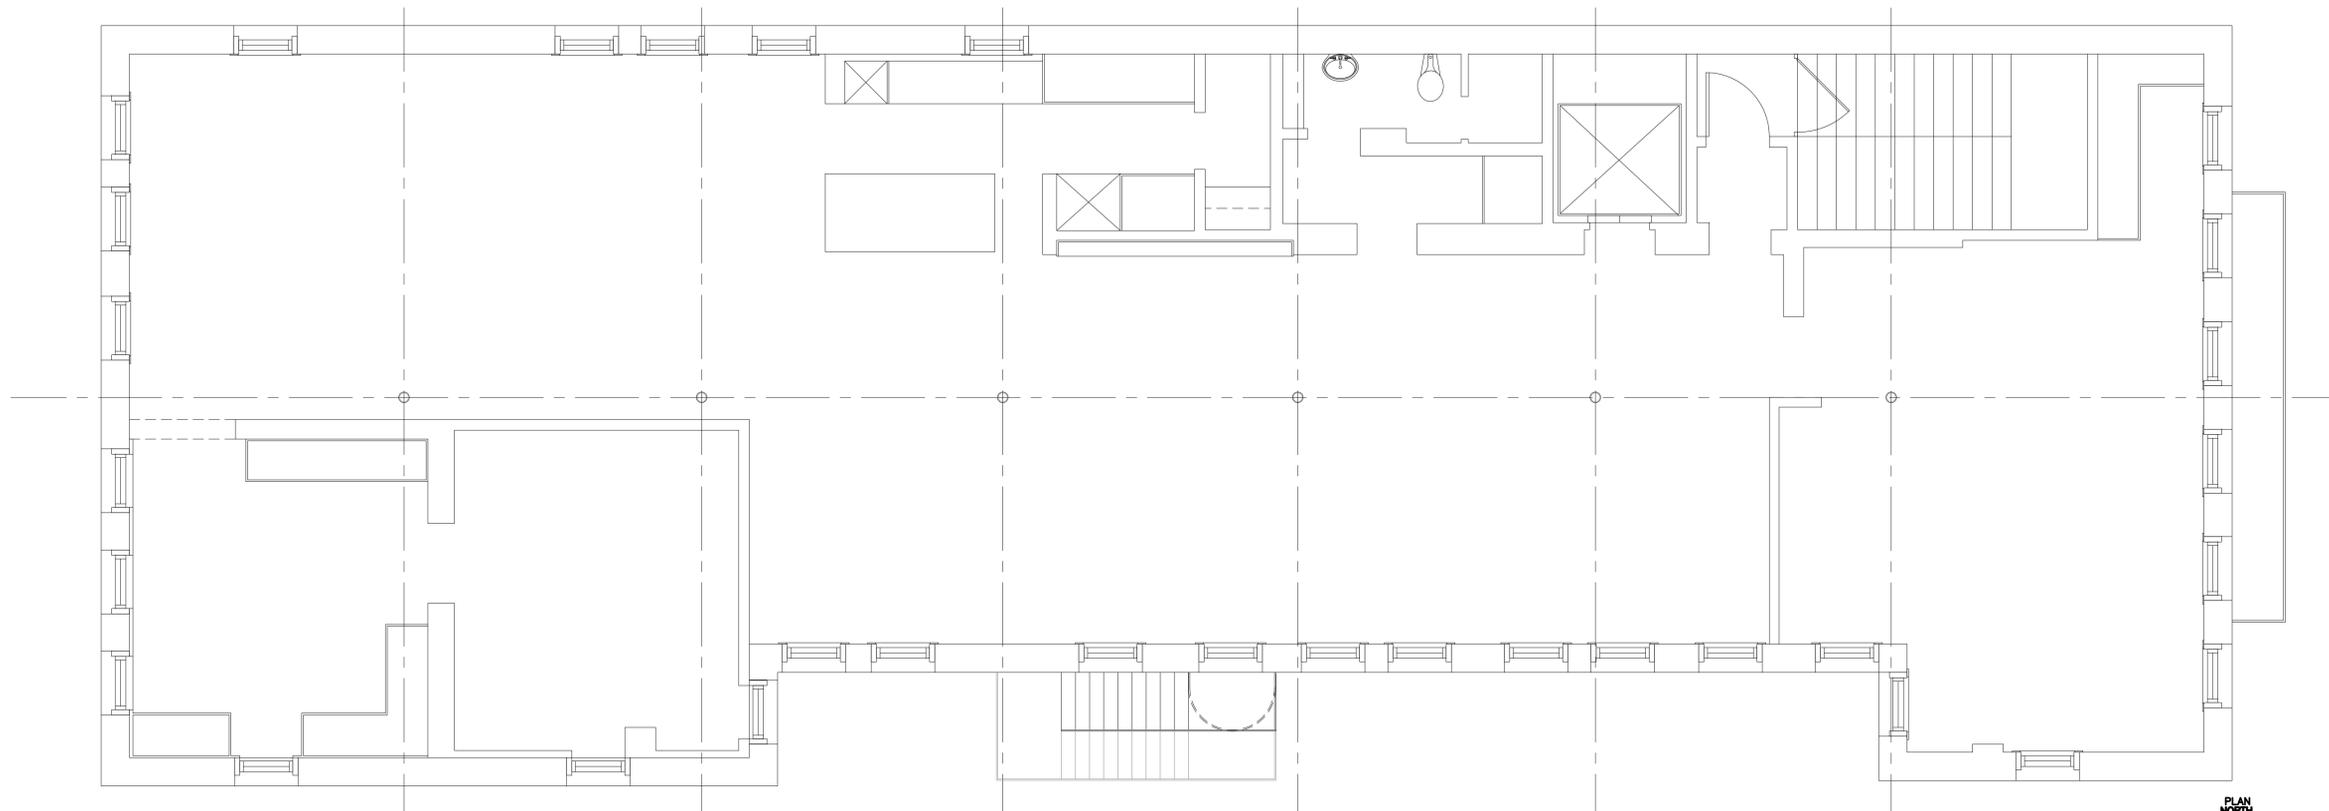
EXISTING FLOOR PLAN

SCALE: 1/4" = 1'-0" 01

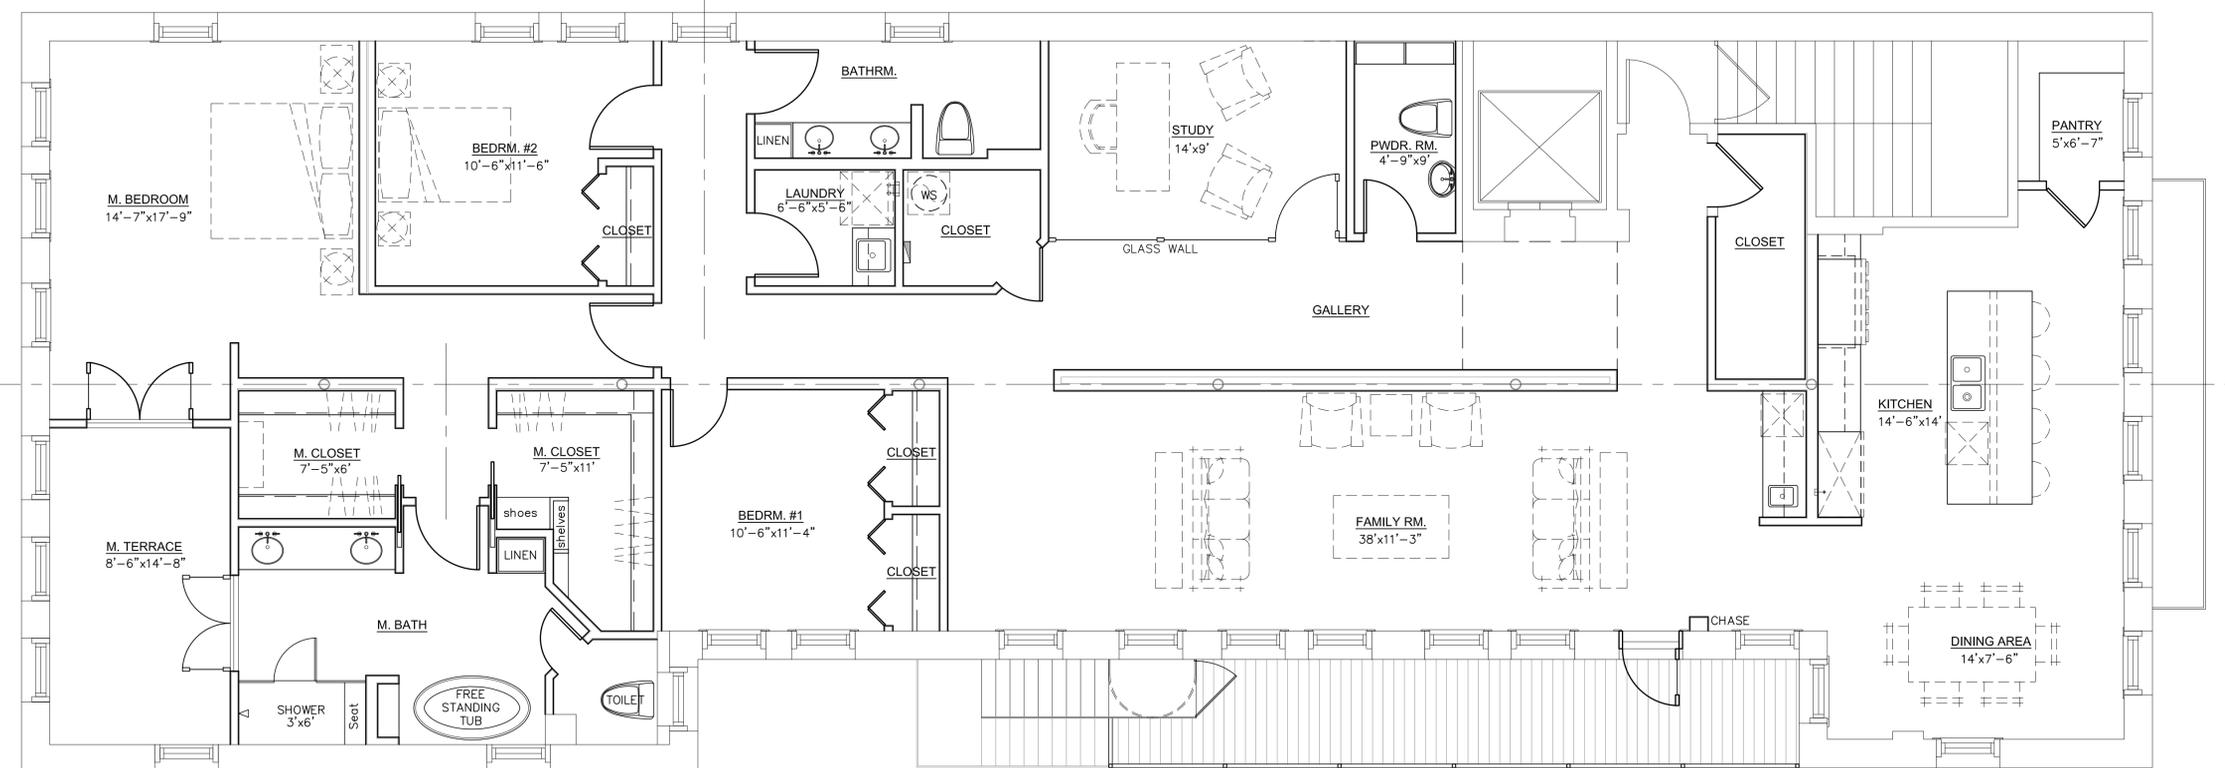
PROPOSED FLOOR PLAN

SCALE: 1/4" = 1'-0" 02

- REPLACE ALL EXISTING EXTERIOR WINDOWS WITH NEW WOOD WINDOWS. "PELLA RESERVE" WINDOWS ARE PROPOSED.
- REPLACE ALL DAMAGED EXTERIOR WINDOW TRIM AND REPAINT TO MATCH EXISTING.
- BUILD A NEW METAL BALCONY ON THE SOUTH FACADE THAT CLOSELY MATCHES THE EXISTING BALCONY ON THE FRONT FACADE.
- REMOVE ONE WINDOW ON THE SOUTH FACADE AND REPLACE WITH A NEW WOOD DOOR WITH GLASS PANELS. THIS WILL FACILITATE EMERGENCY EGRESS BETTER THAT HAVING TO GO THRU A WINDOW.
- REMOVE FOUR EXISTING WINDOWS AND LEAVE THE OPENING CASED WITH THE EXISTING WOOD TRIM. THIS IS TO CREATE AN OUTDOOR TERRACE SPACE ON THE RIVER WALK FACADE WITHOUT MODIFYING THE EXTERIOR WALLS.
- ADD NEW WINDOWS IN ORIGINAL OPENINGS THAT HAVE SINCE BEEN BRICKED OVER ON THE NORTH FACADE.

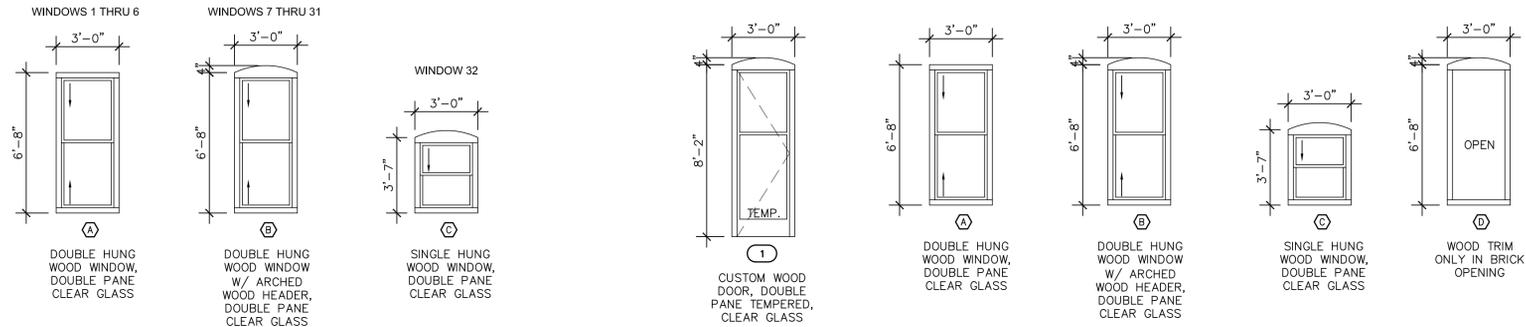
EXISTING WINDOW TYPES 02
SCALE: 1/4" = 1'-0"

REPLACEMENT WINDOW & DOOR TYPES 03
SCALE: 1/4" = 1'-0"

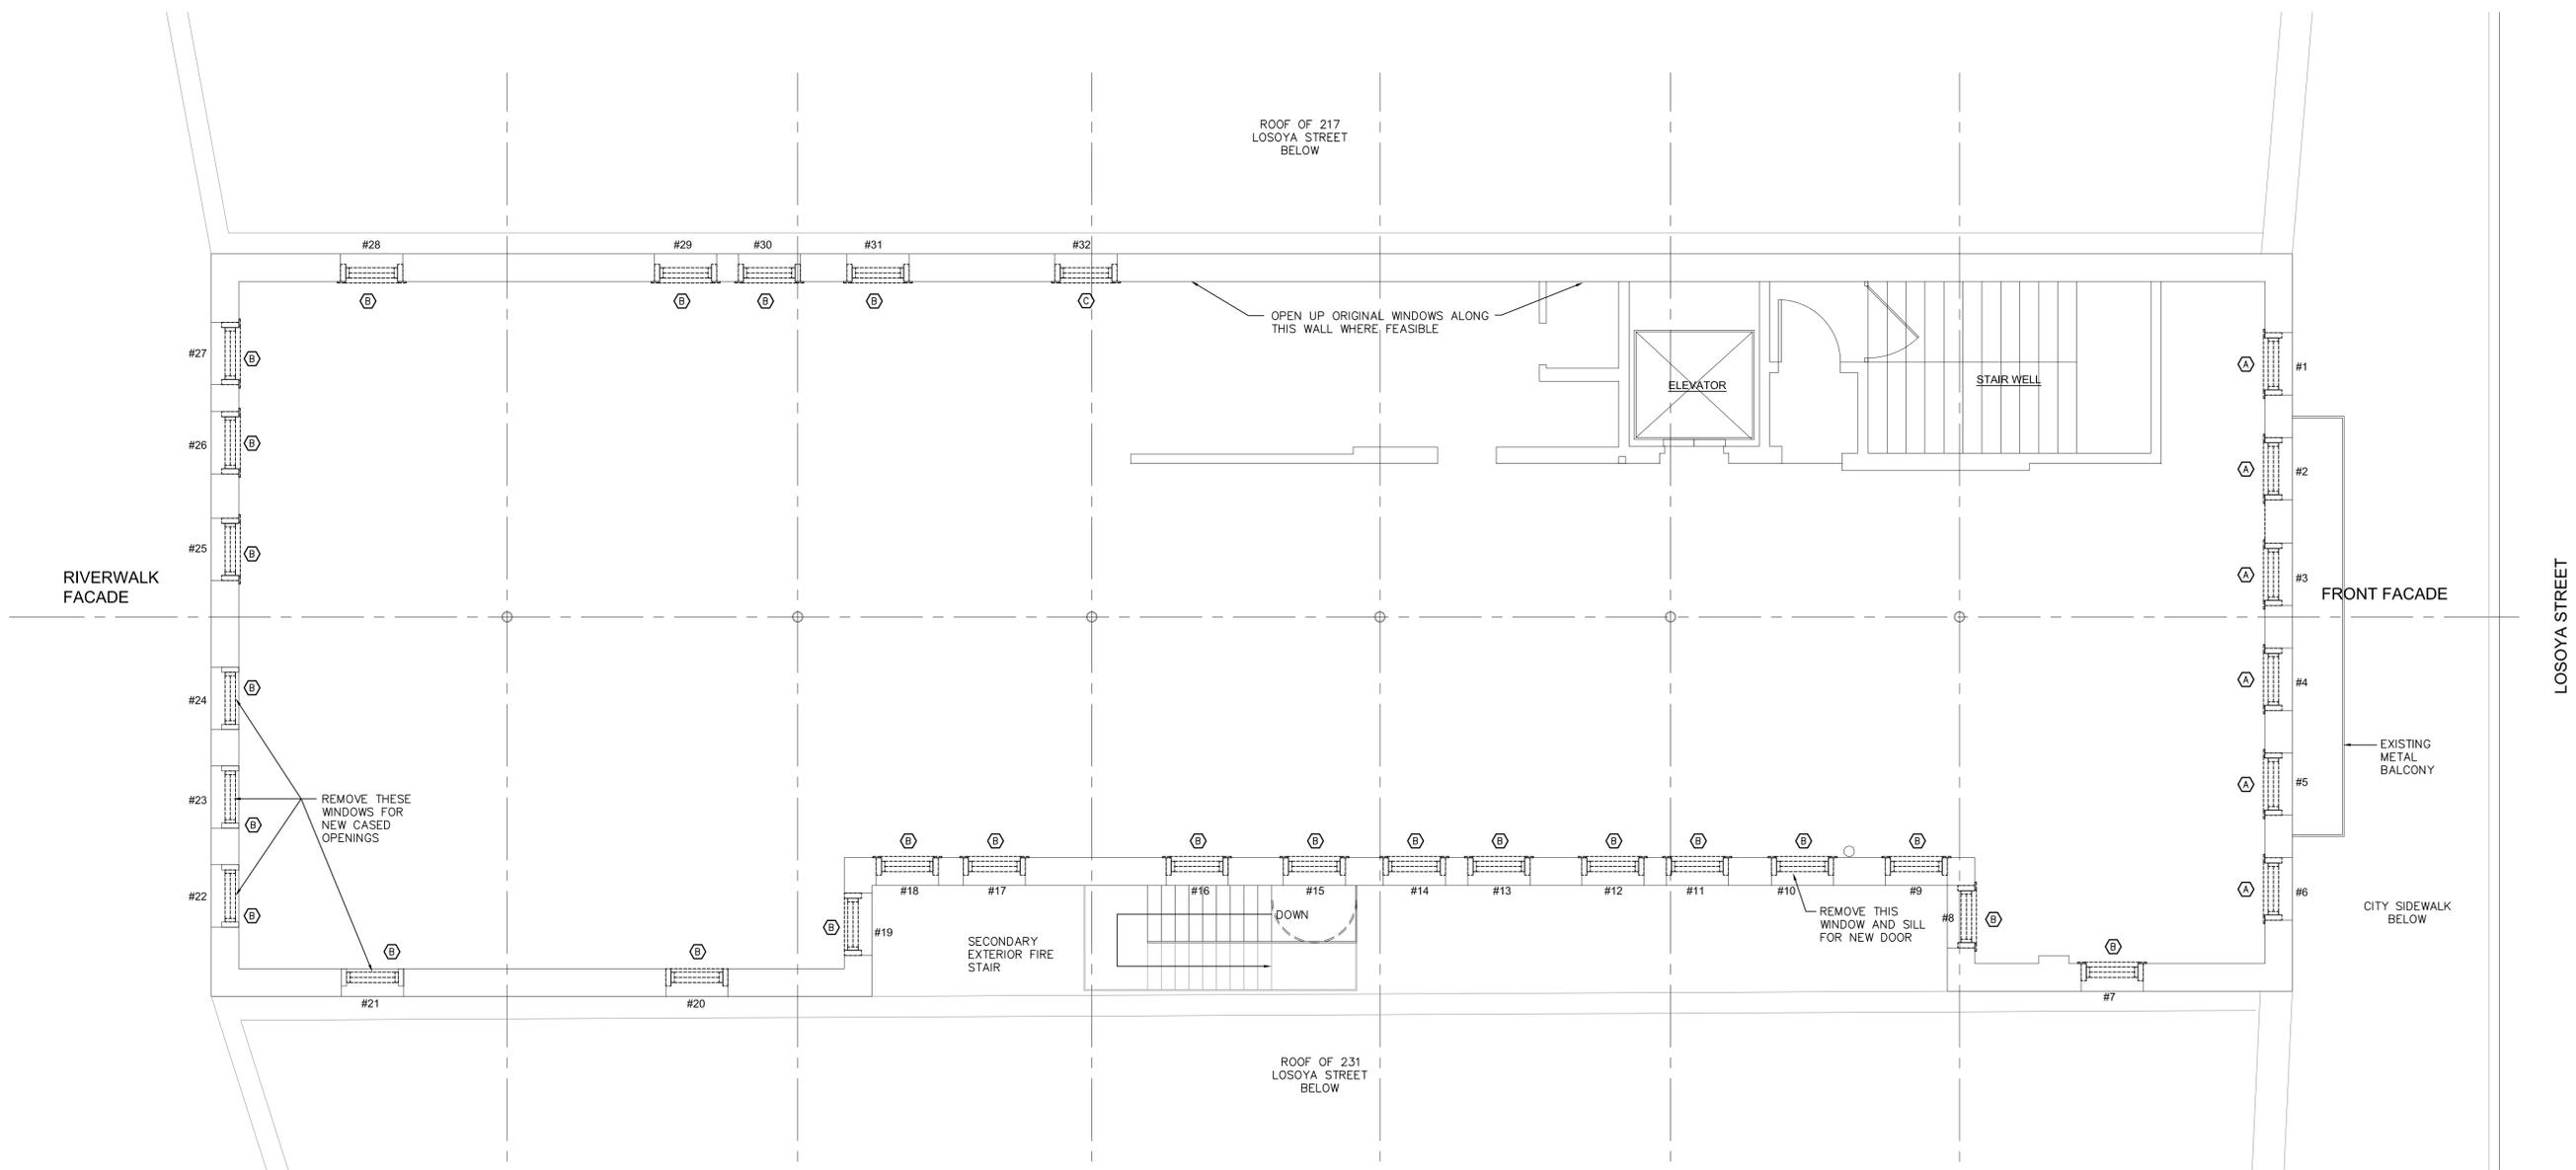
EXISTING CONDITIONS FLOOR PLAN

SCALE: 1/4" = 1'-0" 01

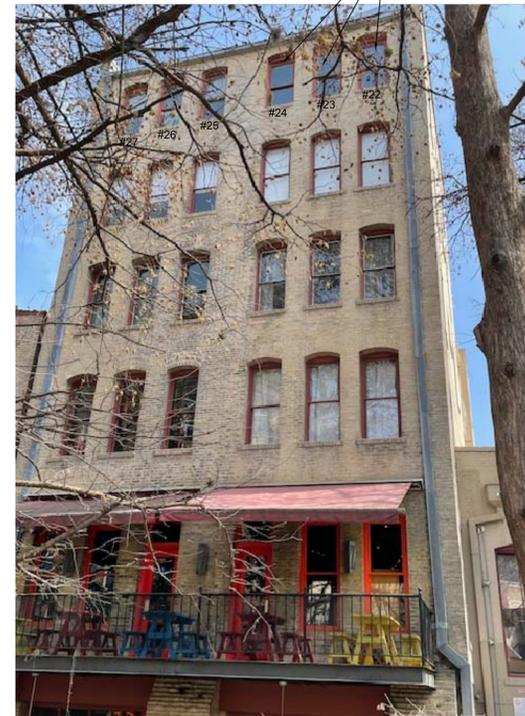
REAR FACADE (River Walk) 03

THESE THREE WINDOWS TO BE REMOVED FOR NEW TERRACE

- c. WINDOW SASH REMOVAL – The applicant has proposed to remove four (4) existing, non-original windows to create an open air terrace at the rear of the structure. Three windows are on the west (rear) façade and one is on the south facade. The original window trim will be repaired and will remain in place. The opening size will not change. Generally, staff finds this proposal to be reversible and appropriate.

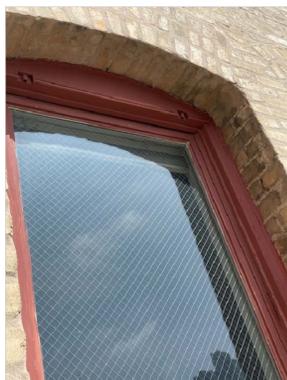
TYPICAL EXTERIOR HEAD CONDITION

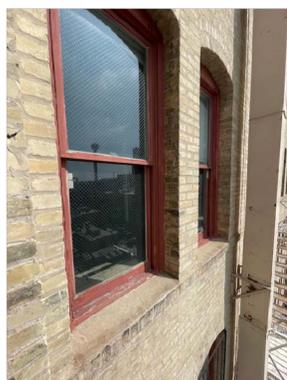
TYPICAL EXTERIOR SILL CONDITION

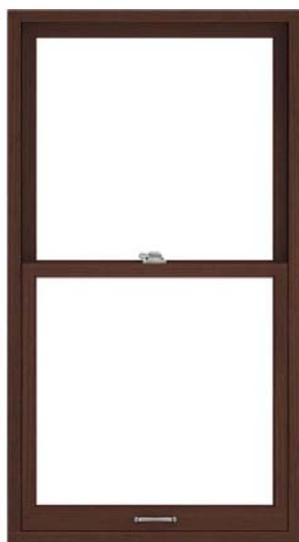
PELLA® RESERVE™ – TRADITIONAL Wood Double-Hung Window

Create the traditional look your historic renovation, new construction or replacement project requires with a traditional wood or aluminum-clad wood double-hung window. This Pella Reserve window proves our uncompromised attention to detail with historic putty profiles, through-stile construction, innovative grilles and authentic spoon-lock hardware.

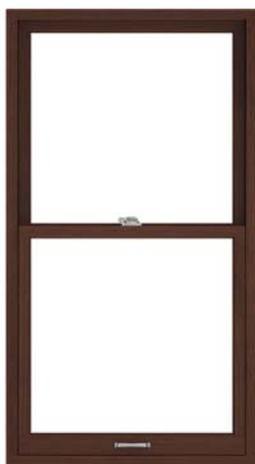
RESERVE - TRADITIONAL DOUBLE-HUNG WINDOW SPECS & INSTALL DETAILS

- Exudes the tenets of traditional design with putty profiles, through-stile construction and Integral Light Technology® grilles
- Performance rating of CW40-CW50 and STC of 28-35
- Available in sizes up to 48" x 96" in 1/8" increments, with equal, cottage and custom splits
- Optional self-storing Integrated Rolscreen appears when the double-hung window is opened and rolls away when it is closed
- Fold-out Fin, Block Frame, EnduraClad Exterior Trim and Brickmould installation and frame options
