HISTORIC AND DESIGN REVIEW COMMISSION

HDRC CASE NO: 2022-430
ADDRESS: 130 KING WILLIAM
LEGAL DESCRIPTION: NCB 737 BLK 2 LOT 7 & 8
ZONING: RM-4, H, HL
CITY COUNCIL DIST.: 1
DISTRICT: King William Historic District
LANDMARK: Individual Landmark
APPLICANT: Marques White/Legacy Home Improvements
OWNER: SAN ANTONIO ART LEAGUE
TYPE OF WORK: Porch roof replacement with pitch change
APPLICATION RECEIVED: July 17, 2022
60-DAY REVIEW: Not applicable due to City Council Emergency Orders
CASE MANAGER: Jessica Anderson

The applicant requests a Certificate of Appropriateness for approval to replace the flat membrane roof of the wraparound porch with a pitched standing-seam metal roof.

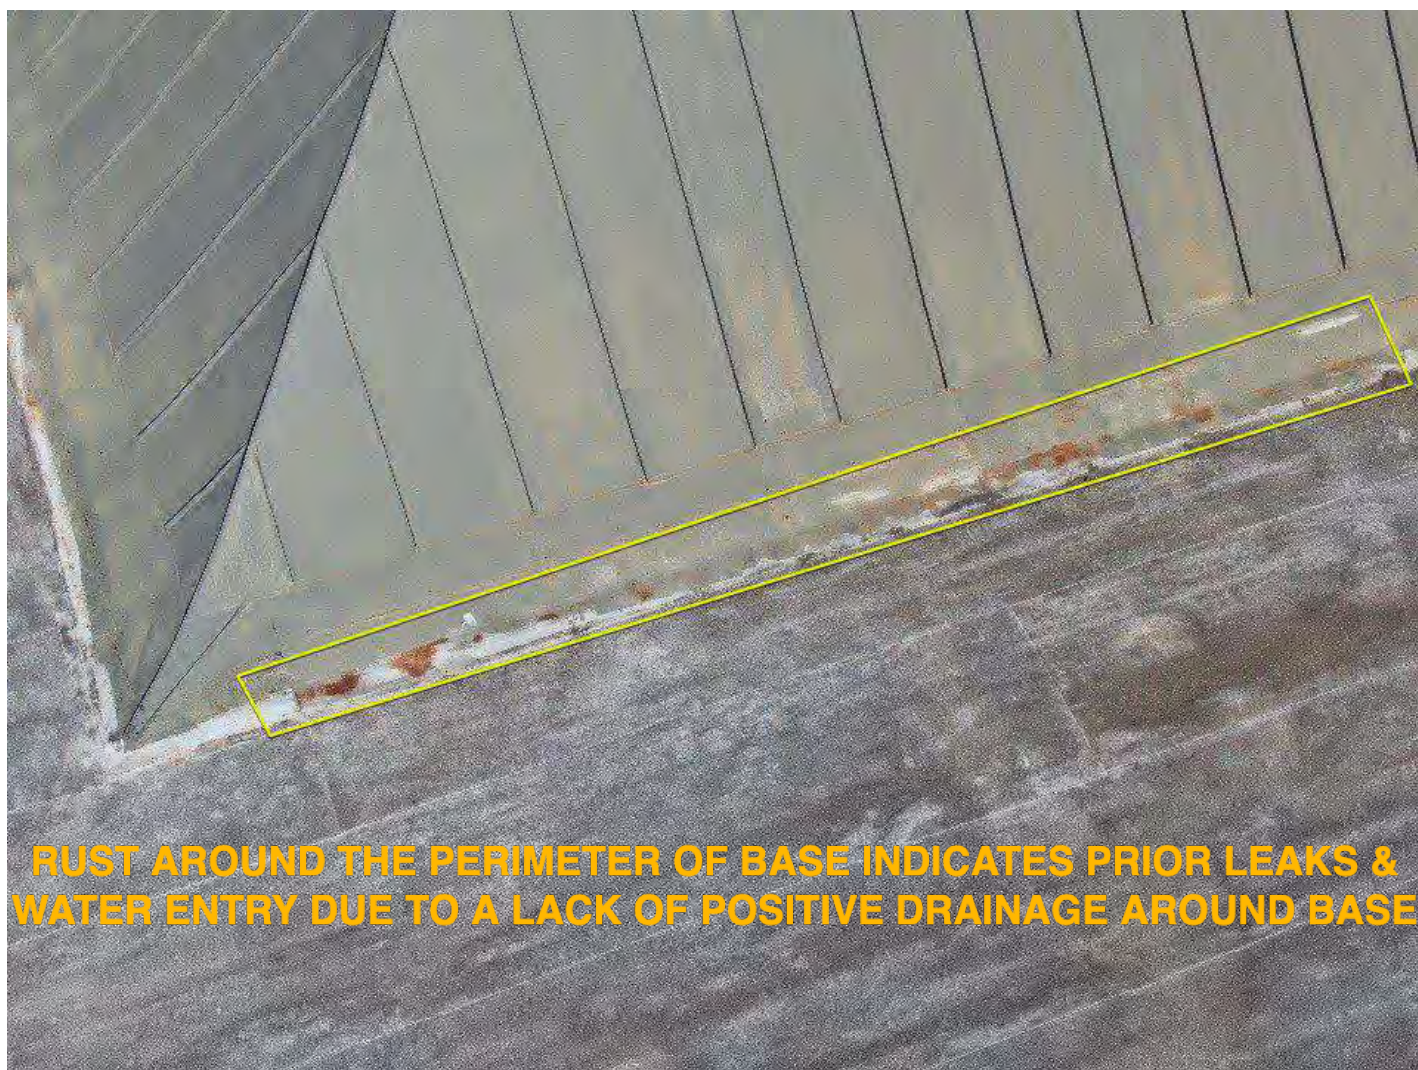
EXISTING LEAK DUE TO POOR DESIGN & LACK OF POSITIVE DRAINAGE

The main reason for adding the pitch to the roof is to prevent water leakage which has occurred in the past where the pitched metal roof joins the flat composition roof. In addition, the change in pitch will allow the entire roof on that section of the building to be covered with metal. This will make the look of the roof more aesthetically pleasing and historically consistent and will greatly extend the lifetime of the roof on that portion. We believe that the minor modification will not significantly alter the appearance of the historic building, especially from a viewing angle on the ground level.

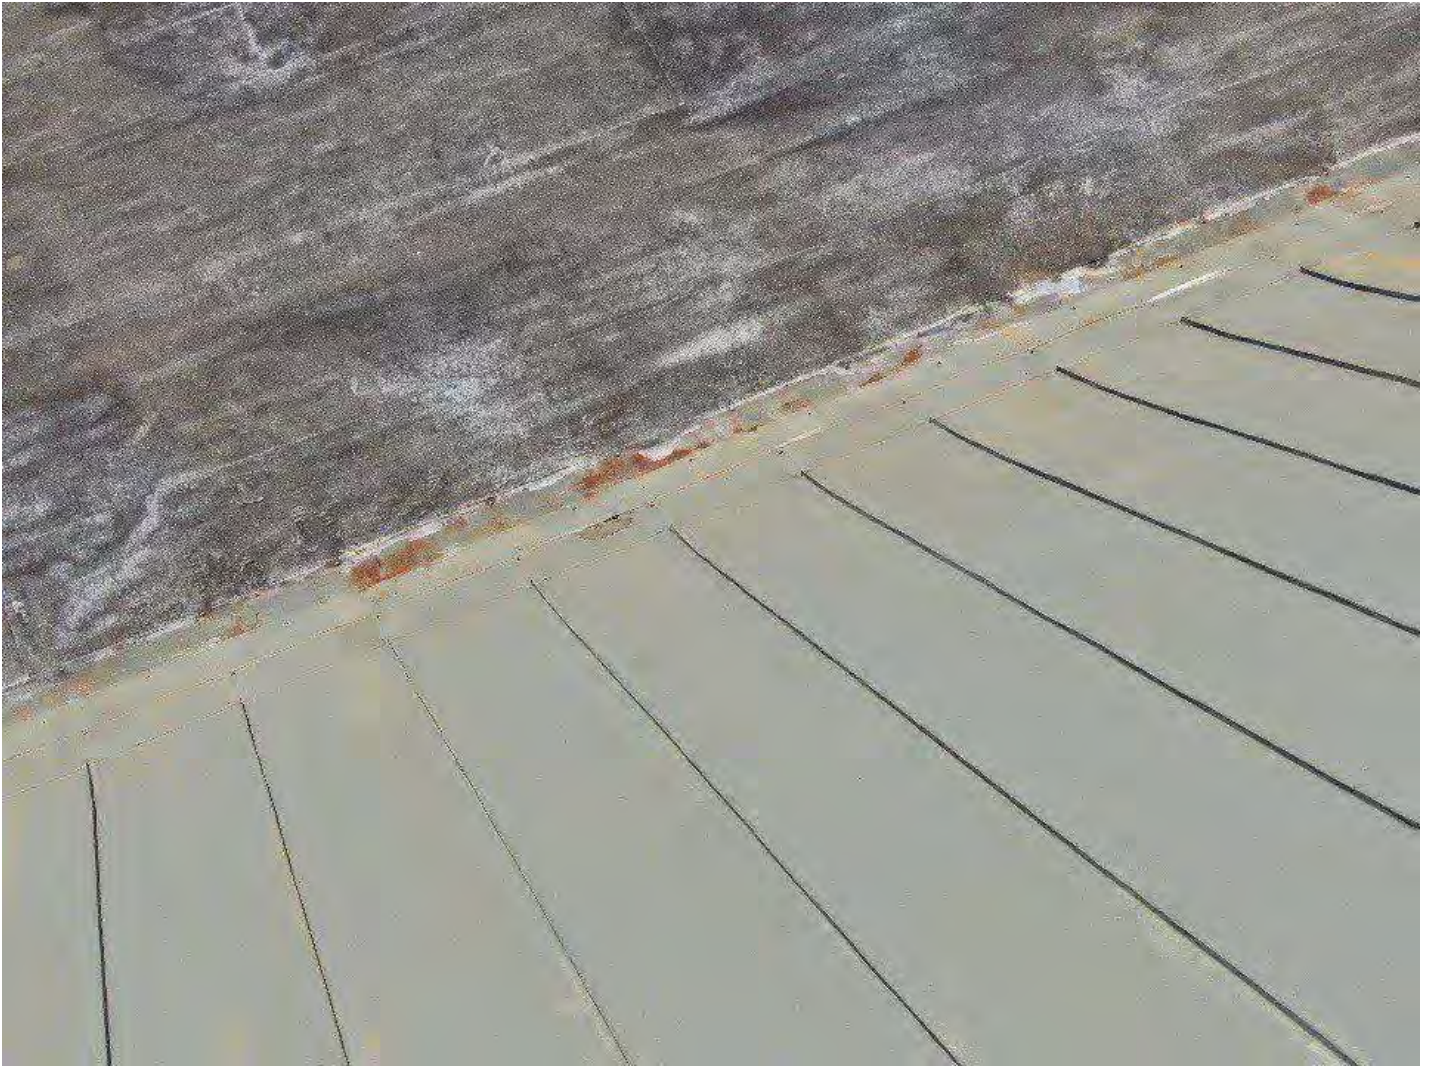
RUST AROUND THE PERIMETER OF BASE INDICATES PRIOR LEAKS & WATER ENTRY DUE TO A LACK OF POSITIVE DRAINAGE AROUND BASE

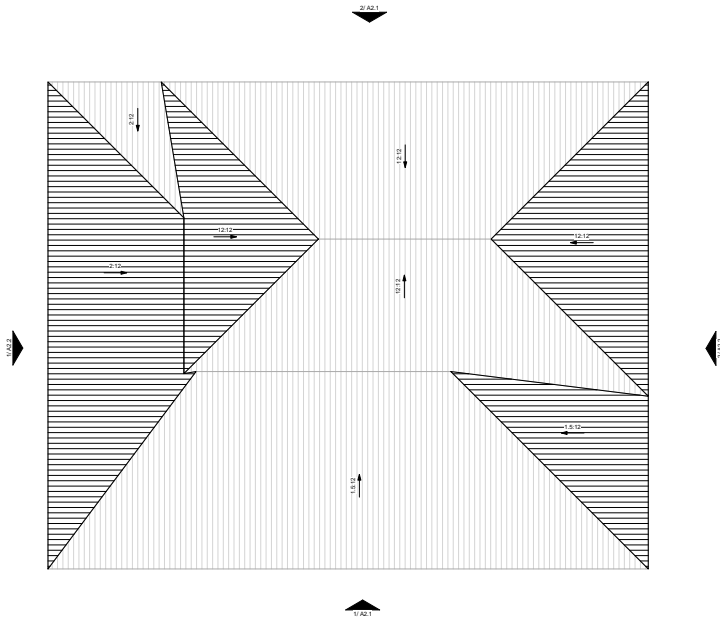
1 ROOF PLAN

EXTERIOR WALL STUD BELOW ROOF

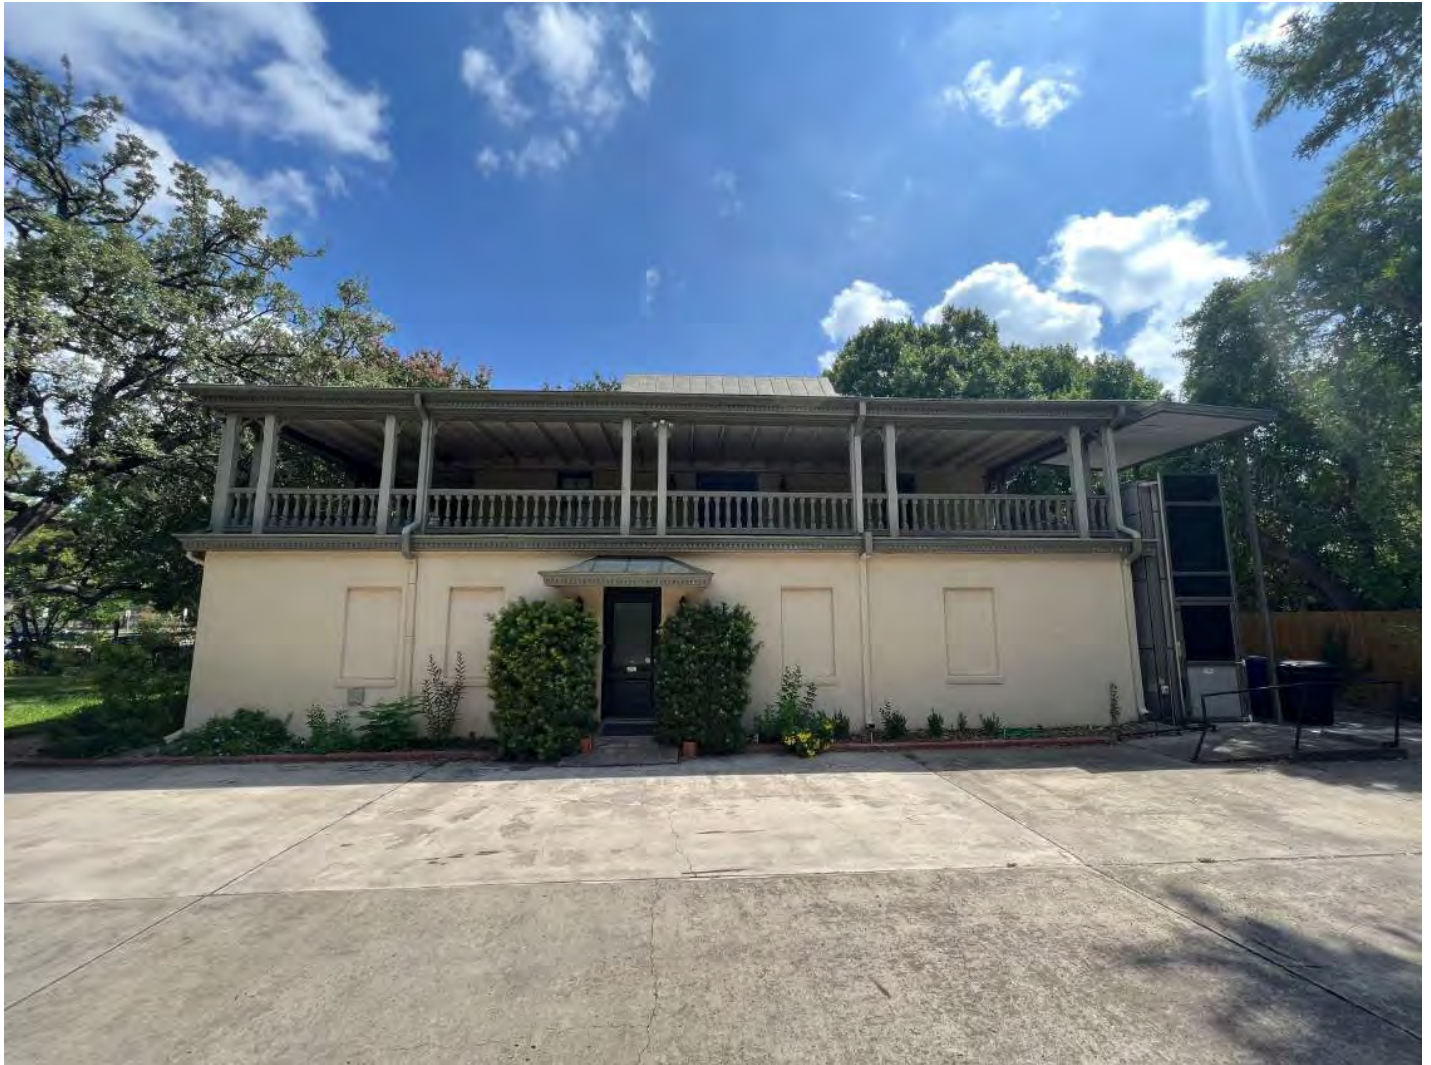
**VIEW FROM NEXT BUILDING
TOP OF TURRET BARELY SEEN**

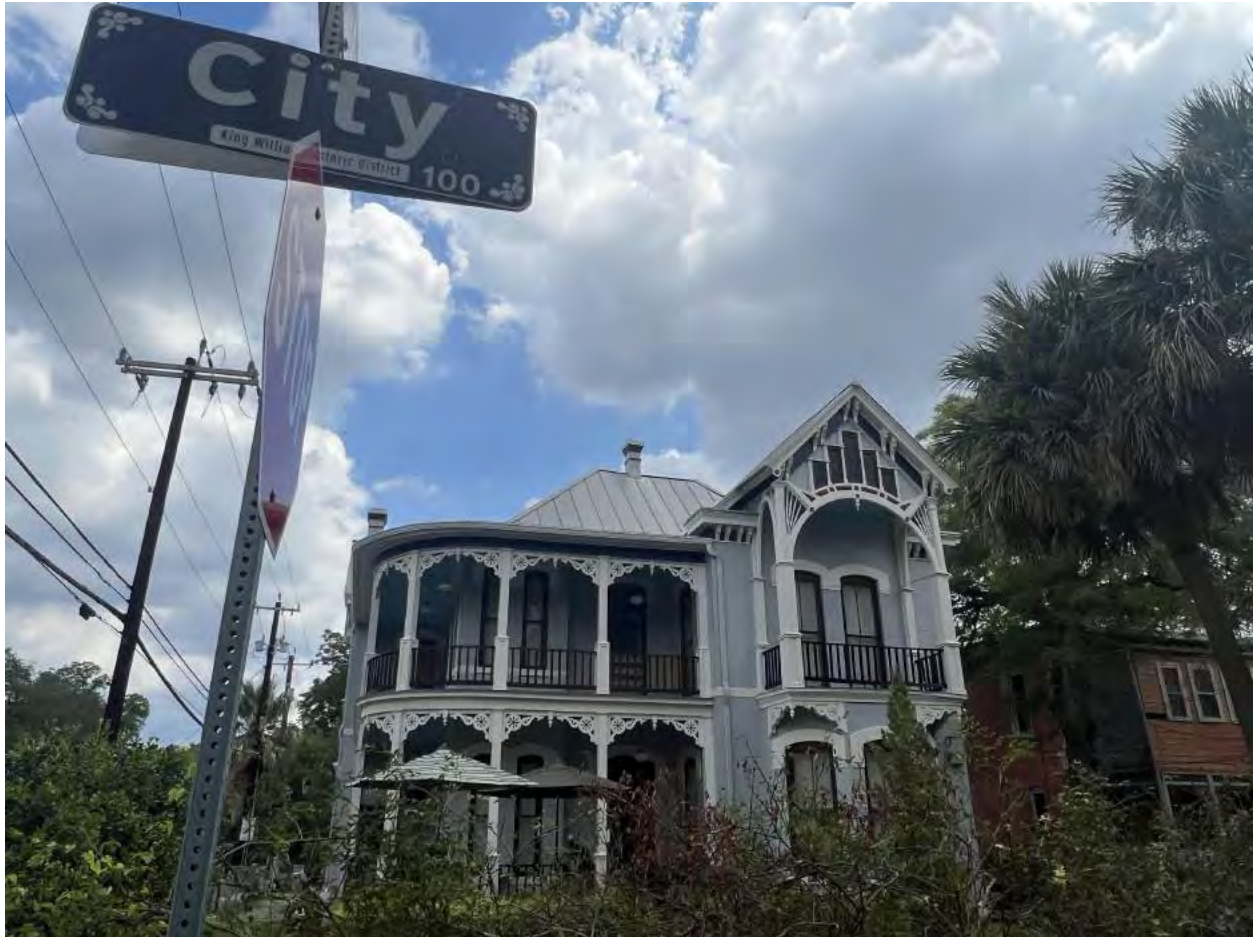
SIMILAR PROPERTY W/ SIMILAR DESIGN
100 BLOCK OF CITY STREET INSIDE OF THE
KING WILLIAM HISTORIC DISTRICT

We received recommendation that: That the pitch of the roof remains unchanged when the new roof is installed **or include a low enough profile as to not be visible from the public right-of-way.** We are pleased to provide additional supporting information that shows that our proposal meets those criteria and in addition, photos showing a similar design detail already existing in a similar property in the 100 block of City Street within the King William Historic District.
