HISTORIC AND DESIGN REVIEW COMMISSION

HDRC CASE NO: 2022-469
ADDRESS: 304 SADIE ST
LEGAL DESCRIPTION: NCB 733 BLK 5 LOT 1 AND 2
ZONING: RM-4, H
CITY COUNCIL DIST.: 1
DISTRICT: Lavaca Historic District
APPLICANT: Henry Tijerina/Tijerina Construction LLC DBA Protec Services
OWNER: GONZALEZ CARLOS OMAR & SELSABEEL A
TYPE OF WORK: Fenestration modifications
APPLICATION RECEIVED: August 31, 2022
60-DAY REVIEW: Not applicable due to City Council Emergency Orders
CASE MANAGER: Claudia Espinosa

Gonzalez Home
304 Sadie

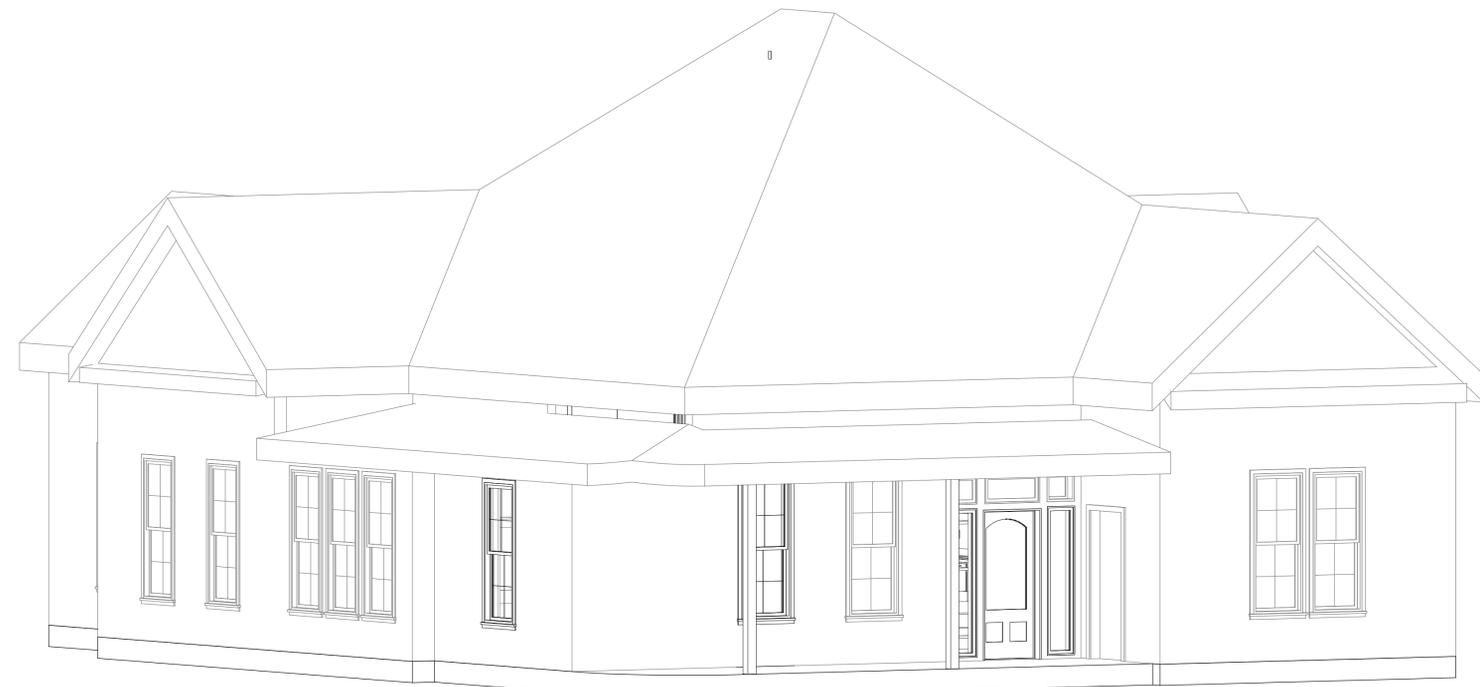
1 North - East

Ogee 2" lap wood siding
Original Single Hung Wood Framed Windows
Shake Shingles at Gable Roof North Elevation
Existing Front Porch

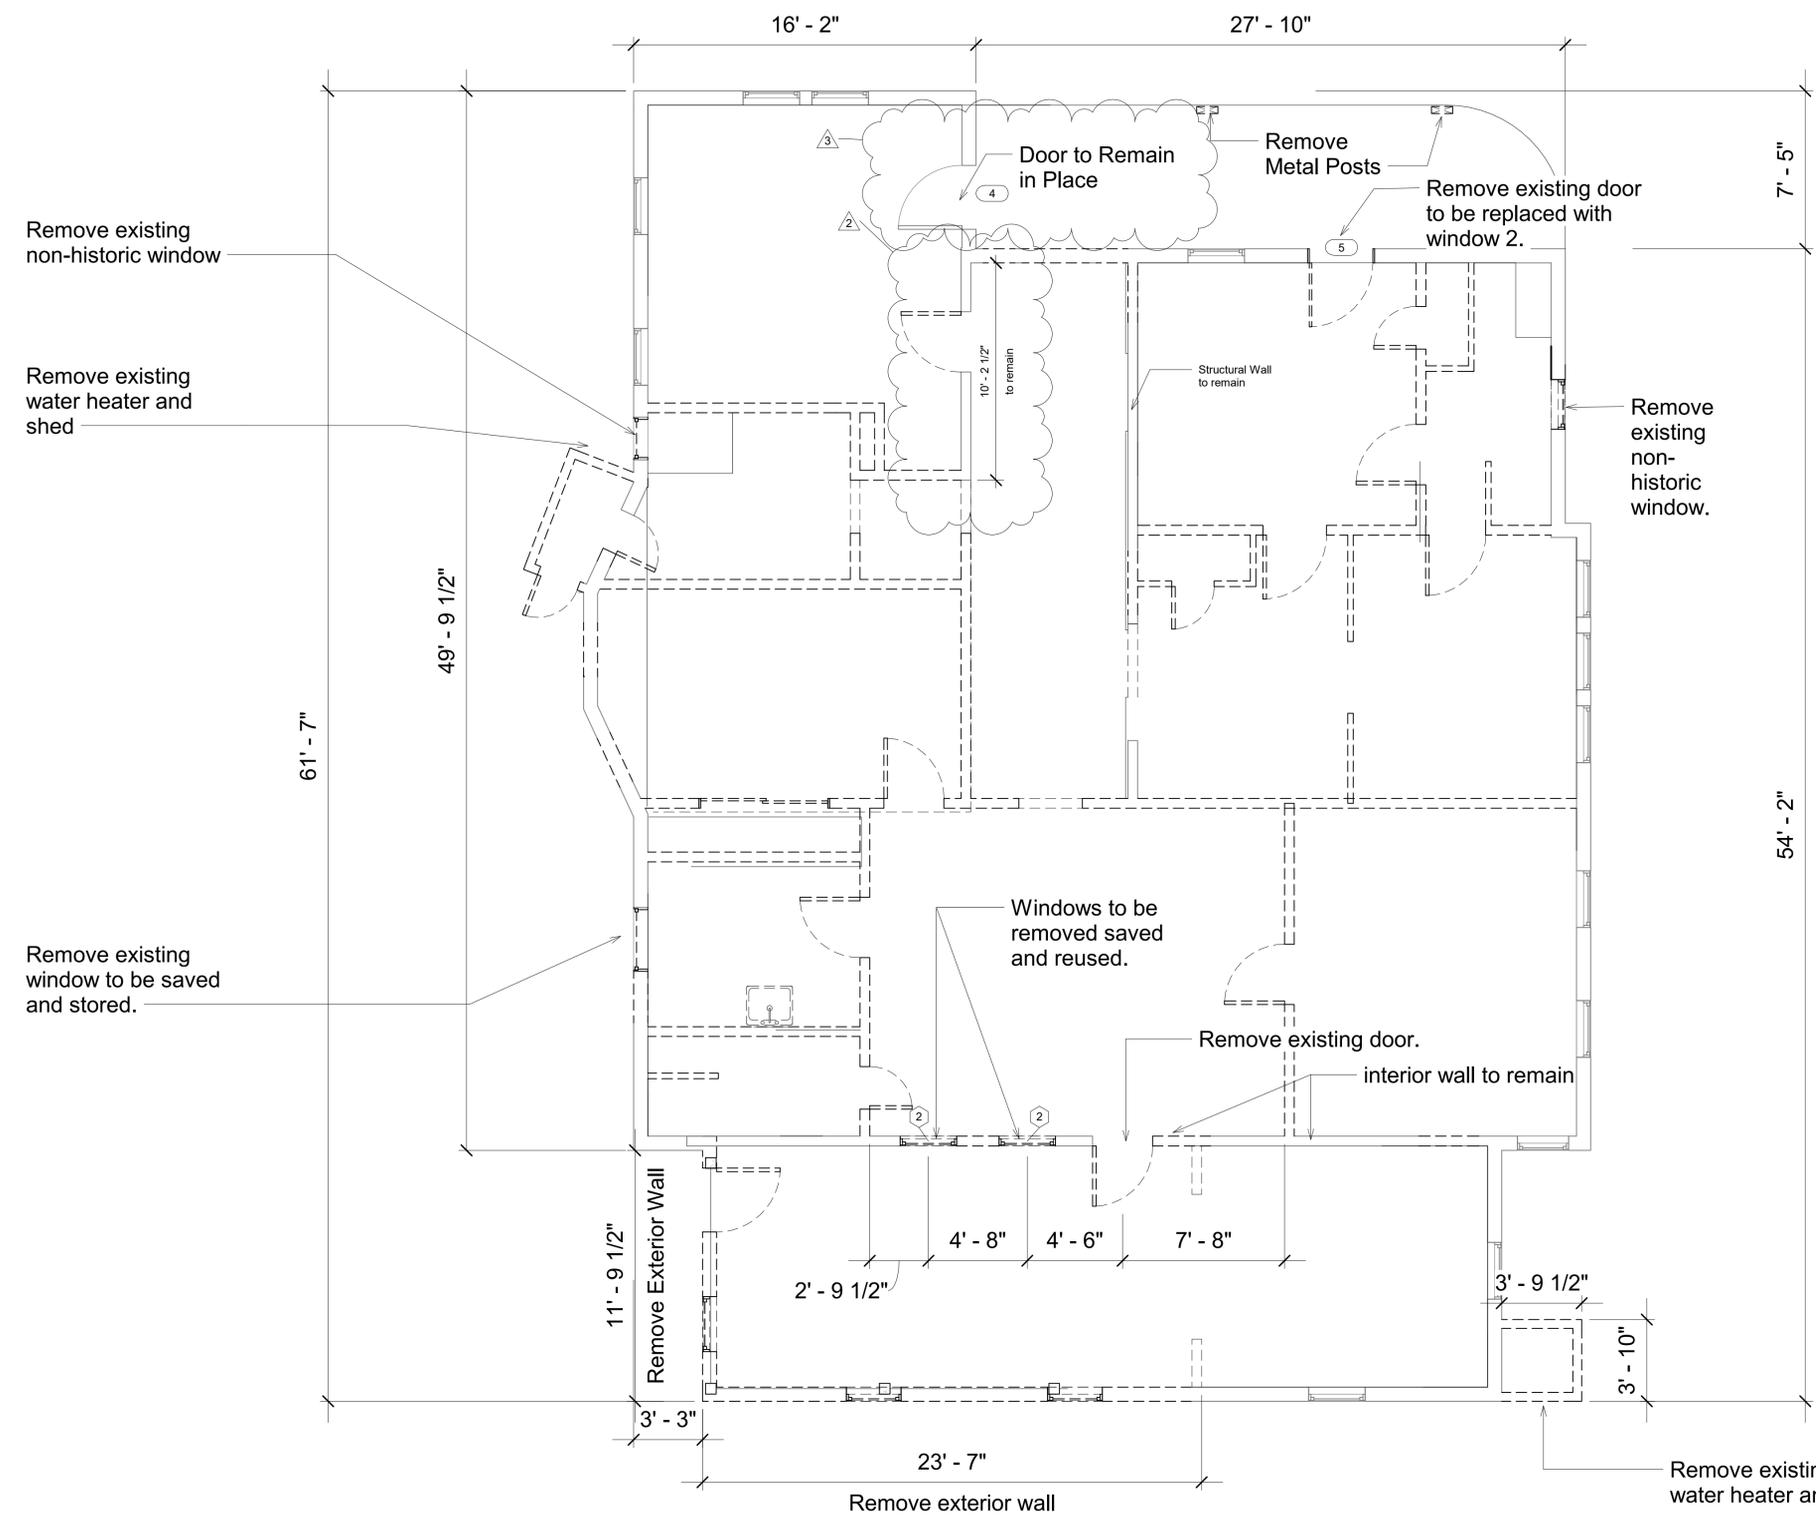
Demolition Generally

All interior walls, door, vinyl floor, plumbing fixtures, cabinets, and appliances, shall be removed except where noted. The home may have lead paint to be disposed of as necessary.

1. Remove all plumbing fixture sinks/ toilets/ showers and tubs and cap where necessary.
2. Remove all kitchen appliances and cabinets.
3. Remove all Vinyl floor.
4. Existing wood floor under vinyl floor shall remain and be sanded, stained and sealed.
5. Verify the existance of asbestos at vinyl floor adhesion.
6. Remove all interior gypsum wall board to stud of wall.

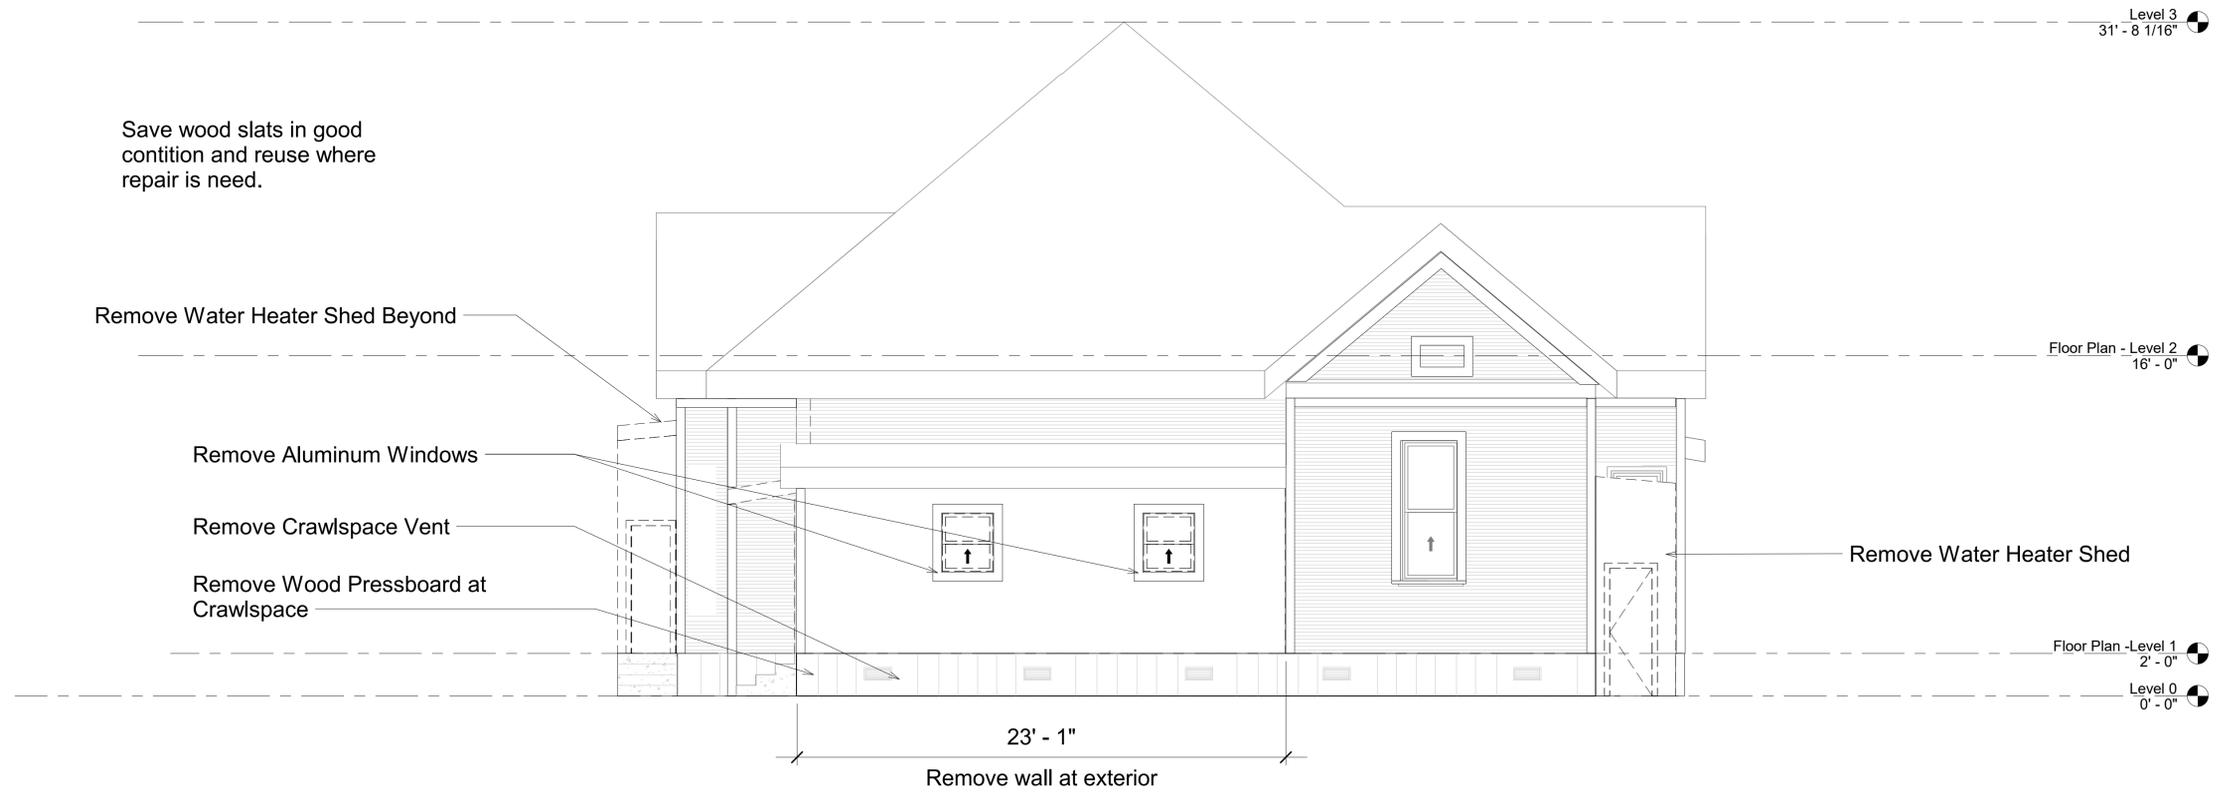
1 South - Demo
 1/4" = 1'-0"

Save wood slats in good condition and reuse where repair is need.

1. Remove a non-original wood sash windows on the rear (south) wing and replace with fixed, transom-style window at the same location.
2. Remove an original wood sash window on the east facade of the south wing and replace with a fixed, transom-style window at the same location.
3. Remove three, non-original grouped windows, replace them with two salvaged wood windows from the south and east facades (as referenced in request items 1 and 2)

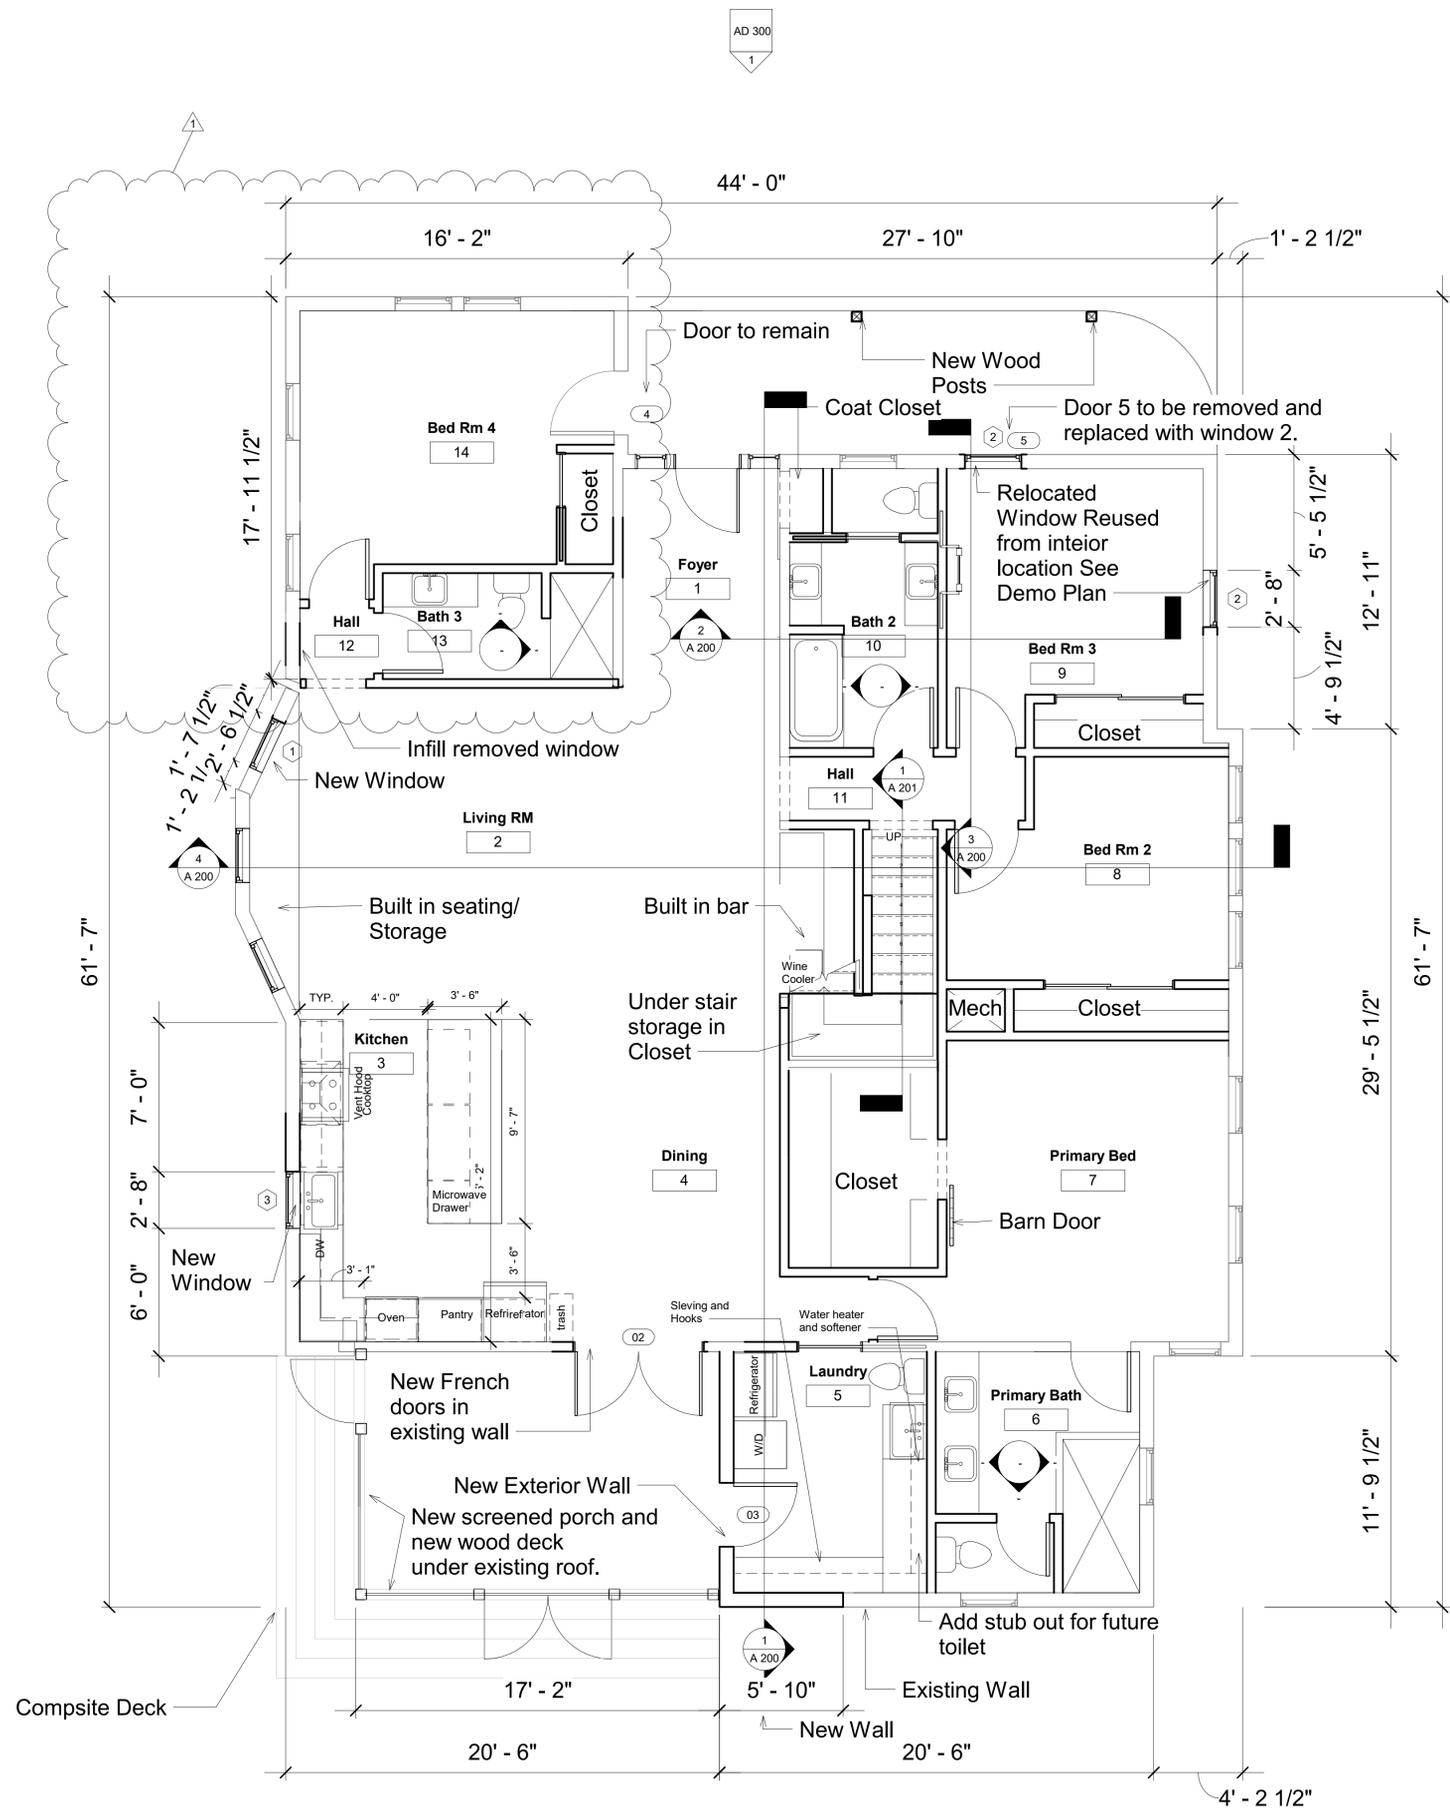
1 Floor Plan - Level 1
1/4" = 1'-0"

- Notes:
1. Sand, stain, and seal all existing wood floors.
 2. Insulate crawlspace with R-13.

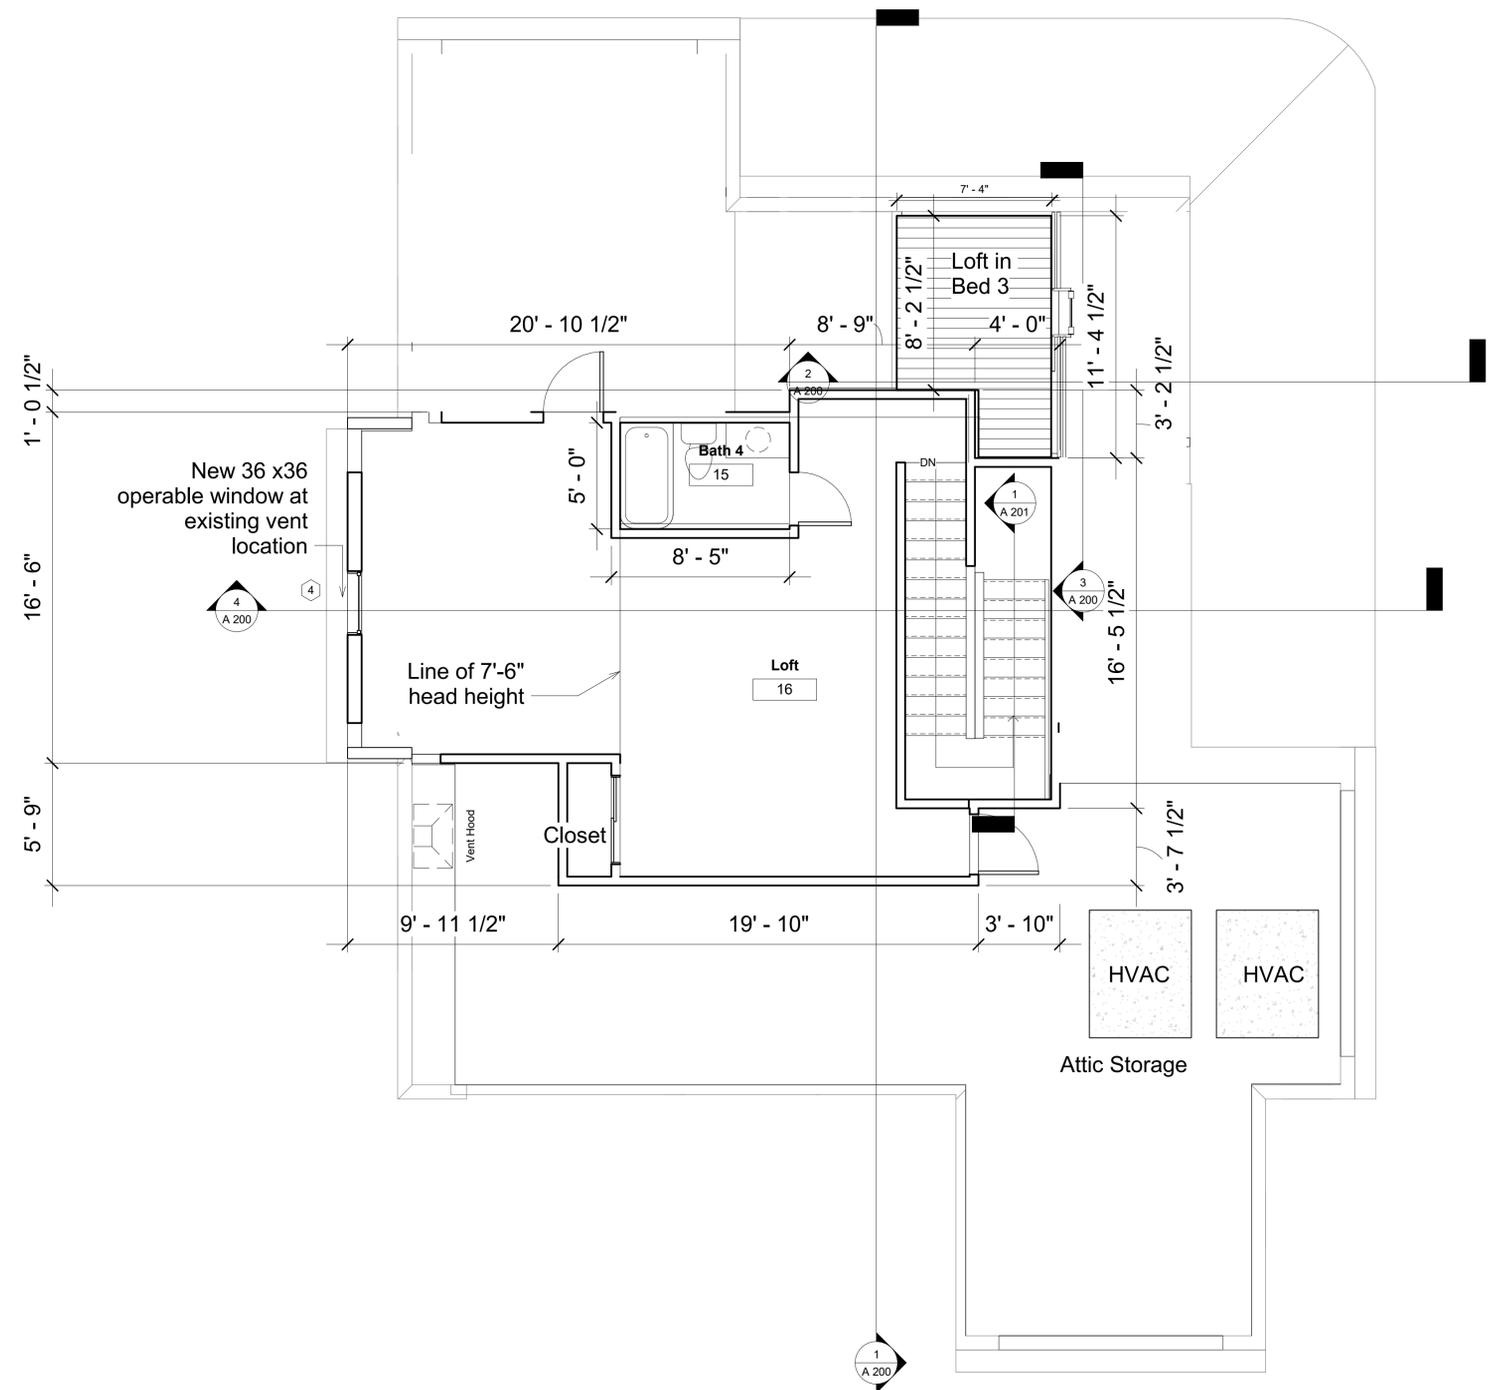
1 Floor Plan - Level 2
 1/4" = 1'-0"

Second Floor 520sf of finish out
 250 SF with Head height of 7'-6"+

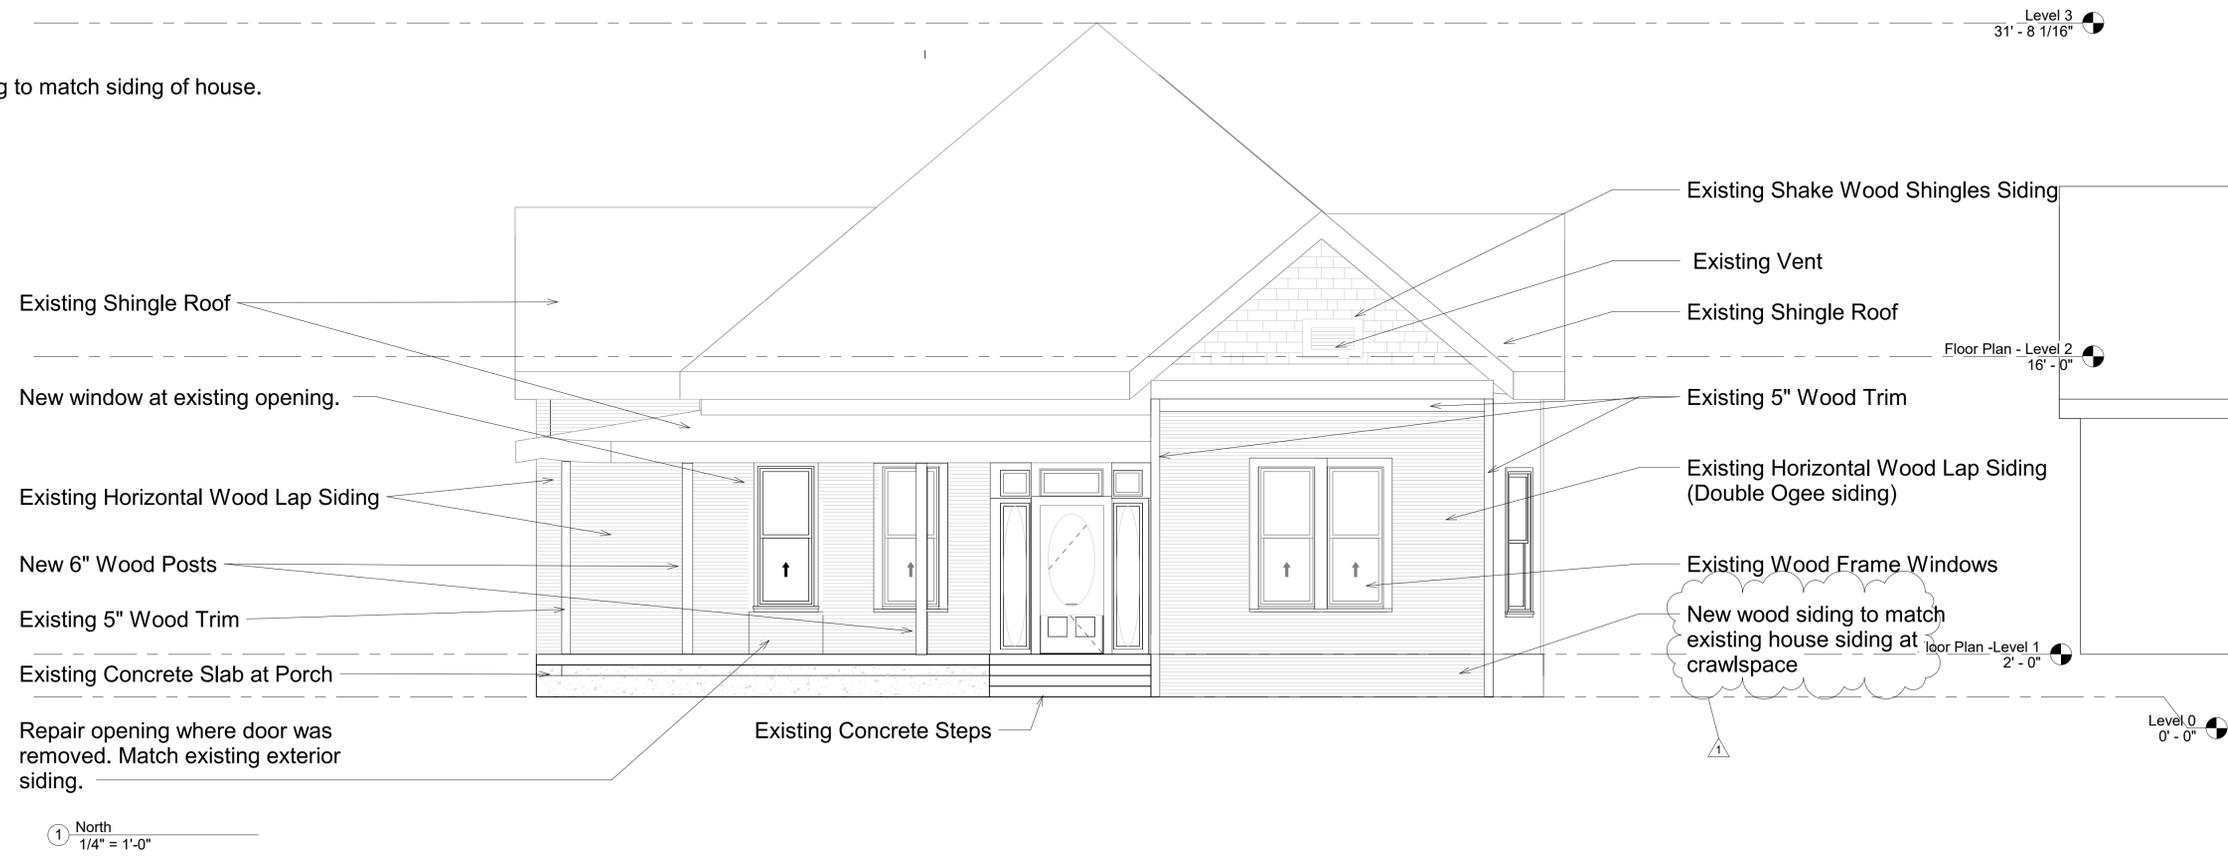
① North
1/4" = 1'-0"

1. Paint all exterior wood of home.
2. Paint windows and trims.
3. Replace crawspace siding with wood siding to match siding of house.
4. Vent crawspace as required.

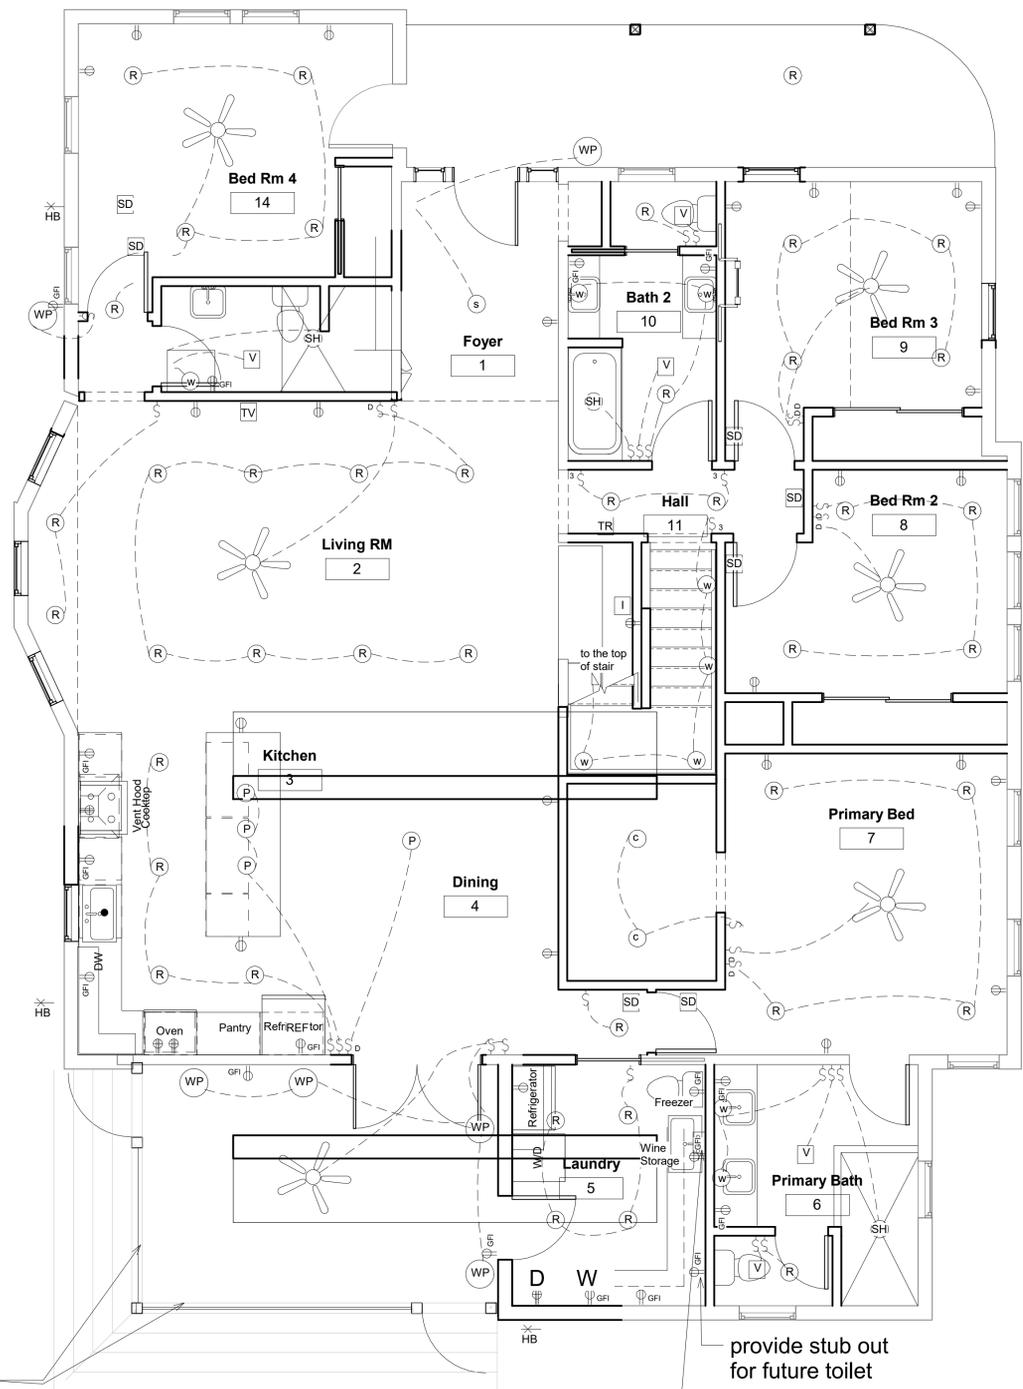
1 Electrical Floor Plan- Level 1
1/4" = 1'-0"

provide electrical as necessary for retractable screens

provide stub out for future toilet

Tankless Water Heater and water softener above the wine storage. Hide in cabinet.

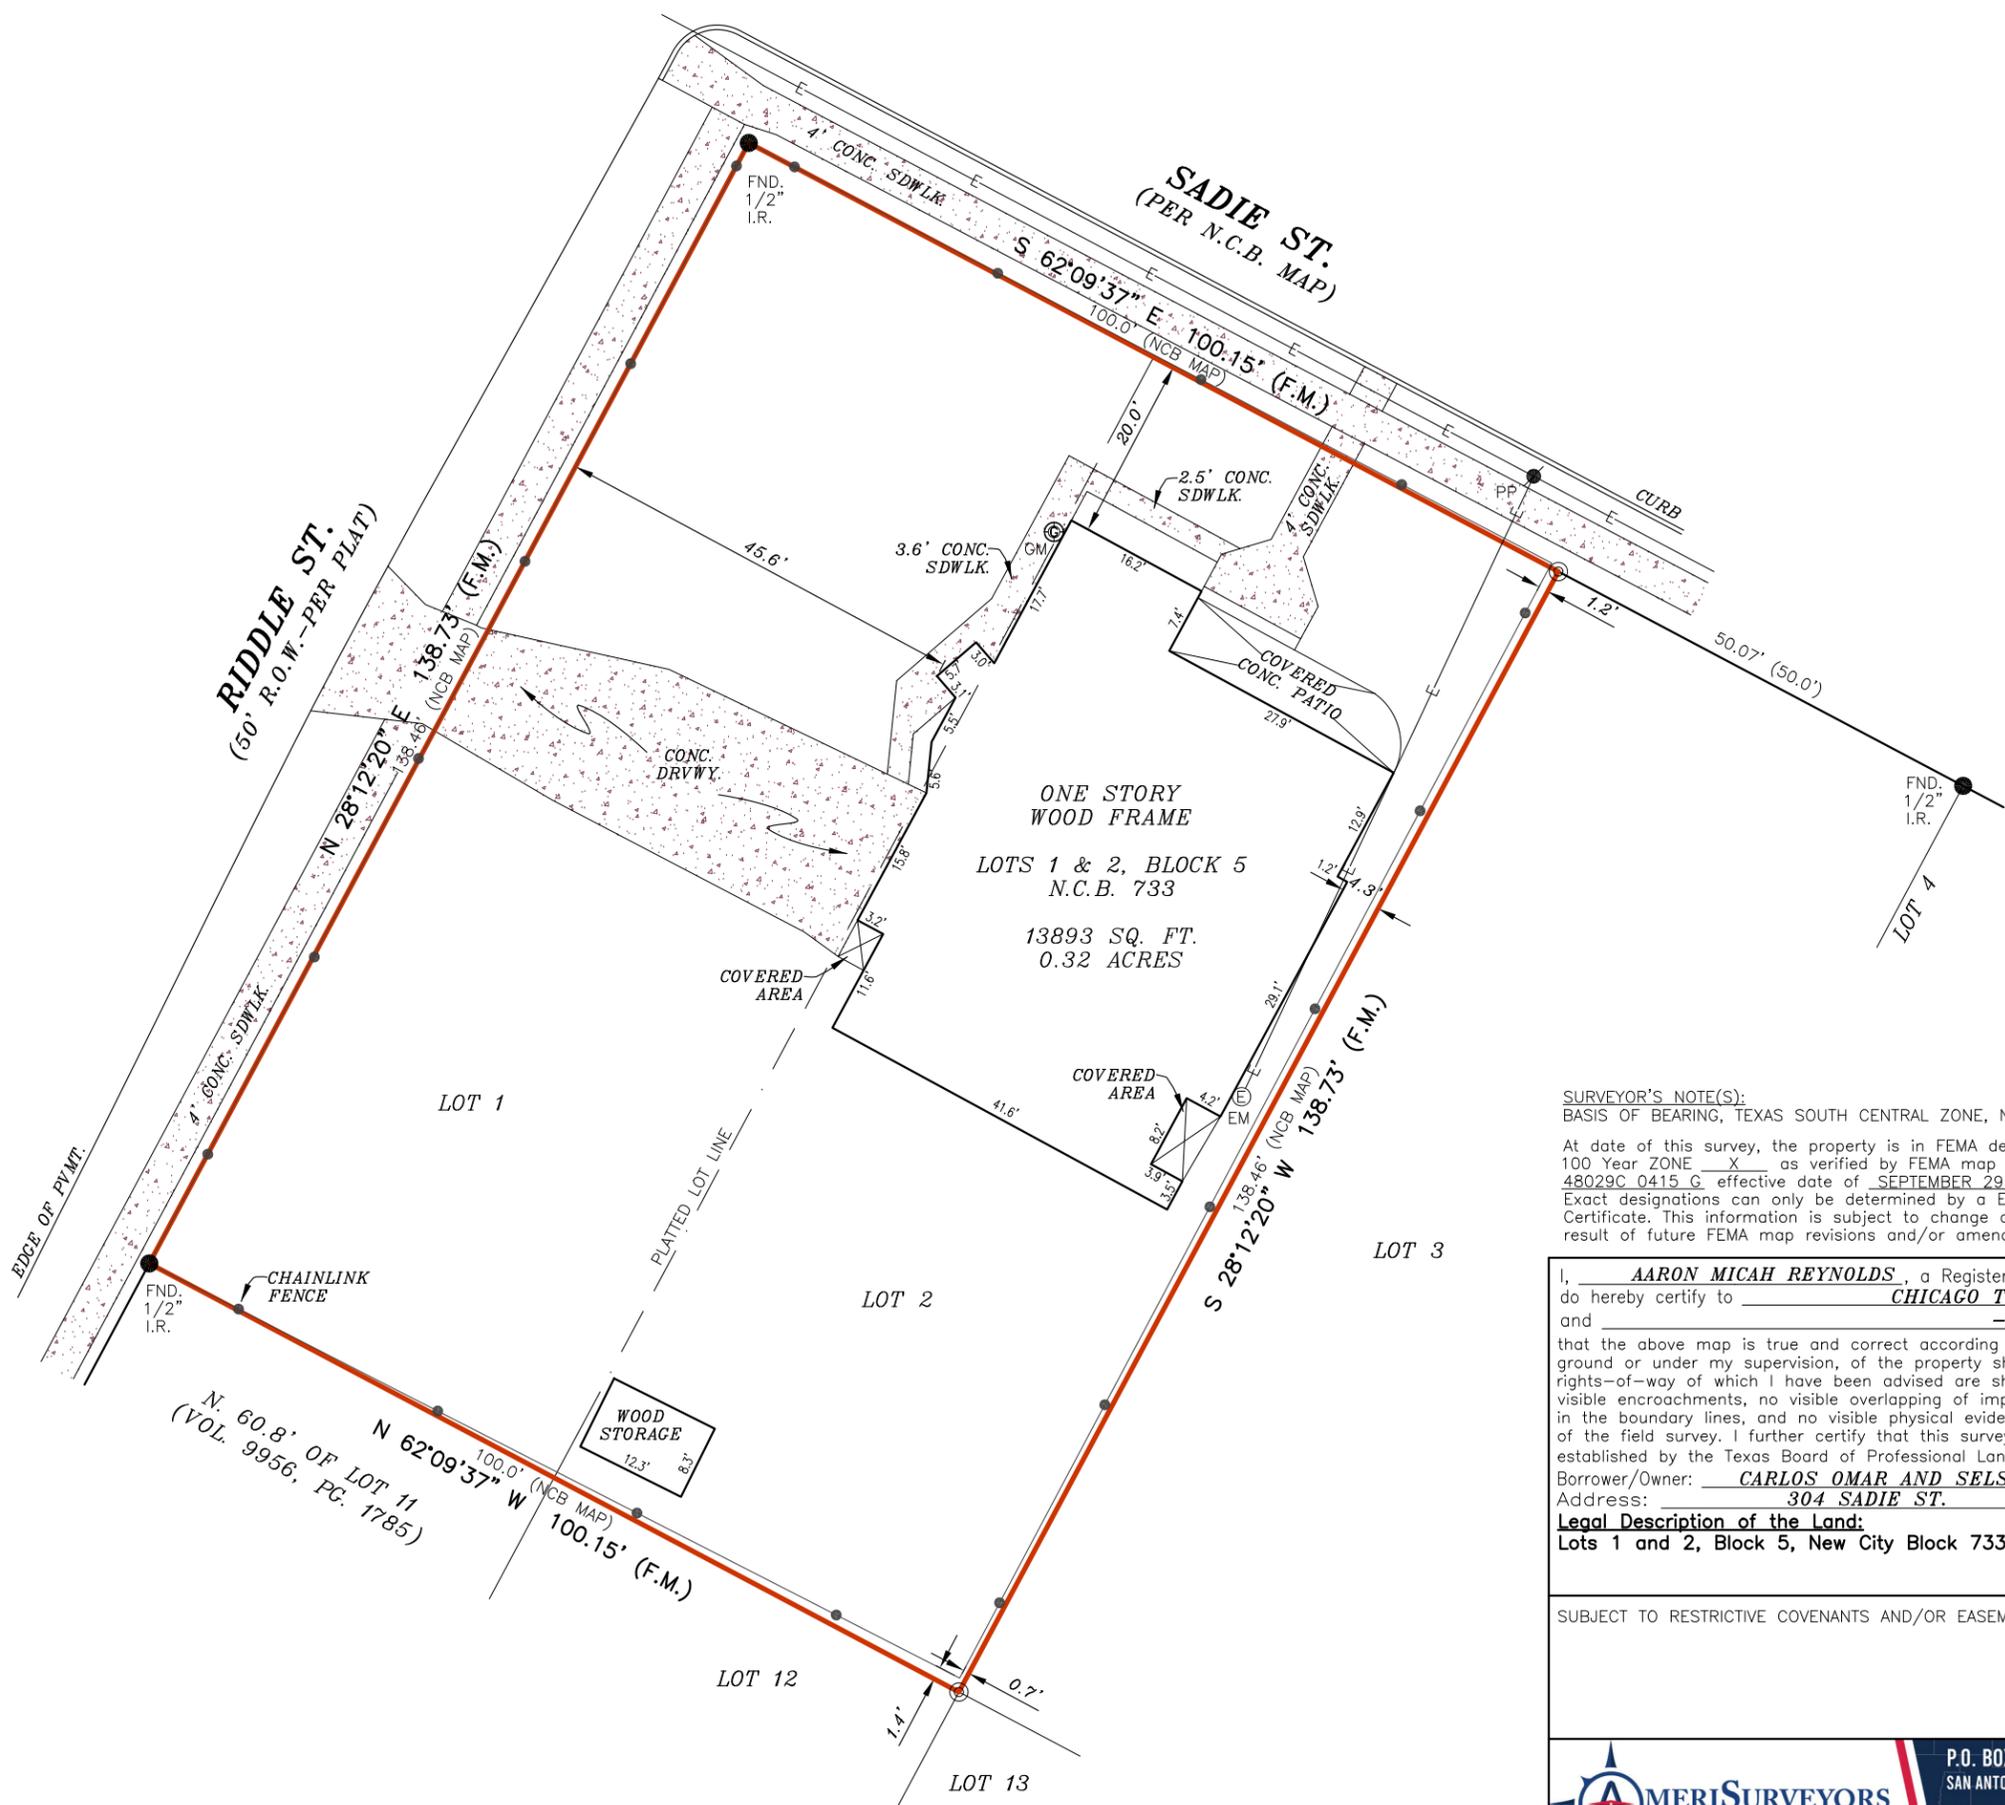
SURVEYOR'S NOTE(S):
 BASIS OF BEARING, TEXAS SOUTH CENTRAL ZONE, NAD 83.
 At date of this survey, the property is in FEMA designated 100 Year ZONE X as verified by FEMA map Panel No: 48029C 0415 G effective date of SEPTEMBER 29, 2010. Exact designations can only be determined by a Elevation Certificate. This information is subject to change as a result of future FEMA map revisions and/or amendments.
