HISTORIC AND DESIGN REVIEW COMMISSION

October 19, 2022

HDRC CASE NO: 2022-506
ADDRESS: 825 E HARLAN AVE
LEGAL DESCRIPTION: NCB 7729 BLK 9 LOT E 171.7 FT OF 11 THRU 14, EXC SE 6.50FT X 10.15FT
ZONING: MF-33, H
CITY COUNCIL DIST.: 3
DISTRICT: Mission Historic District
APPLICANT: Kevin Sekula/SEKULA KEVIN
OWNER: Kevin Sekula/SEKULA KEVIN
TYPE OF WORK: Installation of doors and windows, driveway modifications
APPLICATION RECEIVED: September 19, 2022
60-DAY REVIEW: Not applicable due to City Council Emergency Orders
CASE MANAGER: Jessica Anderson
REQUEST:

The applicant is requesting a Certificate of Appropriateness for approval to:

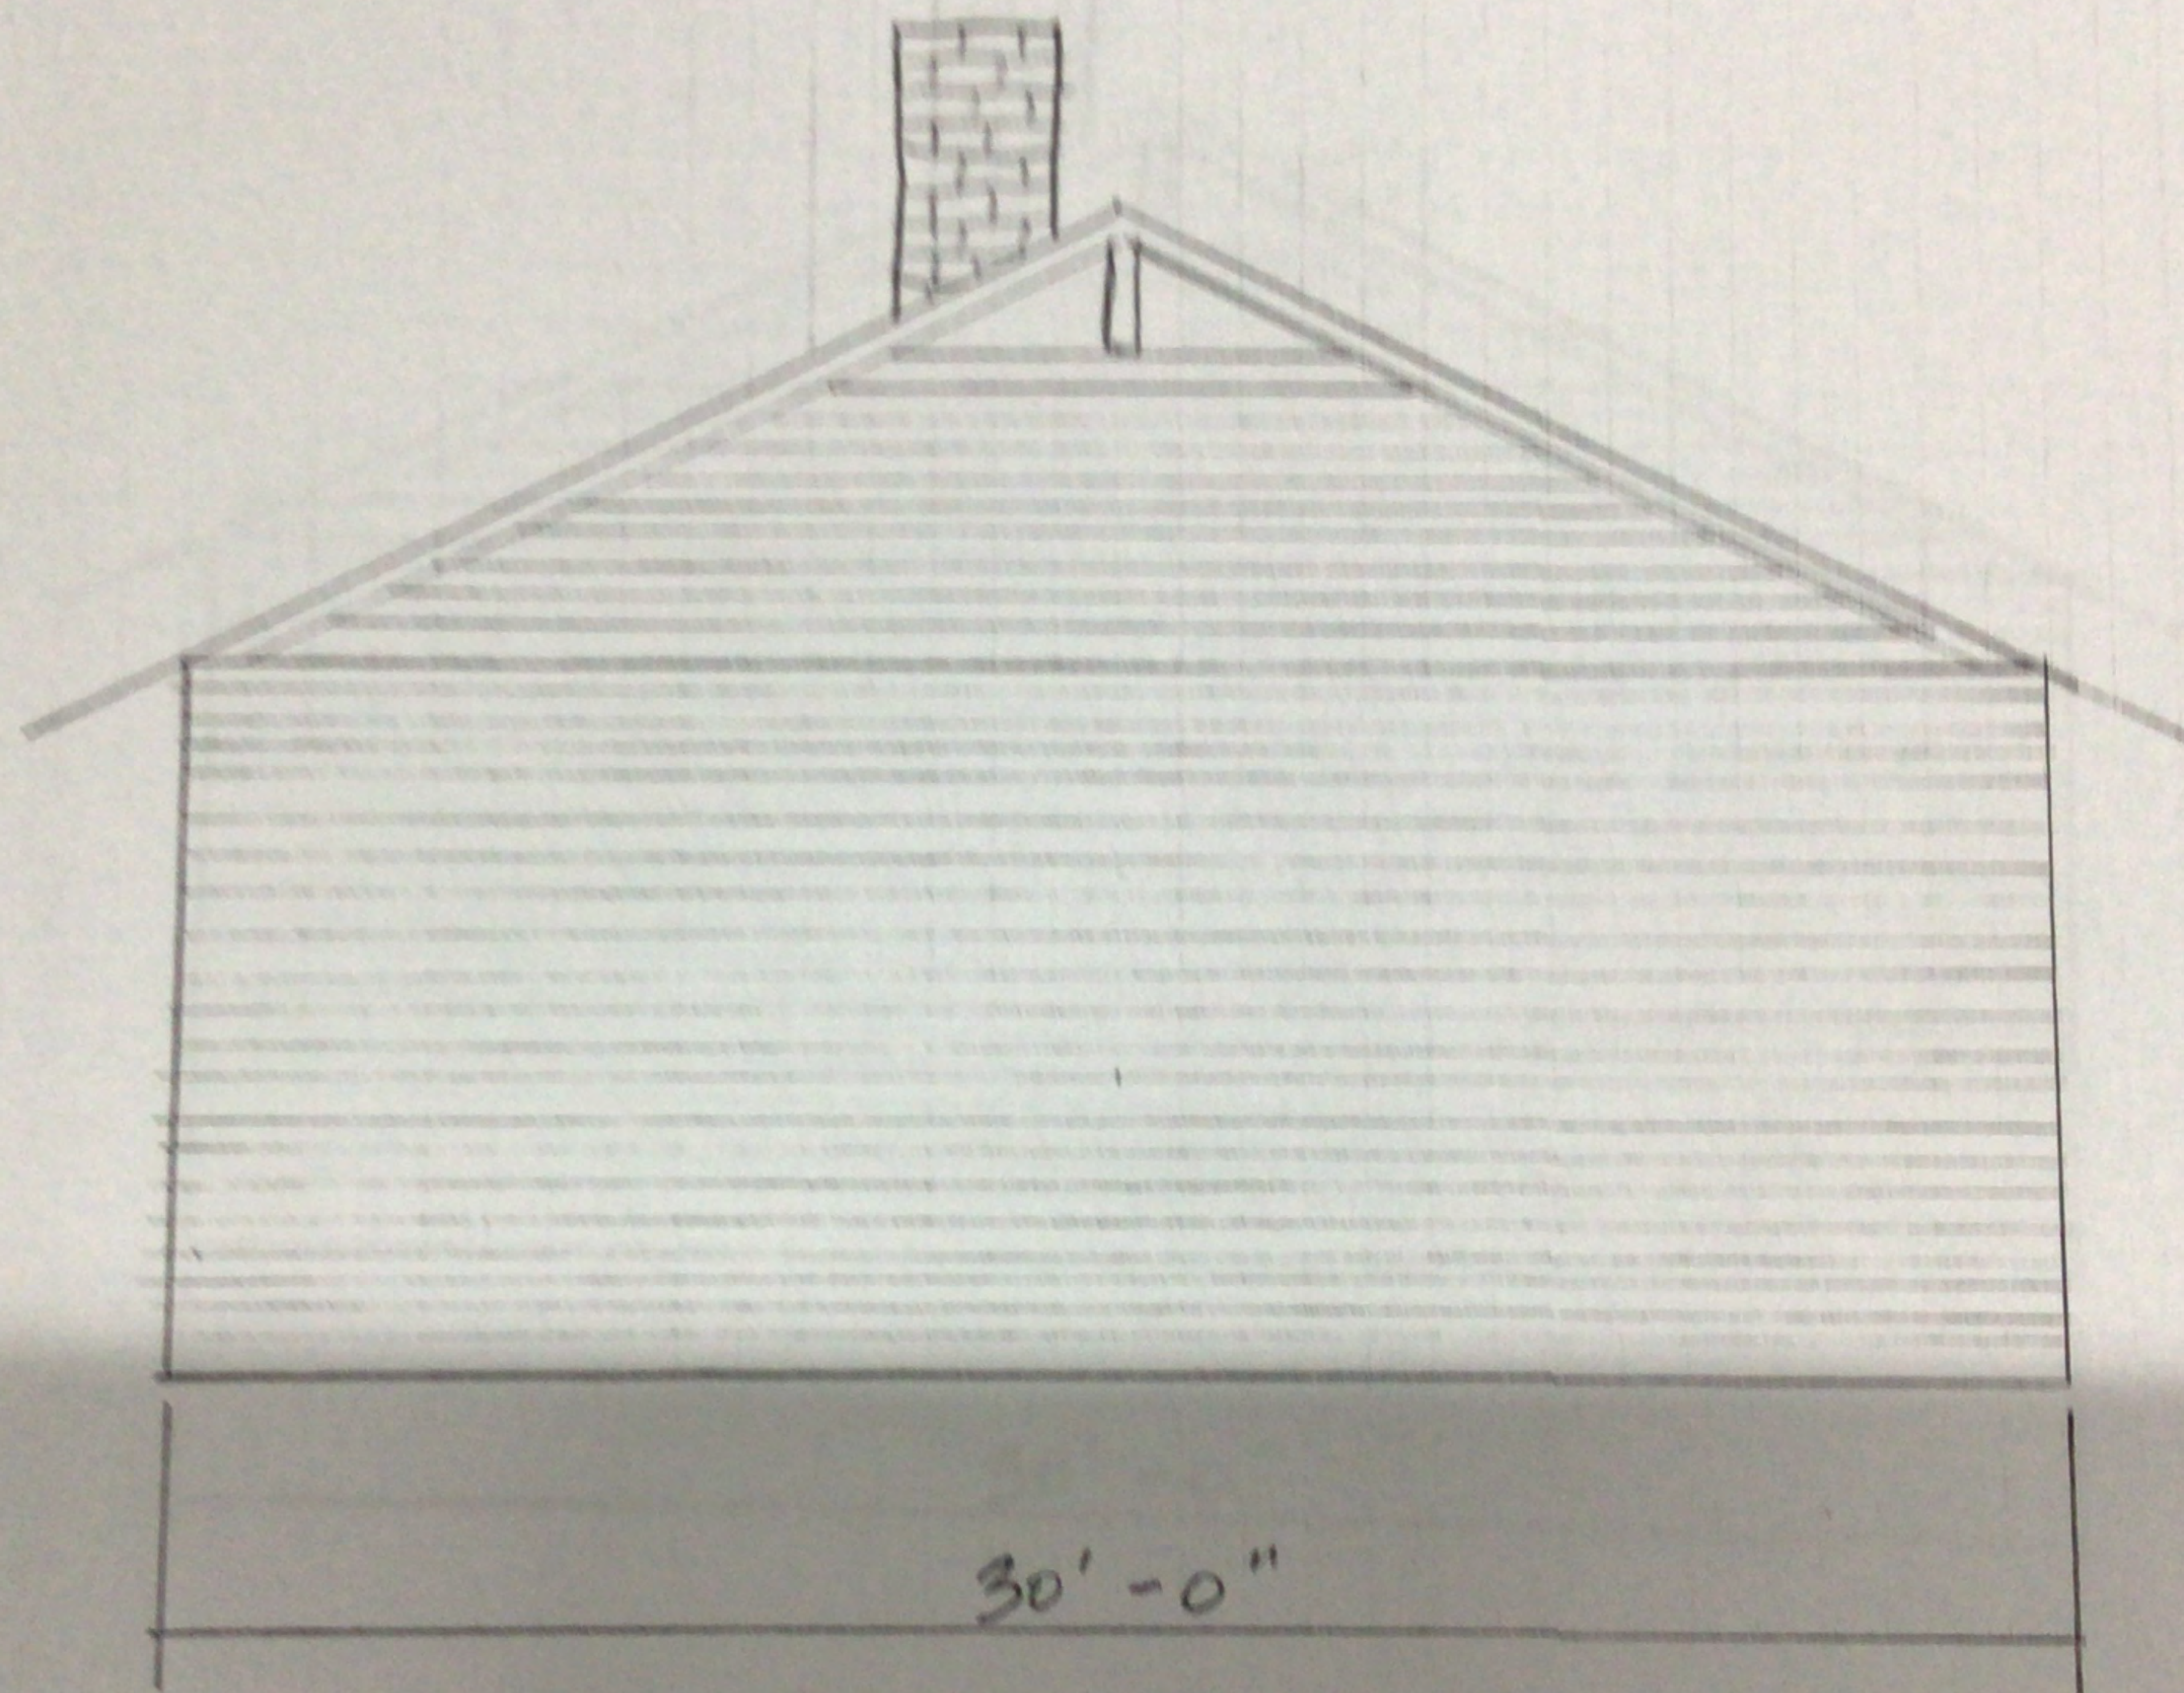
4.) ALL WINDOWS WILL BE
REPLACED WITH SIMILAR STYLE
& SIZE WINDOWS BUT WILL BE
ENERGY EFF. & INSULATED

5.) ALL EXT. DOORS TO BE
3'6" OR LARGER.

- d. FENESTRATION CHANGES: The applicant requests fenestration changes across all elevations. On the east elevation, they propose moving the door to the center of the elevation and creating a new set of three ganged windows to the left of the new door; the three ganged windows right of the proposed door are retained. On the south elevation, the applicant proposes to retain the French doors and three ganged windows, but replace the single bathroom window and pair of ganged windows with two clerestory windows. The applicant requests removal of all fenestration on the west elevation; staff finds removal of the metal-sash window in the gable appropriate, but that the door and first-floor window be retained. (The applicant requested partial demolition of the small west addition; see finding d.) On the north elevation, the applicant proposes relocating a door, three ganged windows, and a pair of ganged windows while completely removing one window. Historic Design Guidelines for Exterior Maintenance and Alterations 6.A.i and ii state that historic doors and windows should be preserved. Staff finds the proposed fenestration changes do not conform to guidelines.

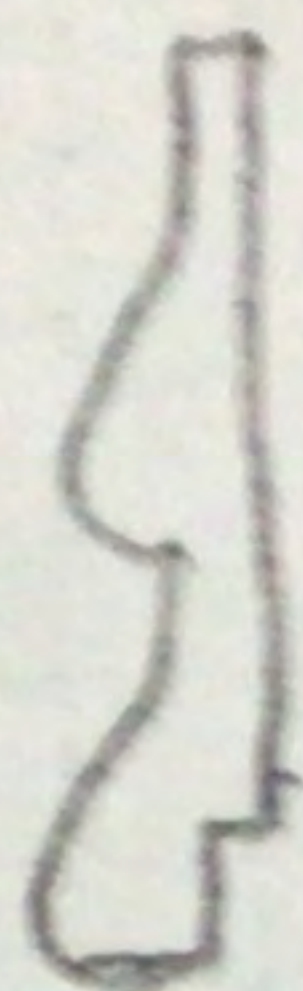
2.) THE EXIST. SIDING IS PINE LAP SIDING

THIS PROFILE IS
STILL AVAILABLE
AND WILL BE USED
