HISTORIC AND DESIGN REVIEW COMMISSION

HDRC CASE NO: 2022-513
ADDRESS: 400 CLUB DR
LEGAL DESCRIPTION: NCB 7013 BLK LOT 9
ZONING: RM-4, H
CITY COUNCIL DIST.: 7
DISTRICT: Monticello Park Historic District
APPLICANT: Paul Zurita/Zurita Construction & Remodeling
OWNER: IDEA INTERNATIONAL LLC
TYPE OF WORK: Window replacement
APPLICATION RECEIVED: October 04, 2022
60-DAY REVIEW: Not applicable due to City Council Emergency Orders
CASE MANAGER: Jessica Anderson

The applicant requests a Certificate of Appropriateness for approval to replace the existing metal casement windows with wood windows and to replace the wood garage doors with an aluminum panel garage door.

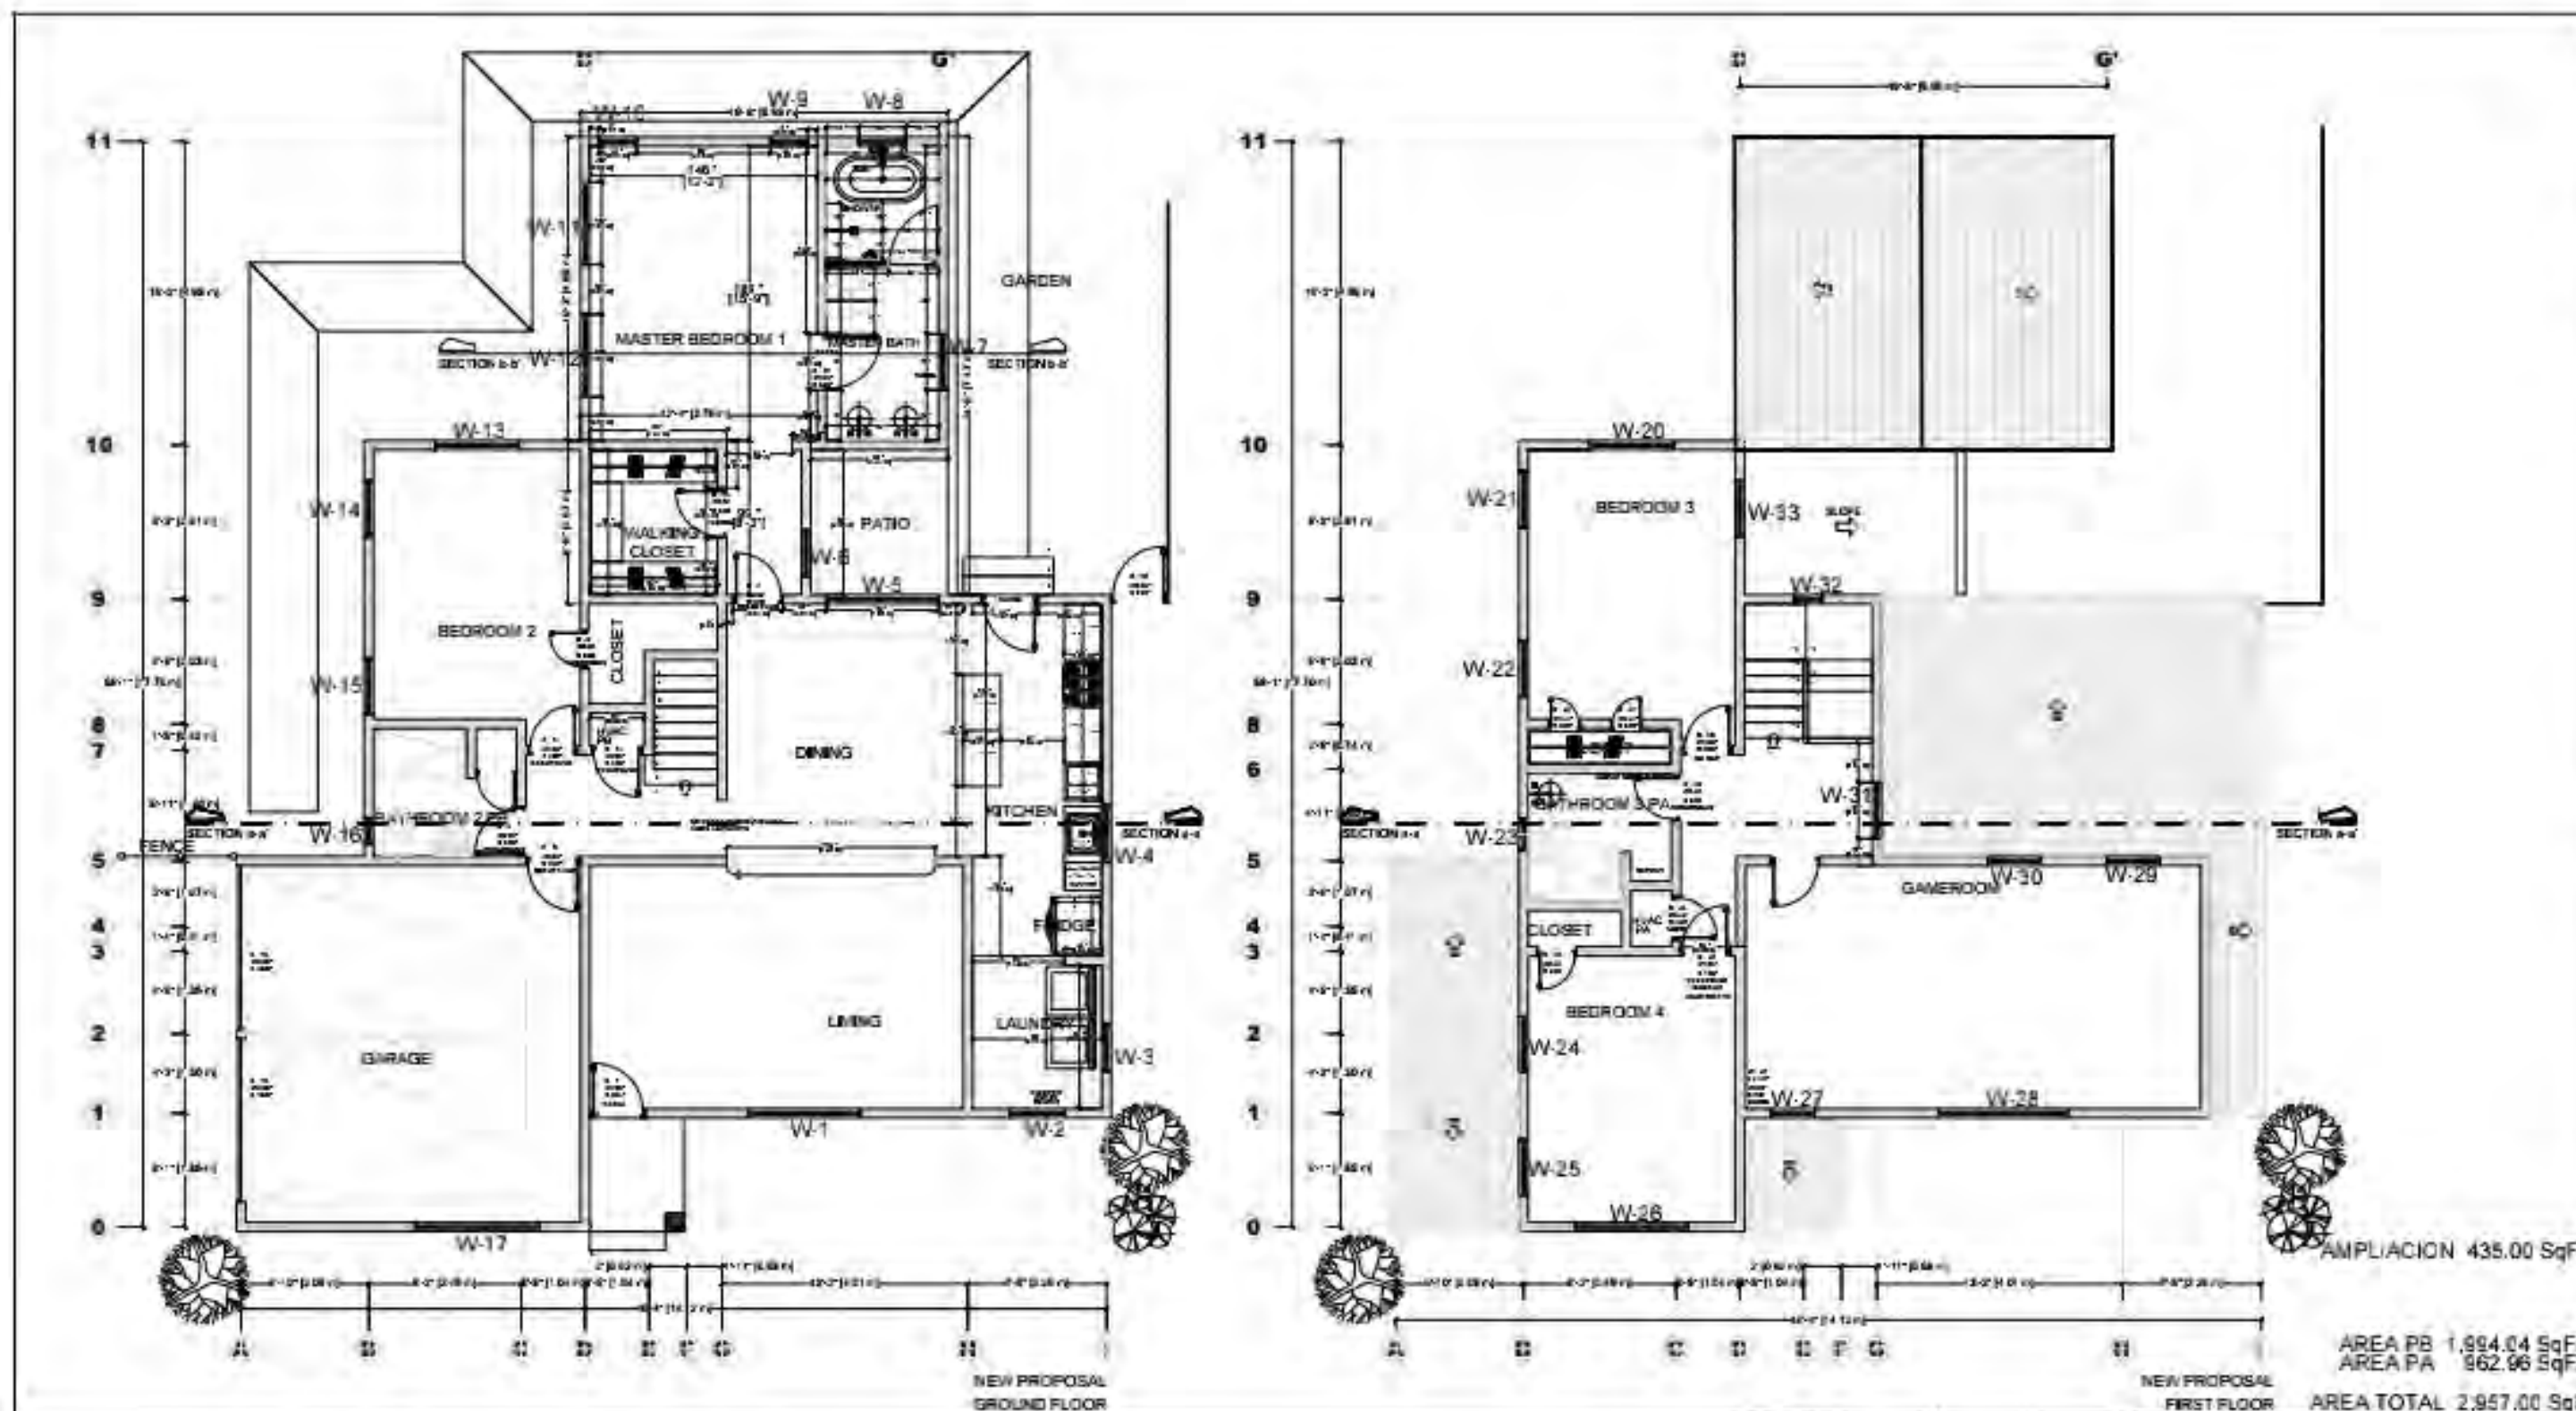
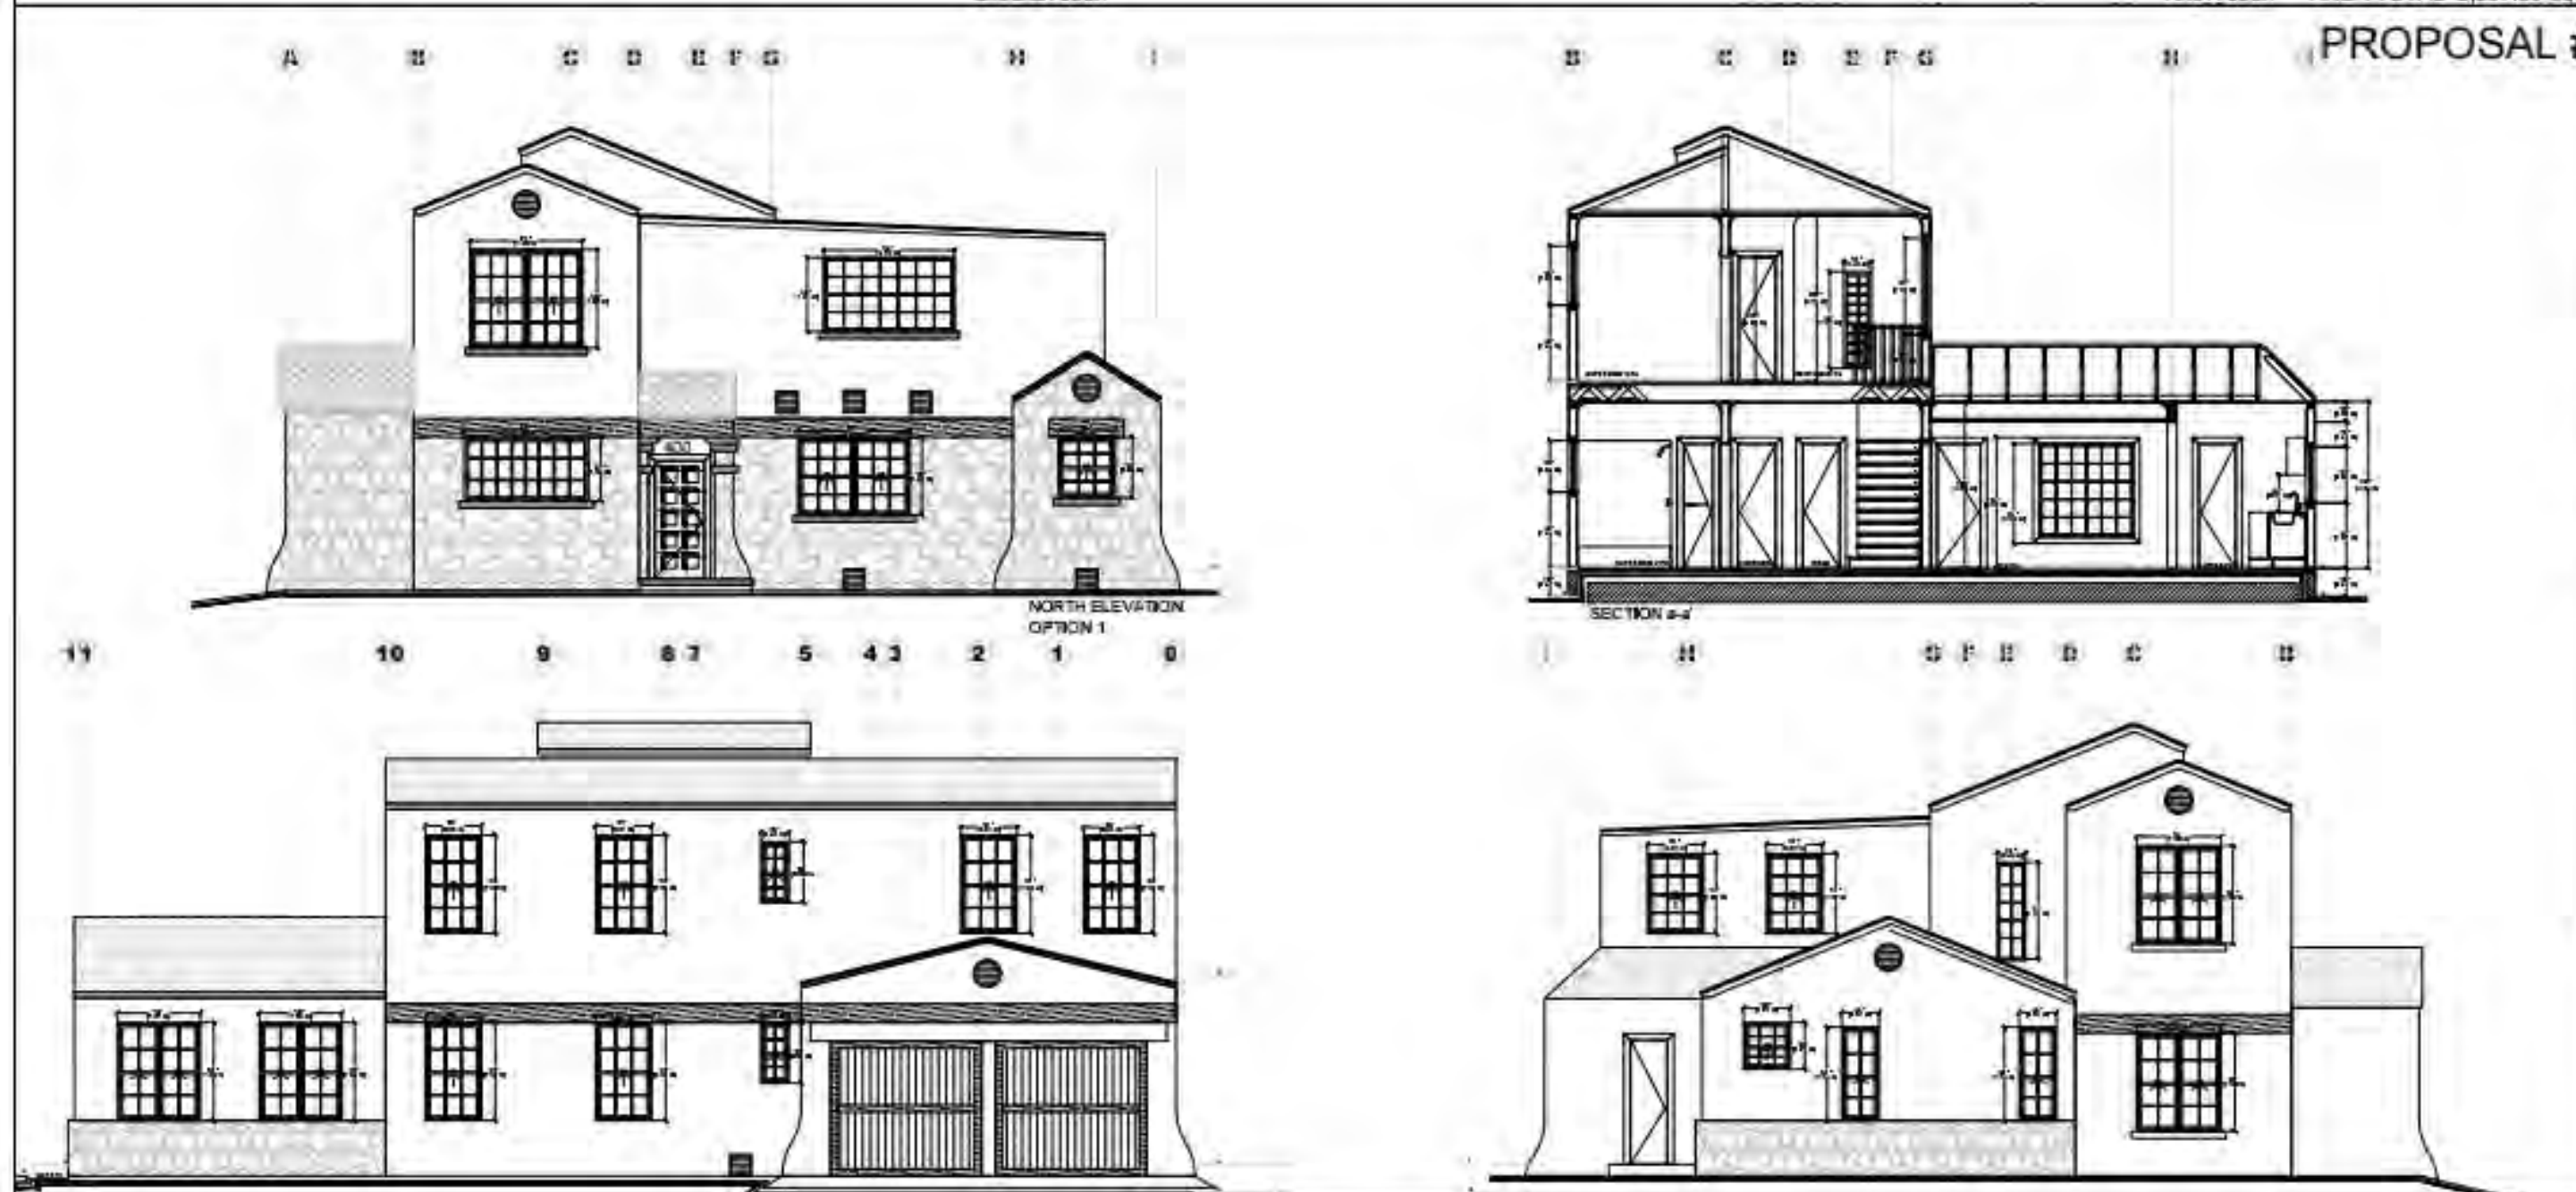
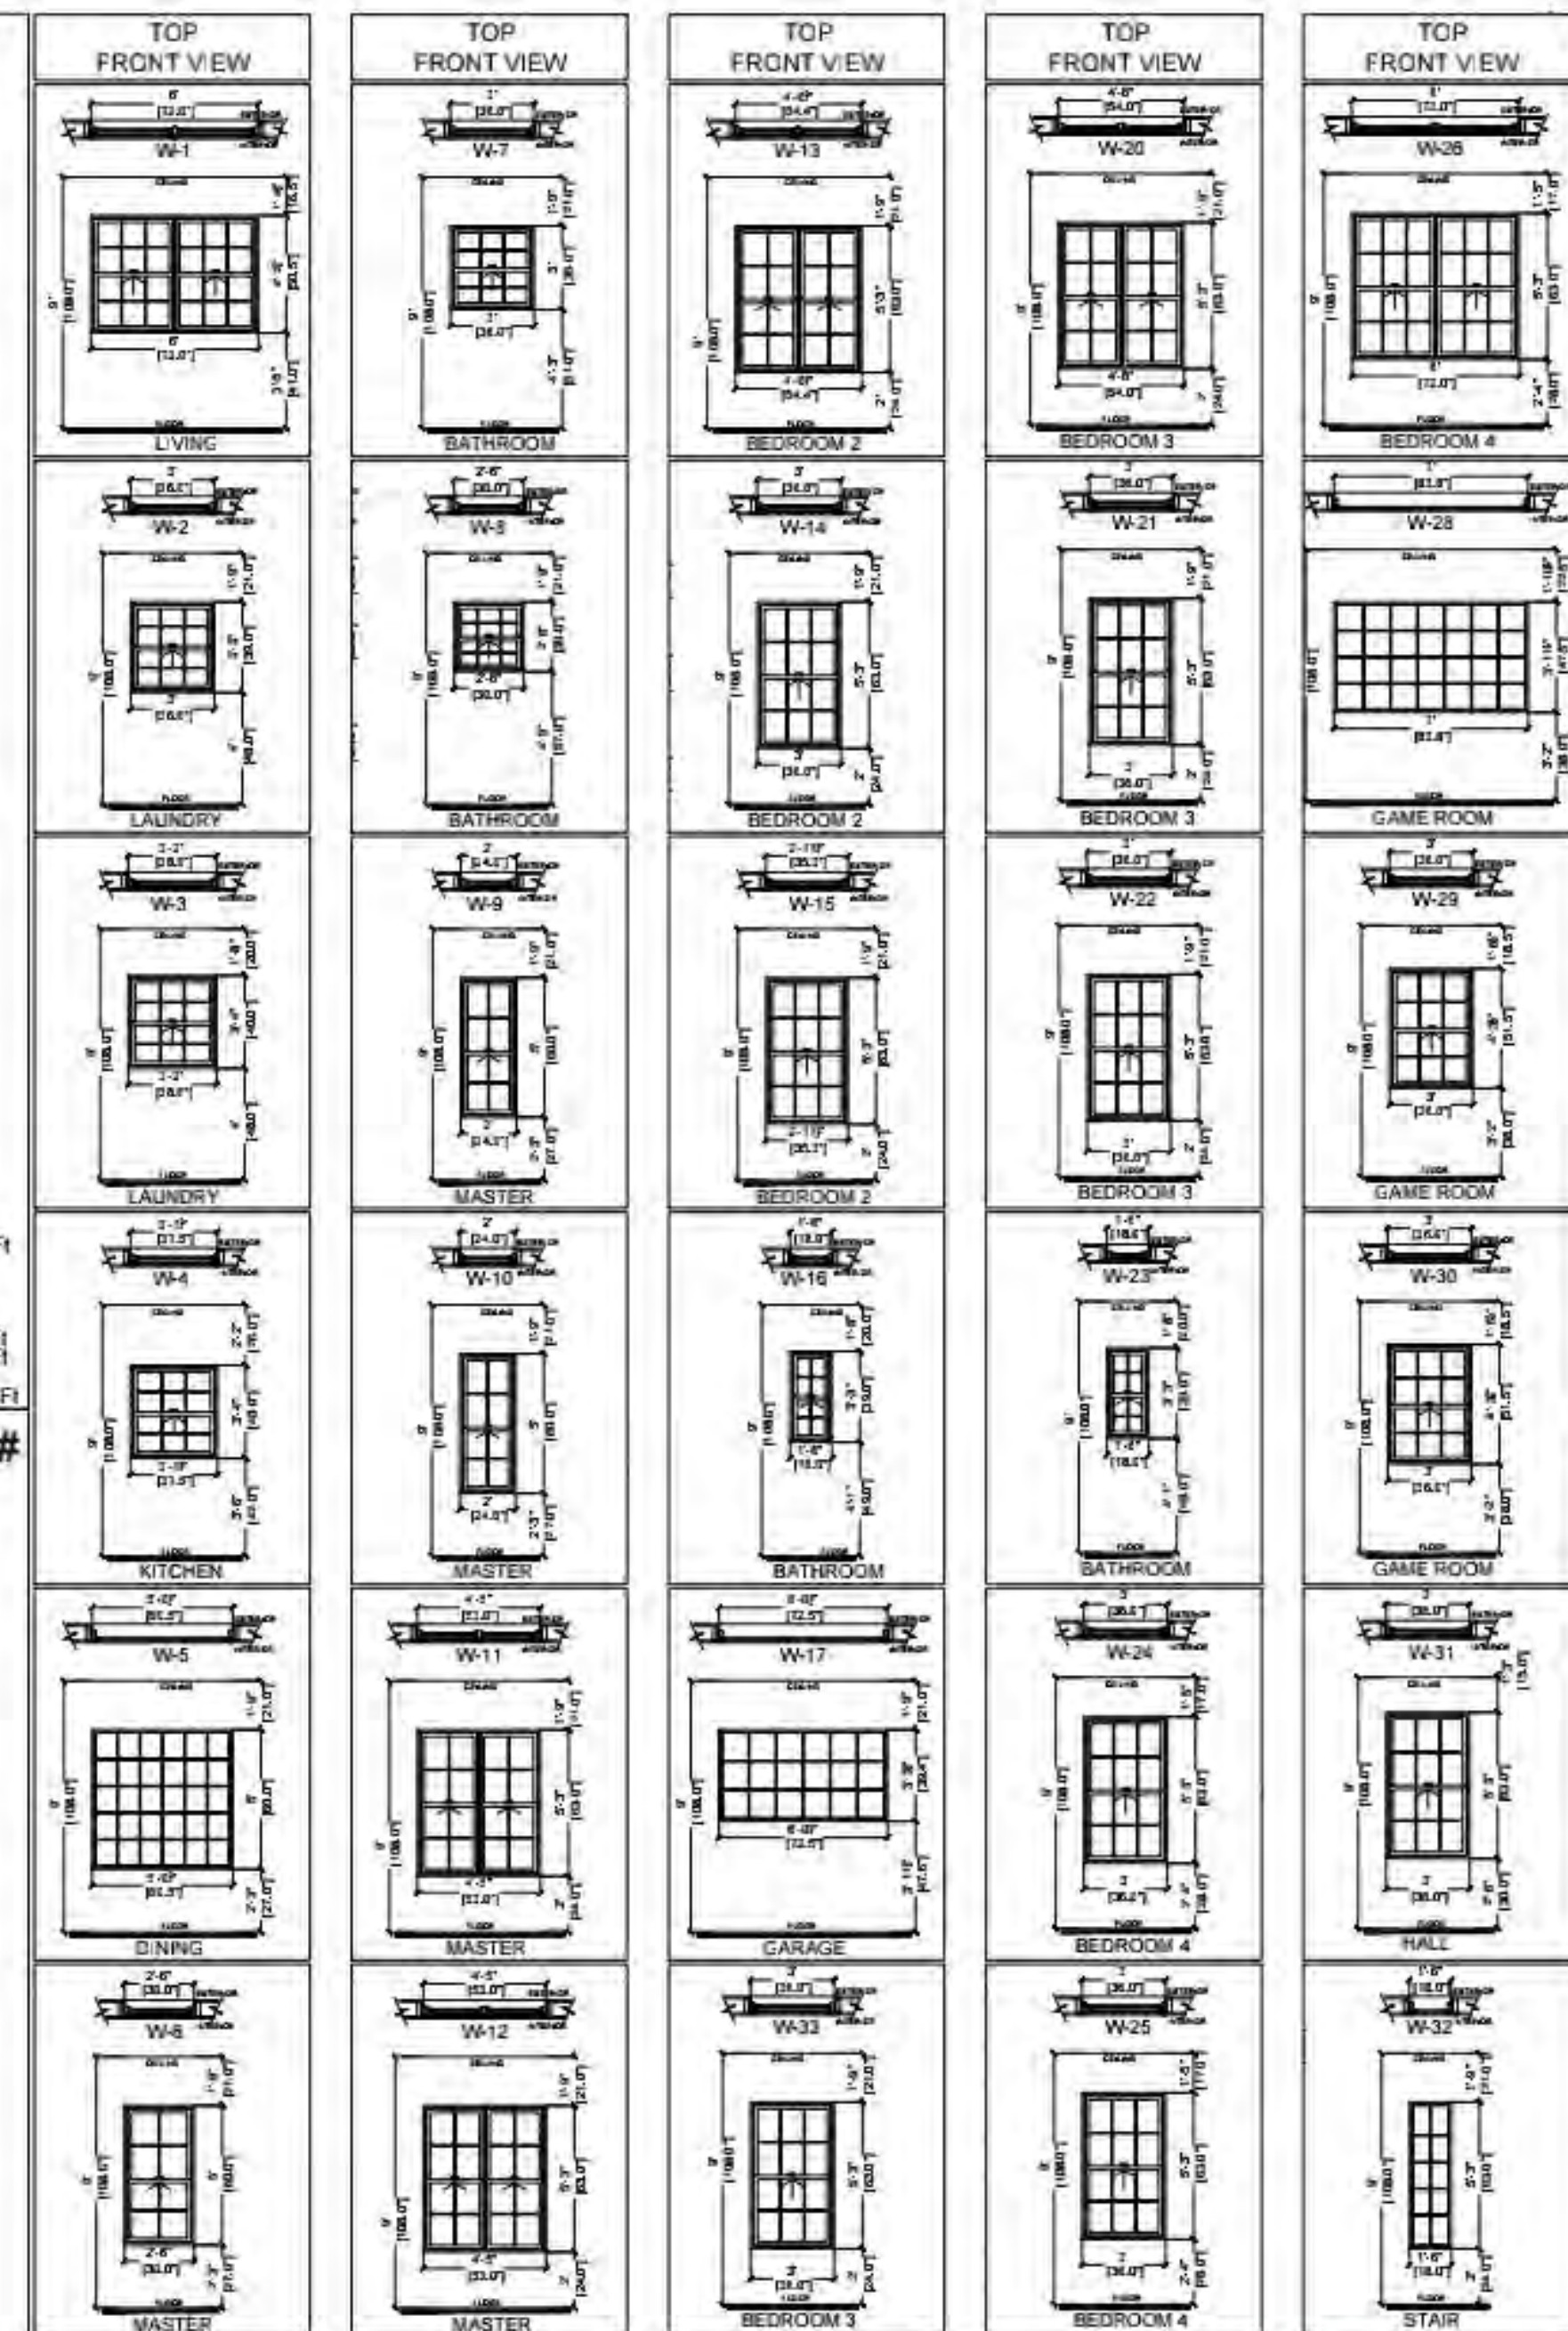
PROJECT: RESIDENTIAL: FAMILY HOME		DATE: 10/10/2022	
ADDRESS: 400 CLUB DRIVE, SAN ANTONIO, TEXAS, 78203, UNITED STATES		PROJECT: 400 CLUB DRIVE	
DRAWN BY: CES INTERNATIONAL LLC		CHECKED BY: CES INTERNATIONAL LLC	
DATE: 10/10/2022		DATE: 10/10/2022	
DESIGN: CES INTERNATIONAL LLC		SCALE: 1/8" = 1'-0"	
PROJECT: 400 CLUB DRIVE		DATE: 10/10/2022

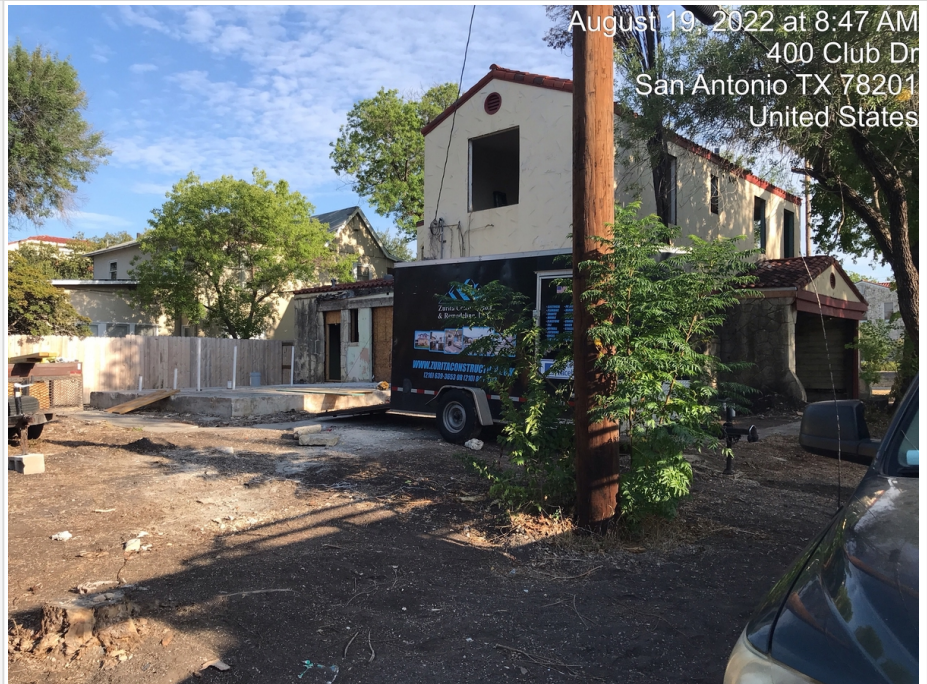
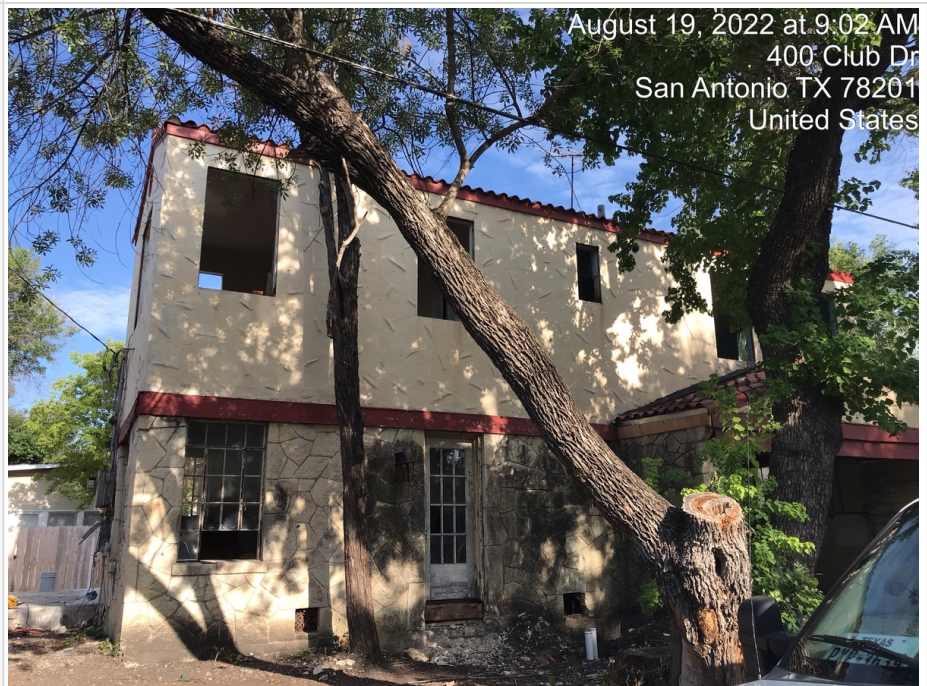
08/19/2022 09:07 AM

Photographs

- b. **VIOLATION:** OHP staff received several citizen reports of work outside of approval at 400 Club Dr. Staff performed a site visit August 19, 2022, and observed removal of metal casement windows on the second floor. Contractors on site shared their intent to replace the casement windows with aluminum sash windows. Staff posted a notice of investigation and noted no other work occurring without a Certificate of Appropriateness. The full report is included in this case file.

Date	08/19/2022
Time	09:03 AM (-5 GMT)
Context	citizen report
Present Staff	Edward Hall
Present Individuals	Contractor(s)
Types of Work Observed	Exterior Maintenance and Alterations
Amount of Work Completed	50%
Description of work	The non-original metal casement windows of the second floor have been removed.
Description of interaction	<p>Contractors on site noted that the intent is to replace with new aluminum windows. OHP staff spoke with the contractors and notified them of the unapproved scope of work and the requirement for a COA for window replacement. No new windows have been installed.</p> <p>OHP issued a Violation Notice for window work. All other scopes of work appeared to be consistent with the issued COA.</p>
