HISTORIC AND DESIGN REVIEW COMMISSION

HDRC CASE NO: 2021-540
ADDRESS: 401 SHOOK AVE
LEGAL DESCRIPTION: NCB 6327 BLK 2 LOT NE TRI 5.3 OF 56 & EIRR 45 OF THE S 100 OF 57 & S 99.58 OF 58
ZONING: R-5
CITY COUNCIL DIST.: 1
DISTRICT: Monte Vista Historic District
APPLICANT: Lewis McNeel/MCNEEL LEWIS MAVERICK
OWNER: Lewis McNeel/MCNEEL LEWIS MAVERICK
TYPE OF WORK: Window and door replacement
APPLICATION RECEIVED: October 02, 2021
60-DAY REVIEW: Not applicable due to City Council Emergency Orders
CASE MANAGER: Katie Totman

1. Replace three (3) existing wood windows at the rear of the house with new aluminum clad wood windows.
2. Replace four (4) existing wood exterior doors with wood and glass doors.

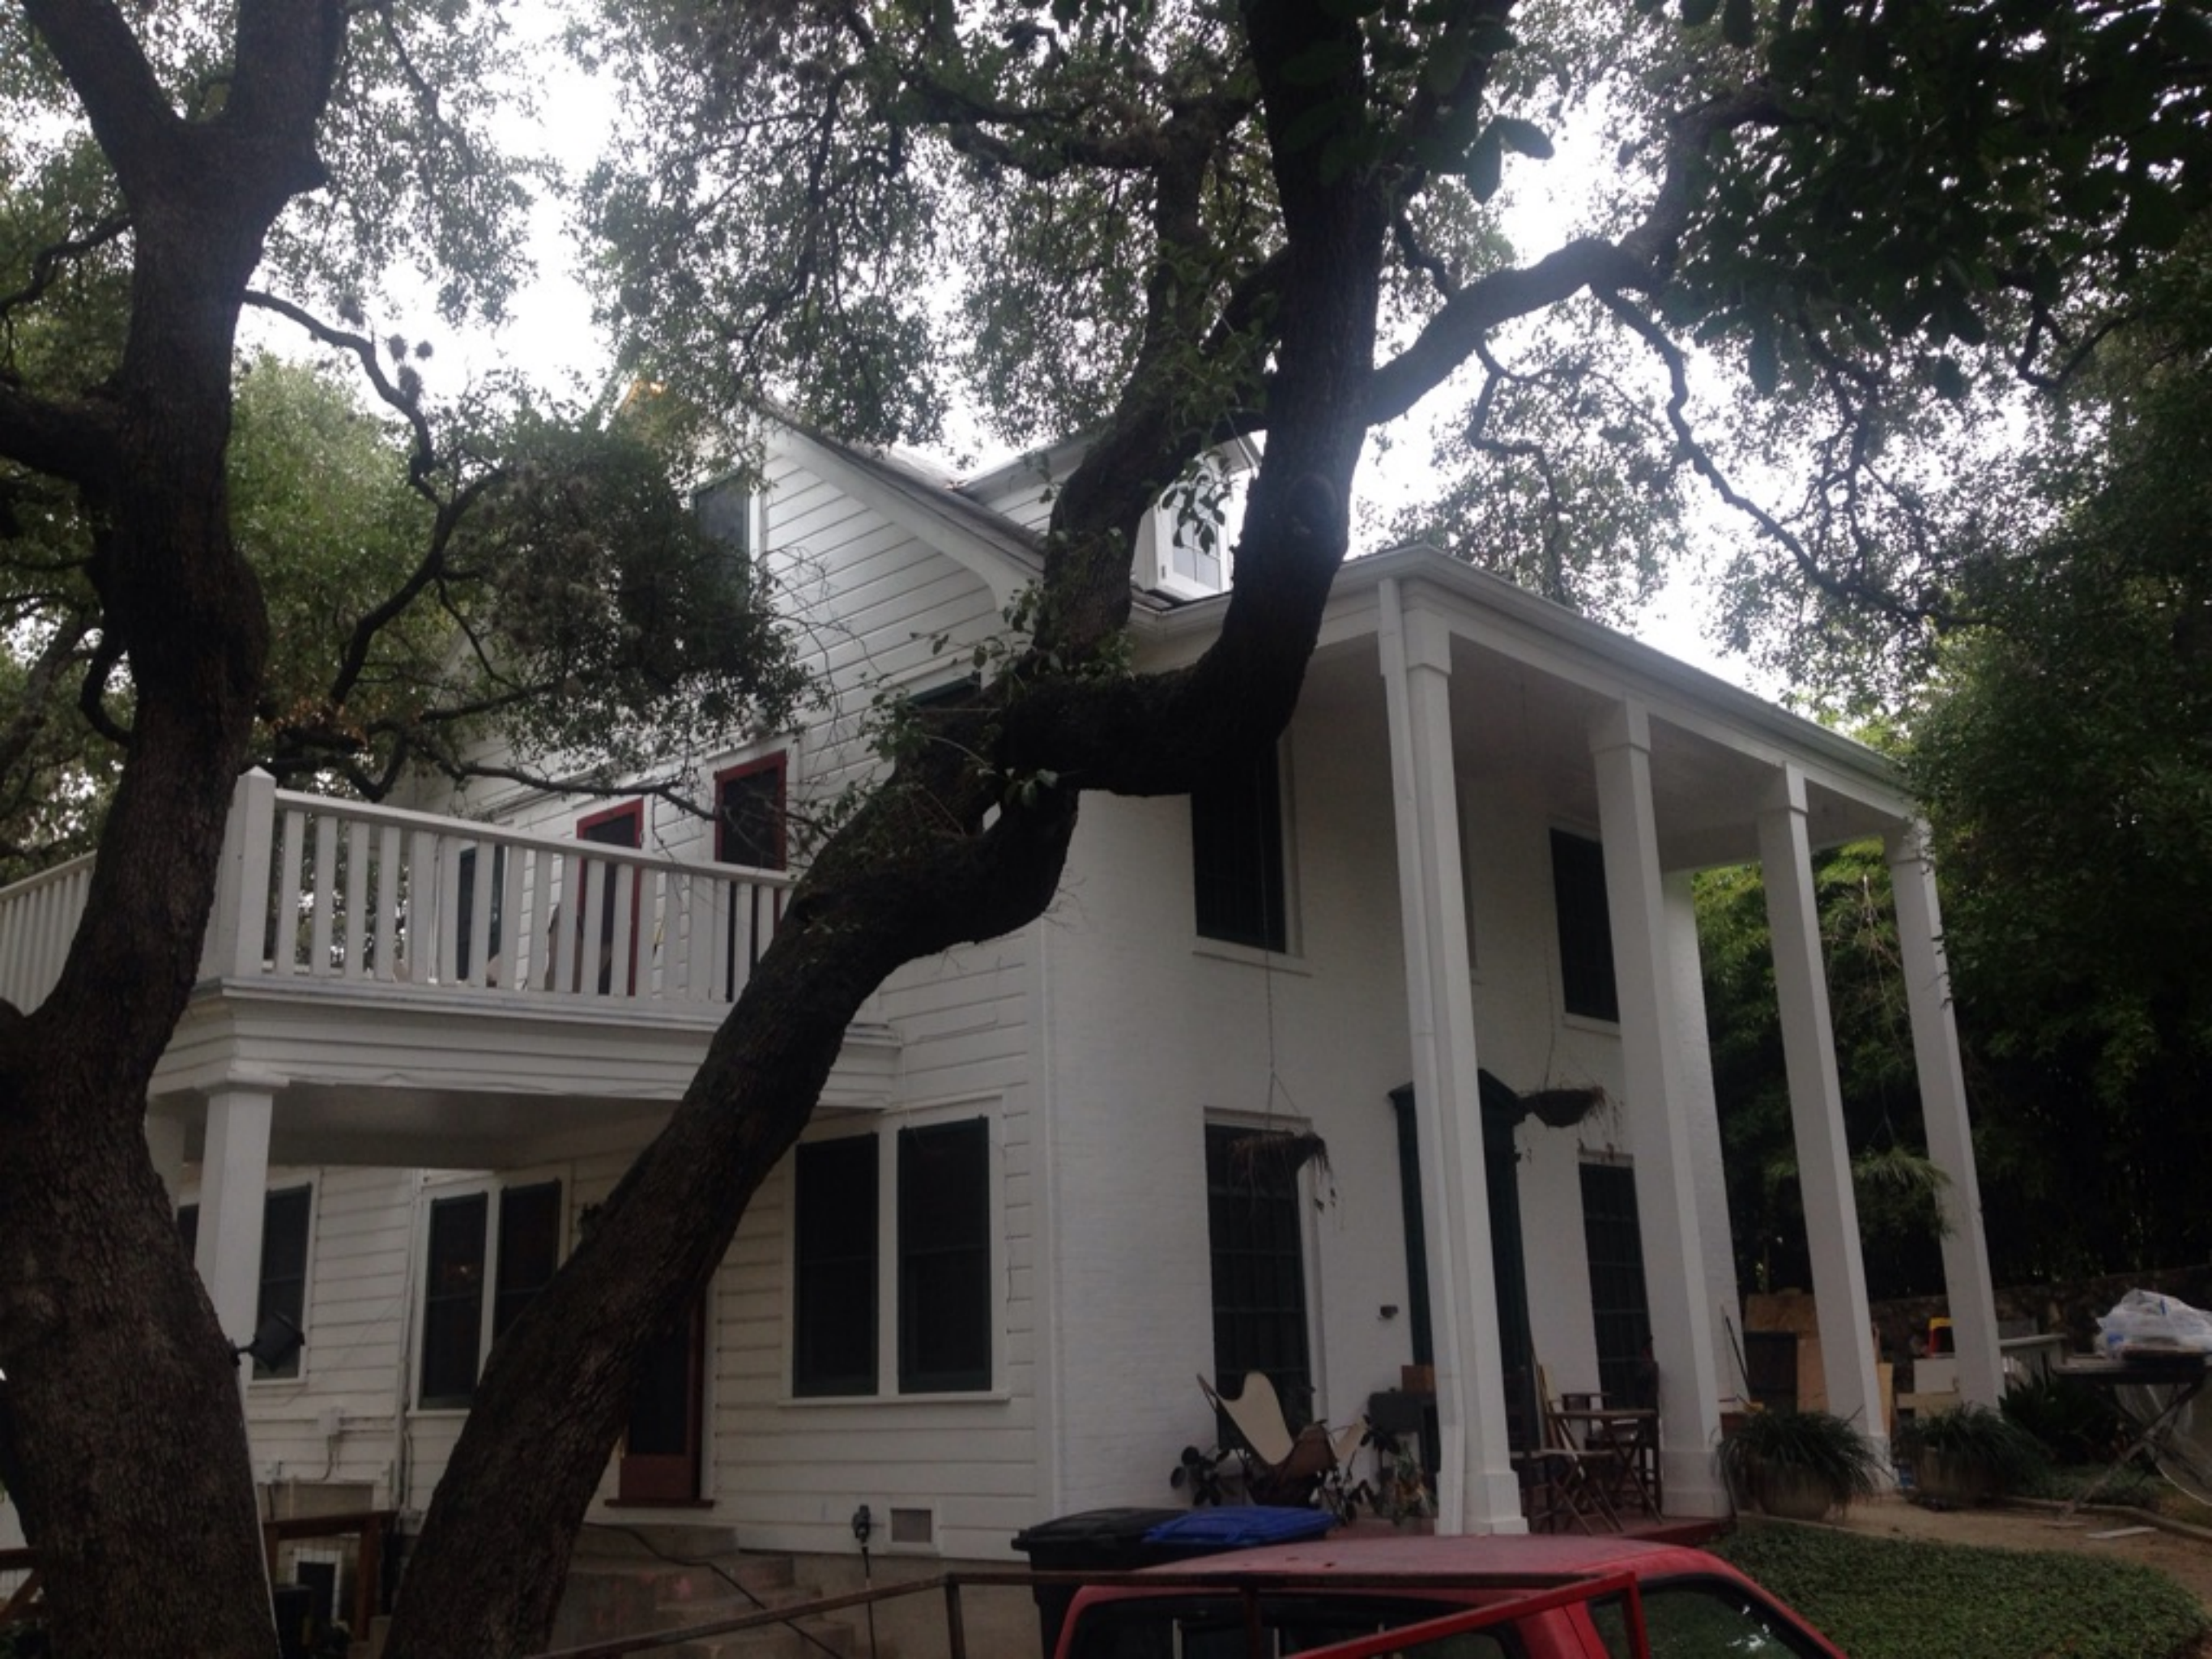
REPLACE
DOORS

TYPICAL
NON-ORIGINAL
DETAILS POORLY
CONCEIVED & EXECUTED

f. DOOR REPLACEMENT – The applicant has proposed to replace two (2) exterior wood doors located above the porte-cochere; one (1) exterior door beneath the porte-cochere; and the front door with aluminum clad wood doors that are similar in appearance to the existing screen doors with a single glass lite in place of the screened area. The two (2) existing doors above the porte-cochere are wood paneled doors without any lites and appear to be damaged at the bottom rails and exhibit some warping. The front door is a wood paneled door with three (3) lites in the top section. The Historic Design Guidelines for Exterior Maintenance and Alterations 6.B.i., advise to replace doors, hardware, fanlight, sidelights, pilasters, and entablatures in-kind when possible and when deteriorated beyond repair. When in-kind replacement is not feasible, ensure features match the size, material, and profile of the historic element. Staff finds that a replacement product that is in line with the Guidelines is appropriate in this instance for the doors at the porte-cochere and that the front door be maintained where possible.

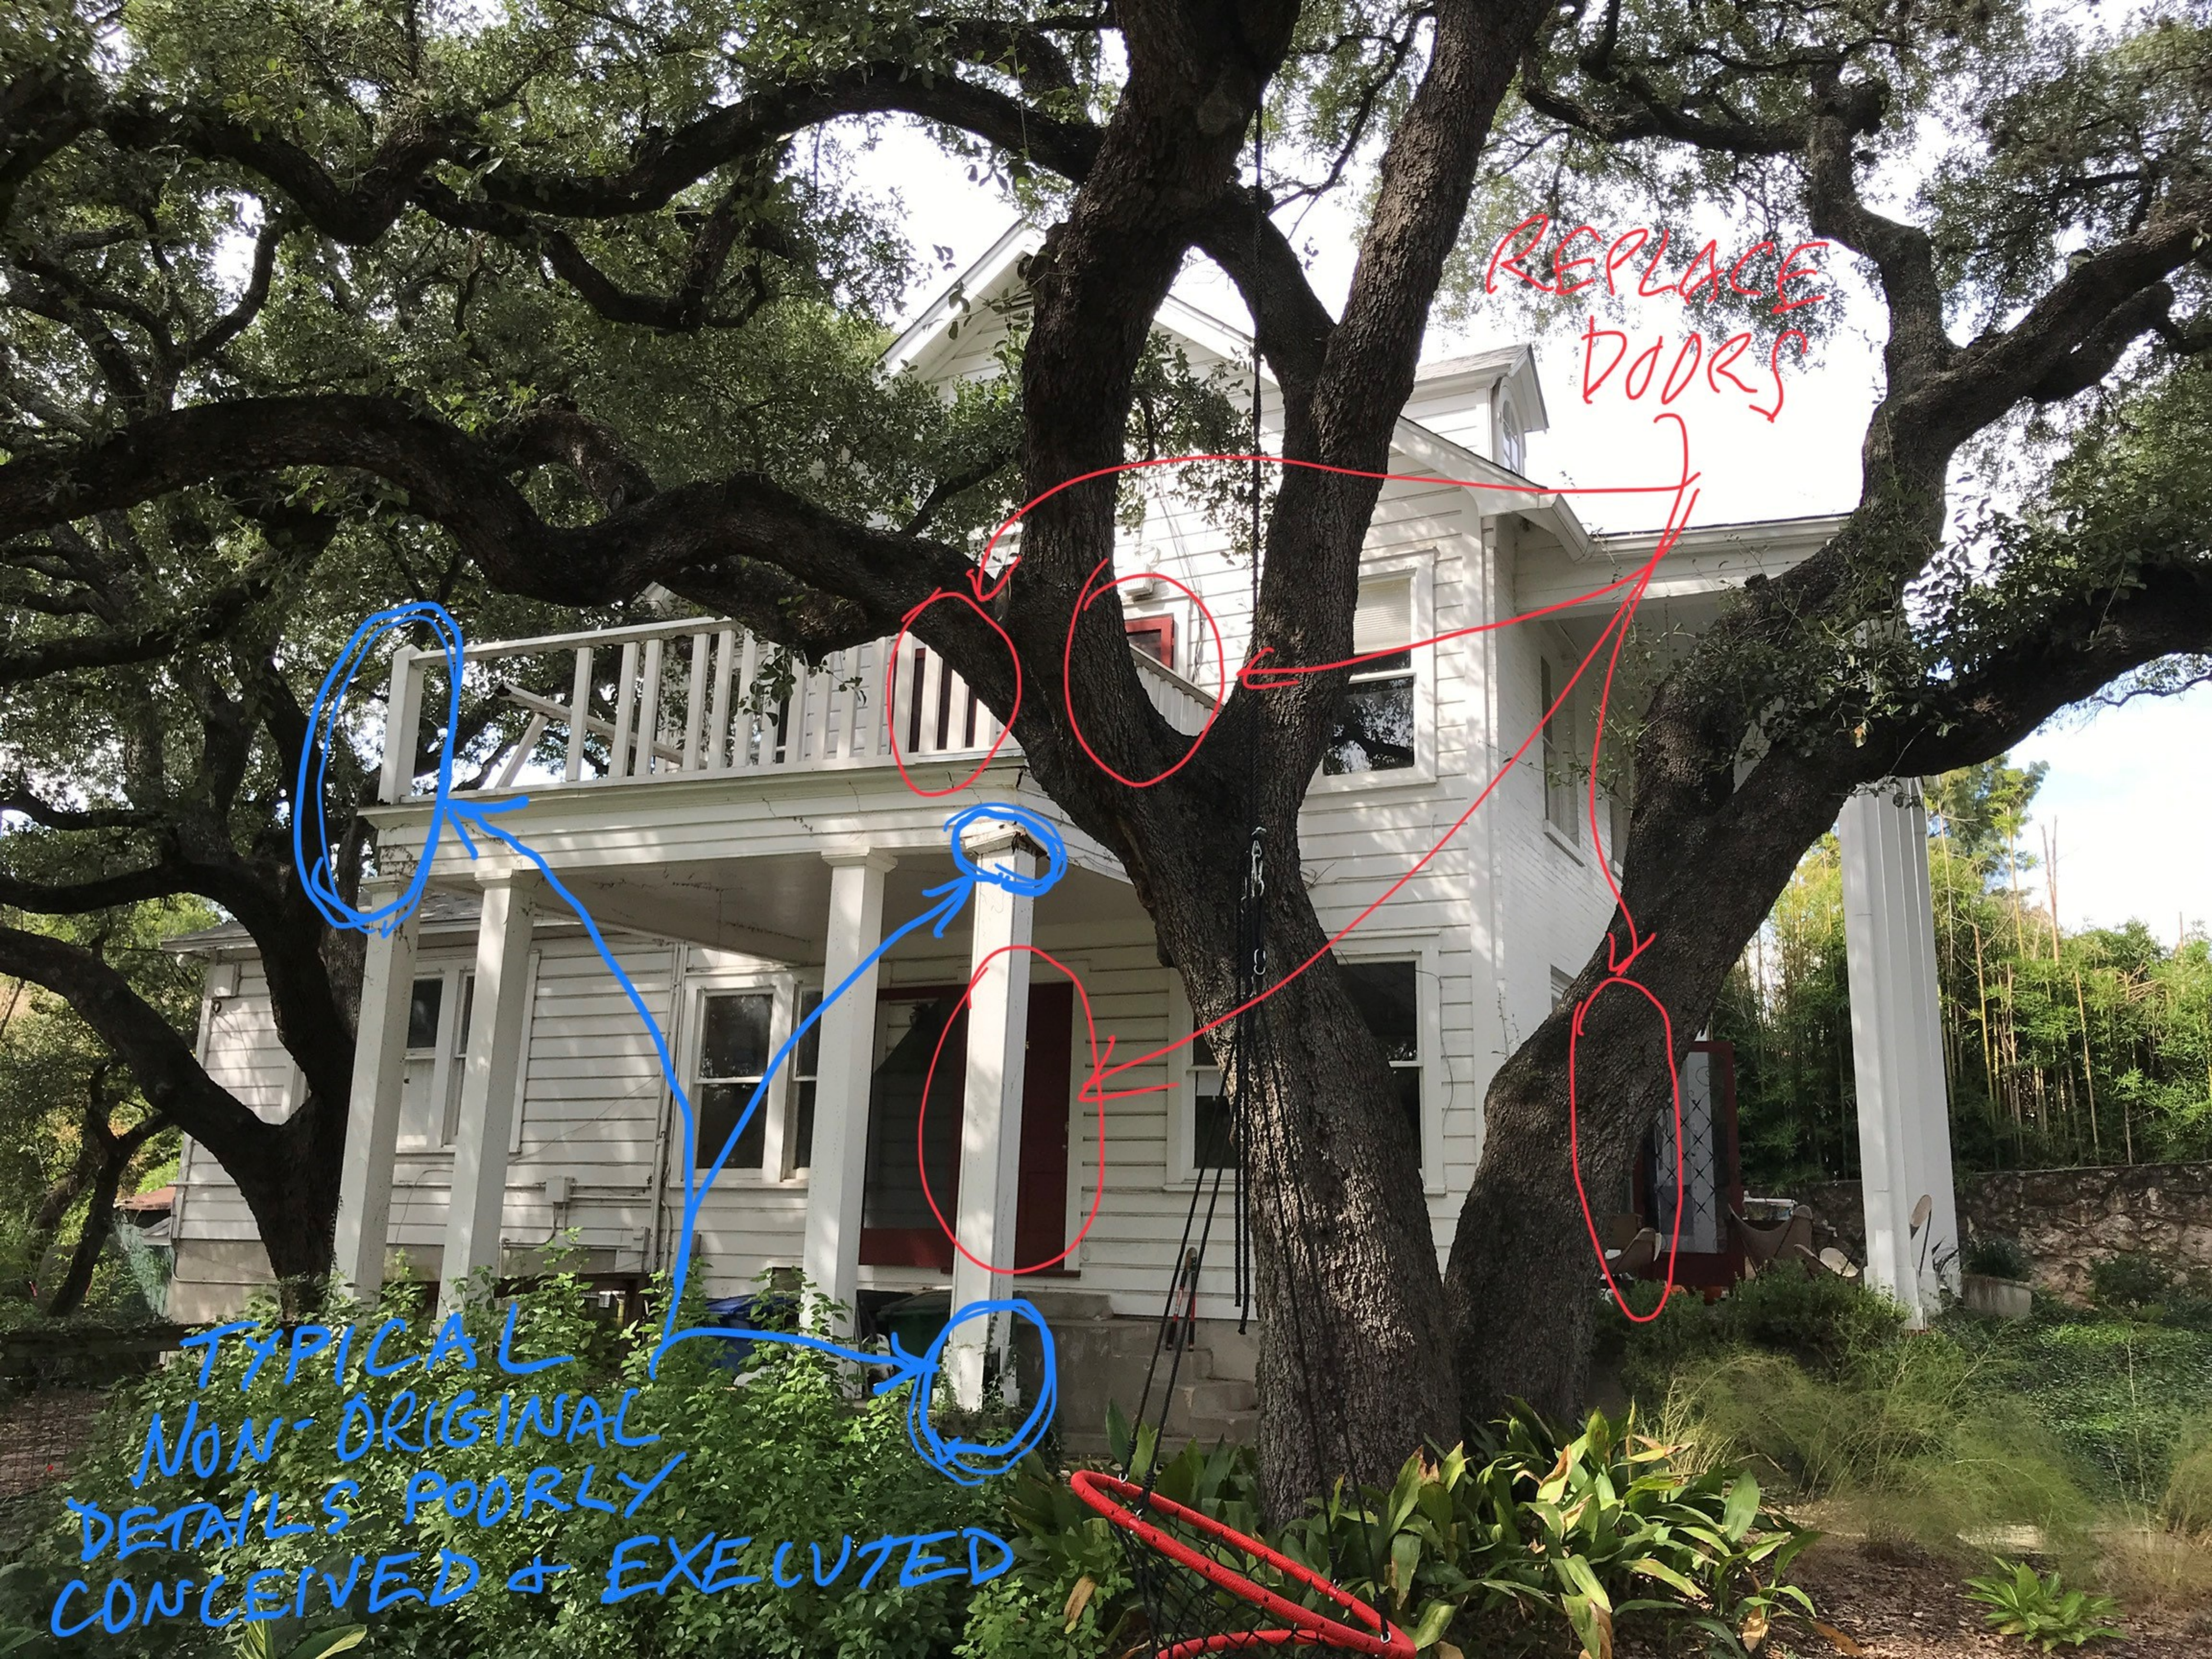
REPLACE
WINDOWS

REPLACE
DOORS

e. WINDOW REPLACEMENT – The applicant has proposed to replace three (3) existing wood windows with aluminum clad wood windows that generally meet staff's standard window stipulations. The applicant has committed to installing replacement windows in a style, size, material, and proportion to match the existing windows being replaced and to recess the windows within the frame with traditional wood trim and sill details. The windows requested for replacement are located on the south and west elevations of the second story. According to the Historic Design Guidelines, wood windows should be repaired in place and restored whenever possible, unless there is substantial evidence that the windows are deteriorated beyond repair. Guideline 6.B.iv for Exterior Maintenance and Alterations states that new windows should be installed to match the historic or existing windows in terms of size, type, configuration, material, form, appearance, and detail when original windows are deteriorated beyond repair. As noted in finding b, while the replacement product is appropriate, staff finds that the windows are in repairable condition.

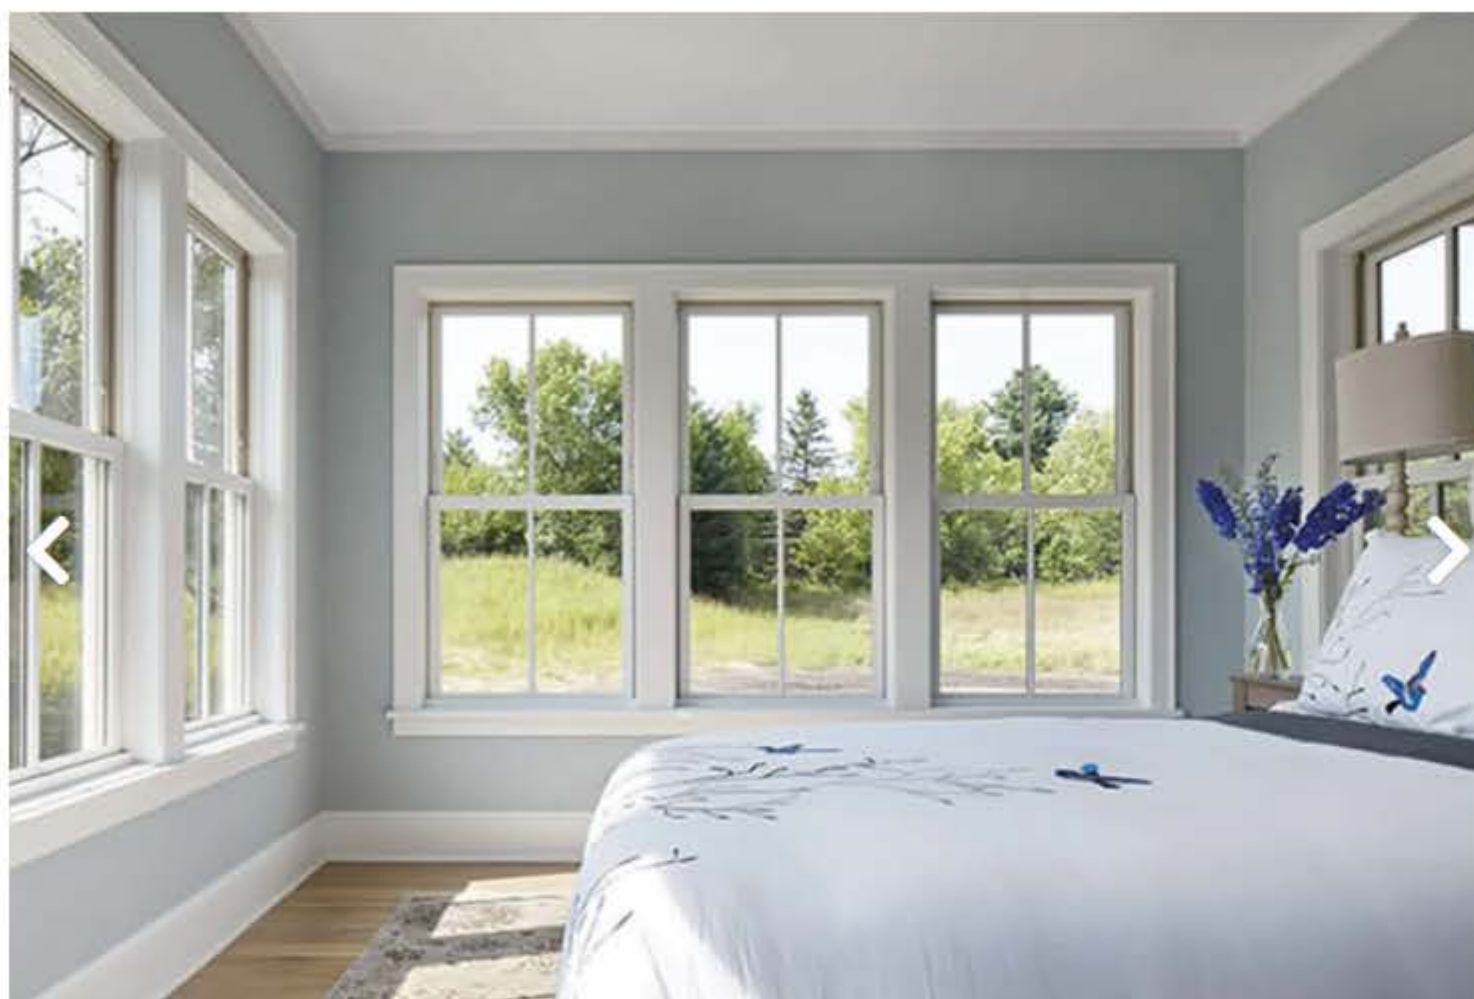
ELEVATE DOUBLE HUNG

Traditional style meets superior strength in this updated take on a classic window. The Marvin Elevate™ Double Hung window's balanced design provides the performance and aesthetic your home deserves, with durable fiberglass exteriors, warm wood interiors and coordinating picture or transom window styles available. Tilt the sash in or remove for easy cleaning.
