HISTORIC AND DESIGN REVIEW COMPLIANCE AND TECHNICAL ADVISORY BOARD

HDRC CASE NO: 2024-312
ADDRESS: 2611 N MAIN AVE
LEGAL DESCRIPTION: NCB 1836 BLK 11 LOT 15, 16, 17, 18
ZONING: C-2, H
CITY COUNCIL DIST.: 1
DISTRICT: Monte Vista Historic District
APPLICANT: Frank Telles | FT Builder Services LLC
OWNER: Kim Ross | Ross Real Estate Ventures LLC
TYPE OF WORK: Window replacement
APPLICATION RECEIVED: August 15, 2024
60-DAY REVIEW: October 14, 2024
CASE MANAGER: Bryan Morales

The applicant is requesting a Certificate of Appropriateness for approval to install new windows on the left (south) facade to feature internal faux muntins.

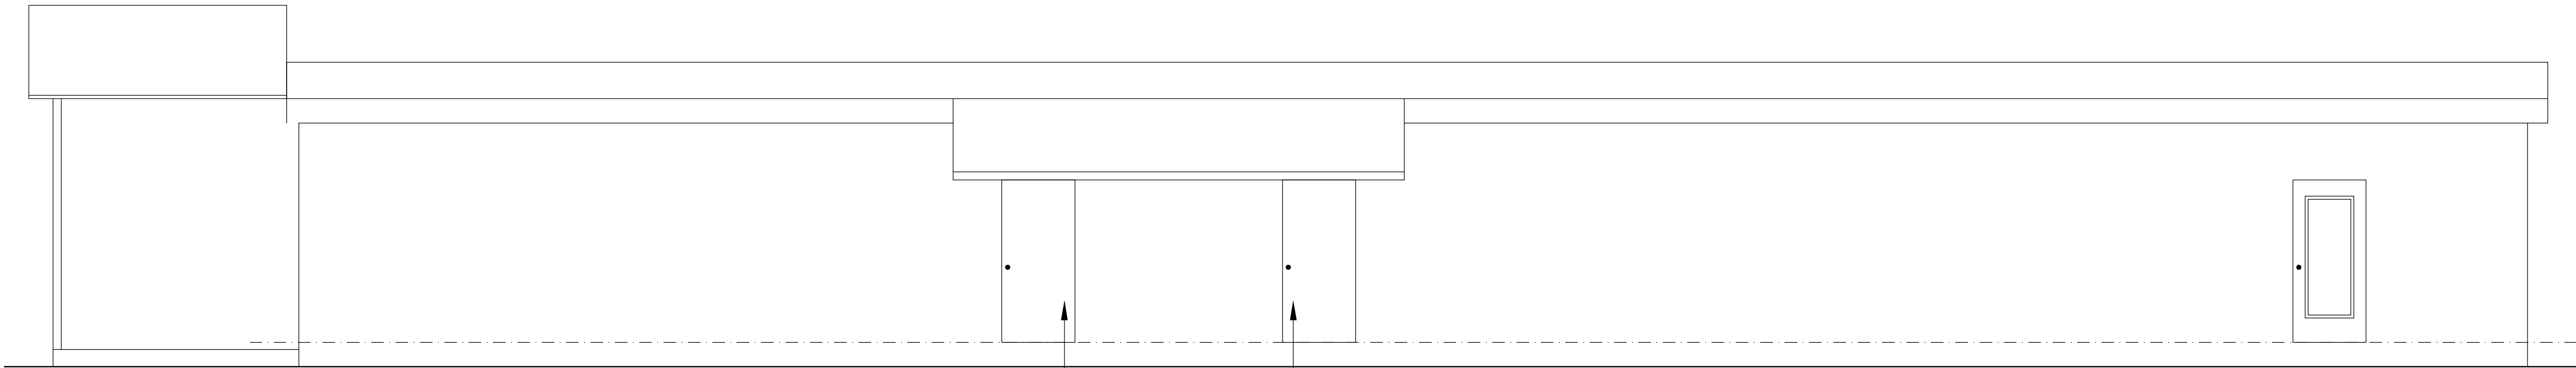
EXISTING RIGHT ELEVATION

DOORS TO BE DELETED

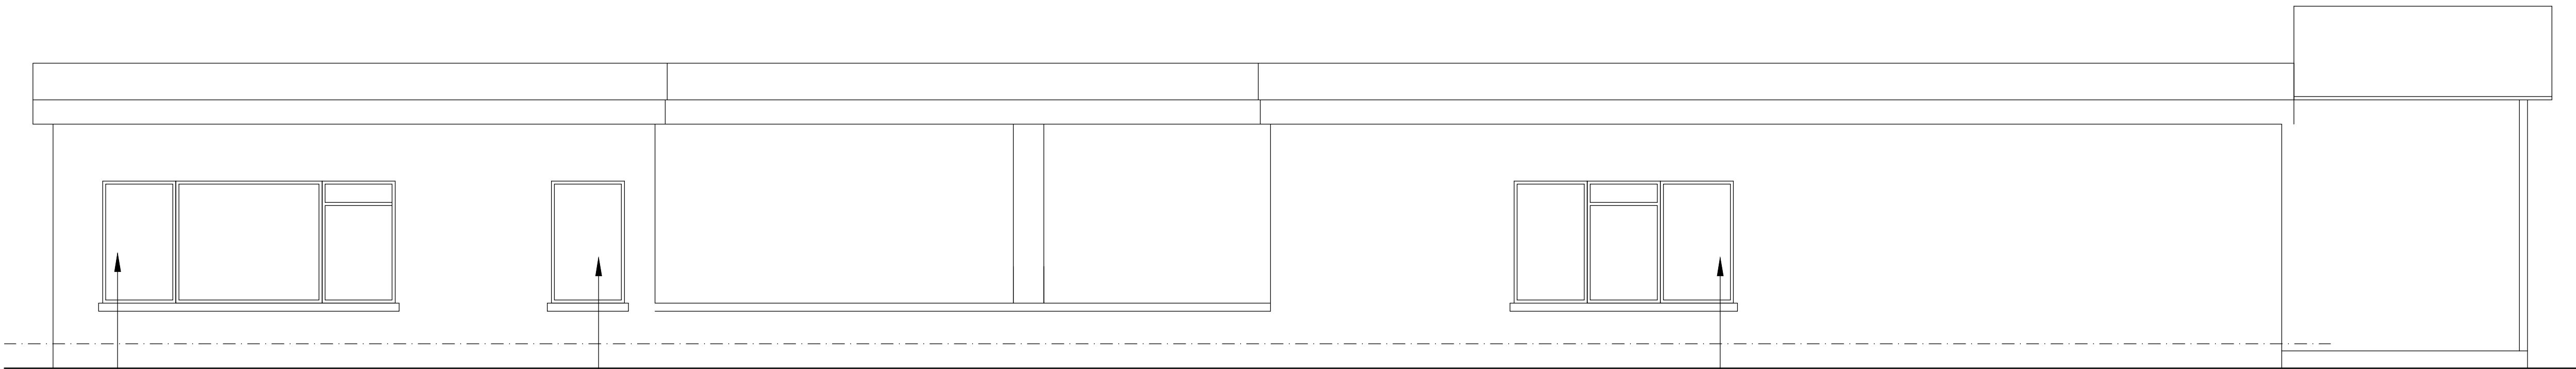
EXISTING LEFT ELEVATION

WINDOW TO BE REPLACED DUE TO CONSTRUCTION DAMAGE

NEW ALUMINUM BRONZE FINISH TO MATCH EXISTING 3/8" SAFETY TEMPERED GLASS

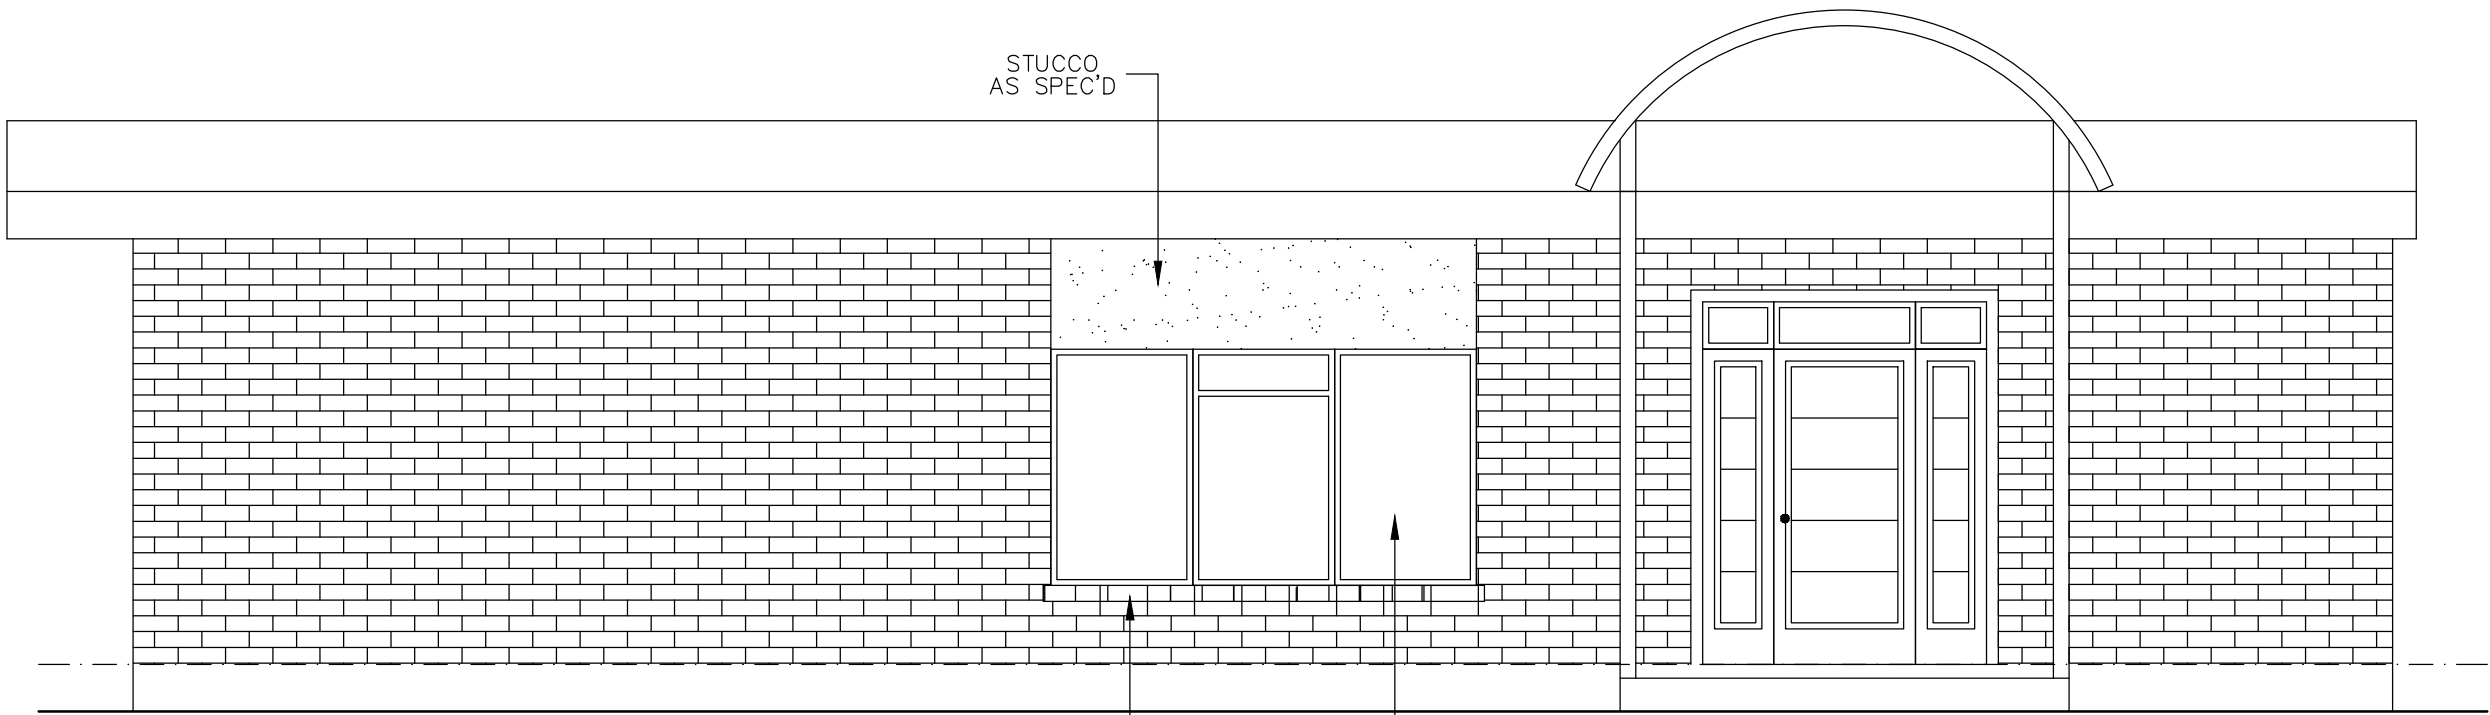
PROPOSED FRONT ELEVATION

STUCCO AS SPEC'D

BRICK SILL

WINDOW FROM LEFT SIDE
