HISTORIC AND DESIGN REVIEW COMMISSION

HDRC CASE NO: 2025-083
ADDRESS: 2053 W GRAMERCY PLACE – 2000, 1900 Blocks of W Gramercy
LEGAL DESCRIPTION: NCB 1932 BLK 39 LOT 14
ZONING: R-6, H
CITY COUNCIL DIST.: 7
DISTRICT: Monticello Park Historic District
APPLICANT: Emanuel Saldana/COSA Public Works
OWNER: N/A N/A/L CINCO INVESTMENTS LLC
TYPE OF WORK: Sidewalk Replacement
APPLICATION RECEIVED: March 28, 2025
60-DAY REVIEW: May 27, 2025
CASE MANAGER: Caitlin Brown-Clancy

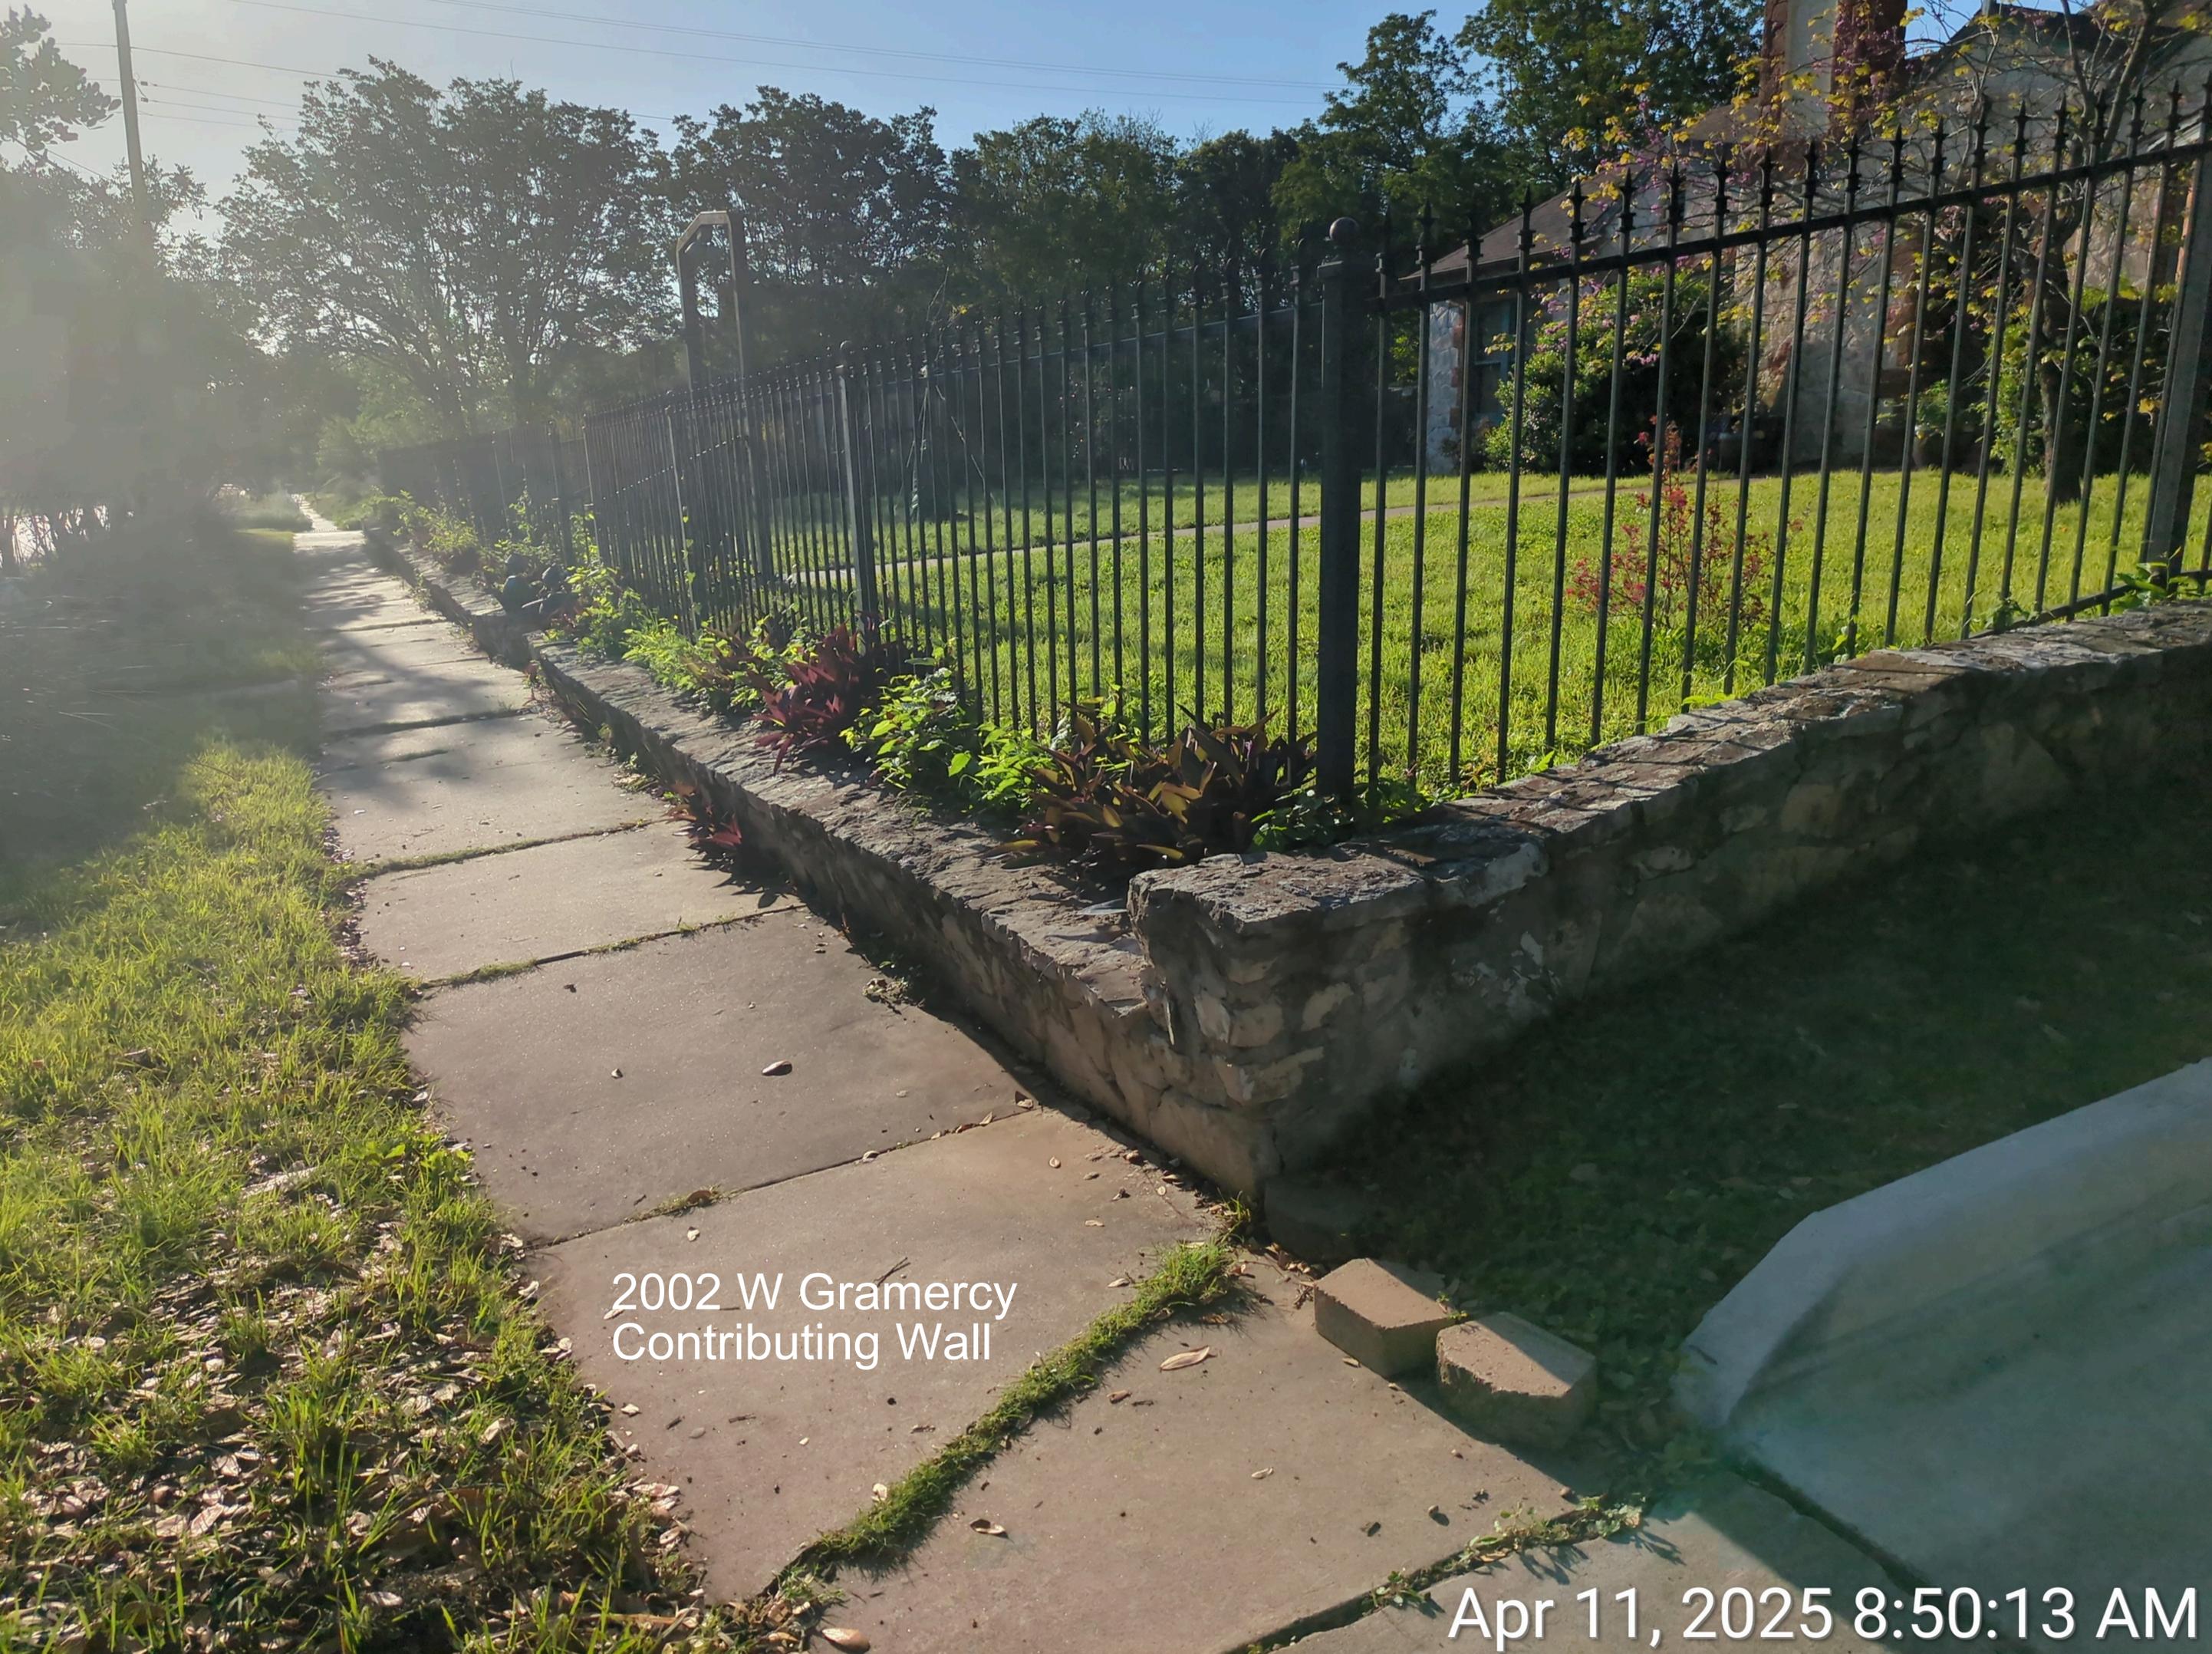
2002 W Gramercy
Contributing Wall

4. Staff recommends the preservation of the seven (7) existing retaining walls and walkways over wholesale replacement. Should replacement be necessary, staff finds every effort should be made to only replace those sections deteriorated beyond repair with material (including mortar) to the color, texture, size, profile, and finish of the original with the following stipulation based on findings a and f. This should be documented by the contractor through photographs and field measurements prior to any demolition work.
