HISTORIC AND DESIGN REVIEW COMMISSION

HDRC CASE NO: 2021-527
ADDRESS: 715 LABOR ST
LEGAL DESCRIPTION: NCB 729 BLK 3 LOT N 46.31 FT OF 8 & N IRRG 45.3 FT OF 9
ZONING: R-6, H
CITY COUNCIL DIST.: 1
DISTRICT: Lavaca Historic District
APPLICANT: Shawna Walker/ROC Acquisitions LLC
OWNER: Shawna Walker/ROC Acquisitions LLC
TYPE OF WORK: Historic Tax Certification
APPLICATION RECEIVED: October 08, 2021
60-DAY REVIEW: Not applicable due to City Council Emergency Orders
CASE MANAGER: Rachel Rettaliata

HISTORIC REHABILITATION APPLICATION PART I

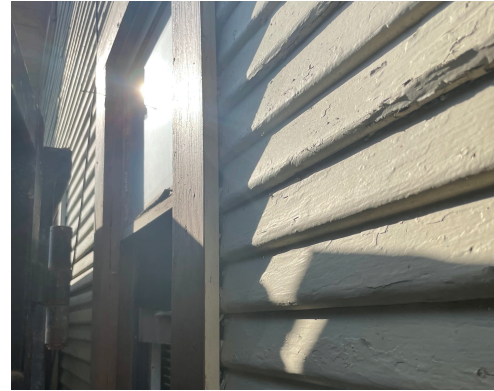
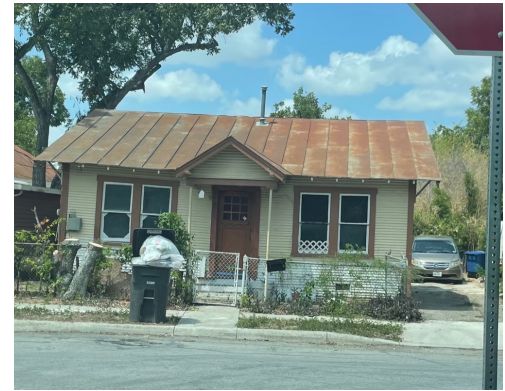
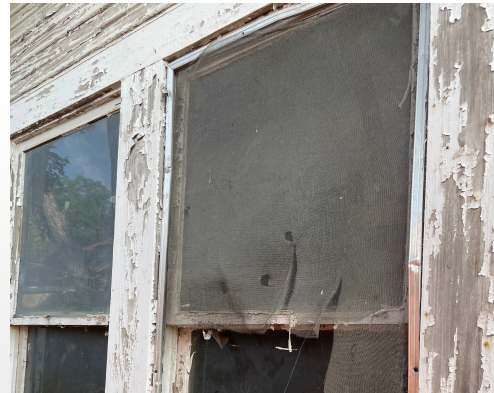
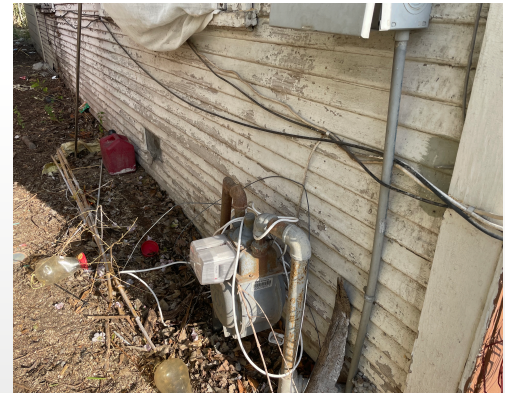
EXTERIOR RESTORATION PLANS

- Completely redo the foundation – all the cedar piers and wood beams underneath were rotten and need to be replaced with new wood concrete piers. Siding will continue down to the ground as pictured.
- Exterior roof is beyond repair. Add a new standing-seam metal roof (after inspection)
- Repair and repaint the exterior wood siding, front door and windows. We will keep the original wood pattern on the house. Rotten wood around windows will be replaced. Repainted with Sherwin Williams Exterior Satin finish paint.

The property needs to be looked at by an engineer to make sure everything is structurally sound. The foundation had wood rot and was completely caving in the middle. All underneath had to have new wood and new concrete piers installed. The back of the house was not done to code and was falling over so the structure will need to be properly framed to hold up the roof. The front two poles are literally sitting on the ground. So, we need to reframe the front (one historical gives us an approval of what we can do). The steps have crumbled in the front and need to be redone. The exterior siding will remain the same we will just replace the wood that is damaged and run the siding all the way to the ground to cover the pier and beams. The exterior will have fresh paint on the trim, door, and siding. The original door will be restored and painted. All glass that is broken in the windows and doors will be repaired. The interior has beautiful hard wood floors throughout which we will try to salvage. There is an original tub that we will also try to restore. Some of the trim will be salvaged. The shiplap on the interior will be used in decorative ways and also to keep the strength of the walls inside. The attic will be inspected to make sure all the trusses and everything are still holding strong – added straps, wood, and beams to make sure it's safe before adding a new metal roof. (approved by historical). The driveway and fence will be added at the end. We hope to once again, beautify another historical home in Lavaca.

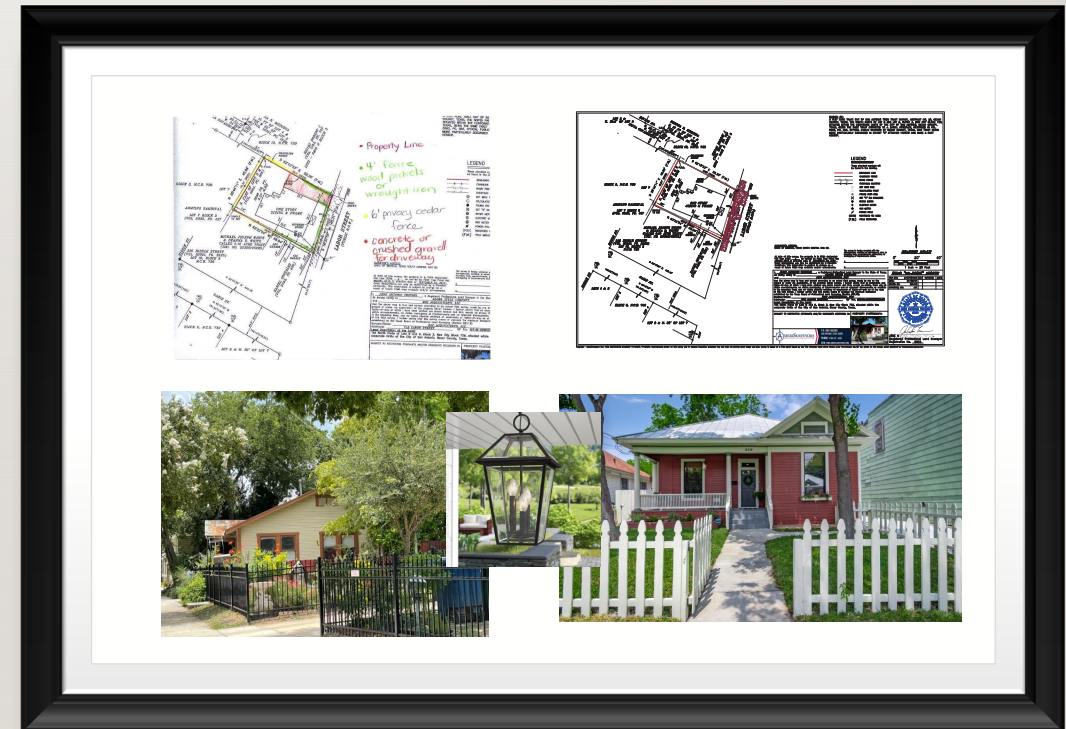
EXTERIOR RESTORATION CONTINUED

- With Historical approval we would like to add a driveway on the right side of the property with a new sidewalk to the front door.
- New fence around the property either a wood picket or a wrought iron like the neighbors on either side (see photos)
- New Front door Porch light

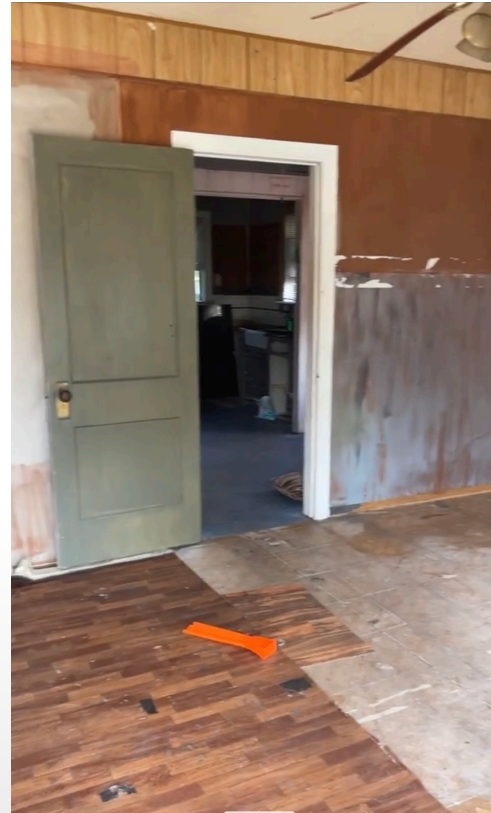
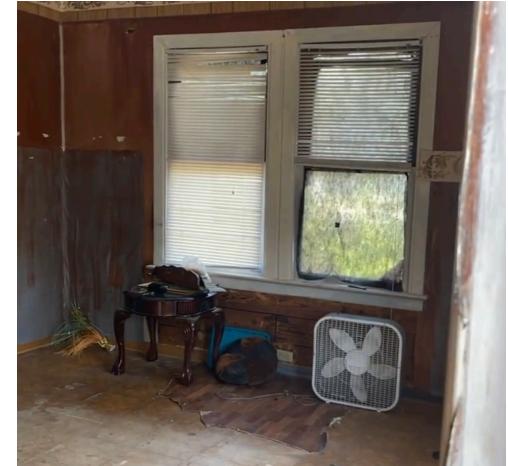
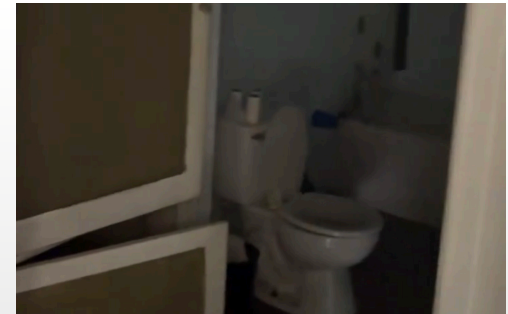
RESTORATION OF INTERIOR

- Remove all sheetrock and paneling and install brand new sheetrock
- Where shiplap is exposed that is restorable – it will be sanded, stained, and sealed
- All trim restored, repaired and repainted
- All interior doors replaced with solid wood craftsman style doors, new hinges, new handles
- Original hardwood exposed, sanded, stained, and clear coat.
- Where wood is rotten, long leaf pine wood will be added to match the existing floor
- Original tub will be resanded epoxied and used again

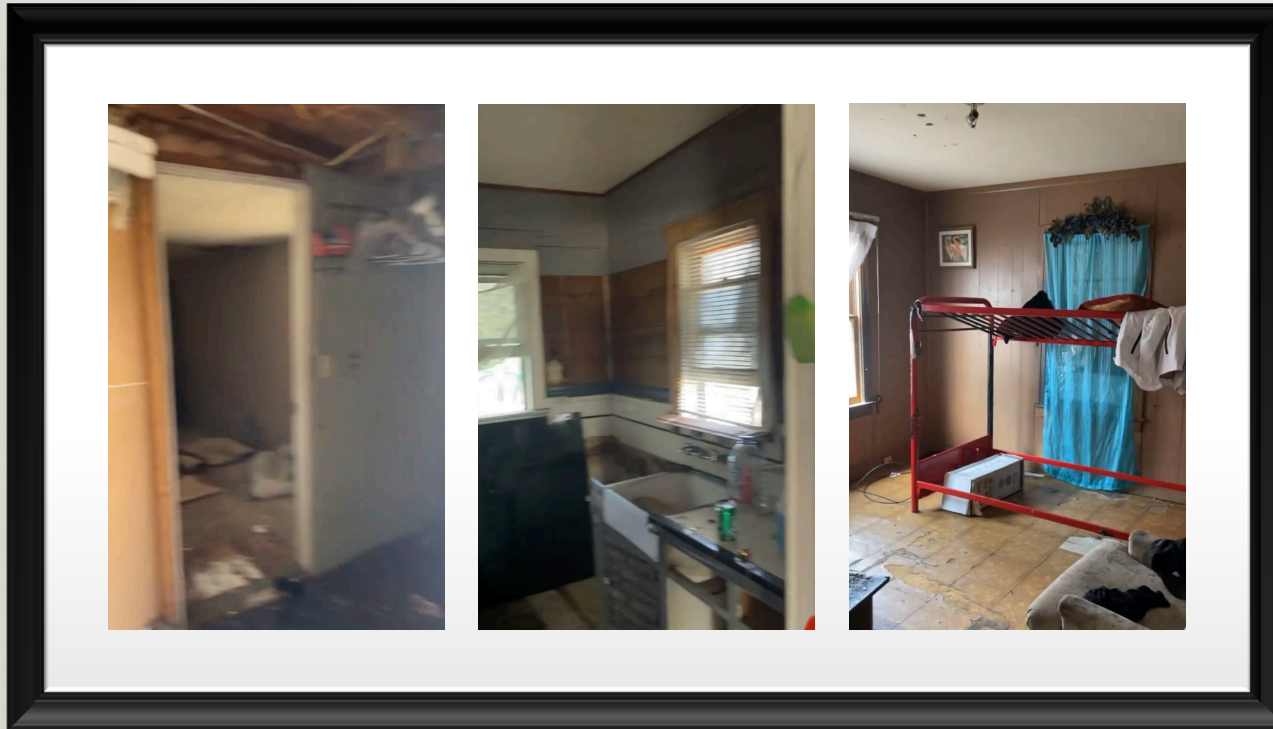
INTERIOR RESTORATION CONTINUED

- Brand new HVAC to be added
- Brand new electric from the city pole to the panel inside
- Brand new plumbing from the city connection to the fixtures inside to include new water lines, new sewer lines, new gas lines

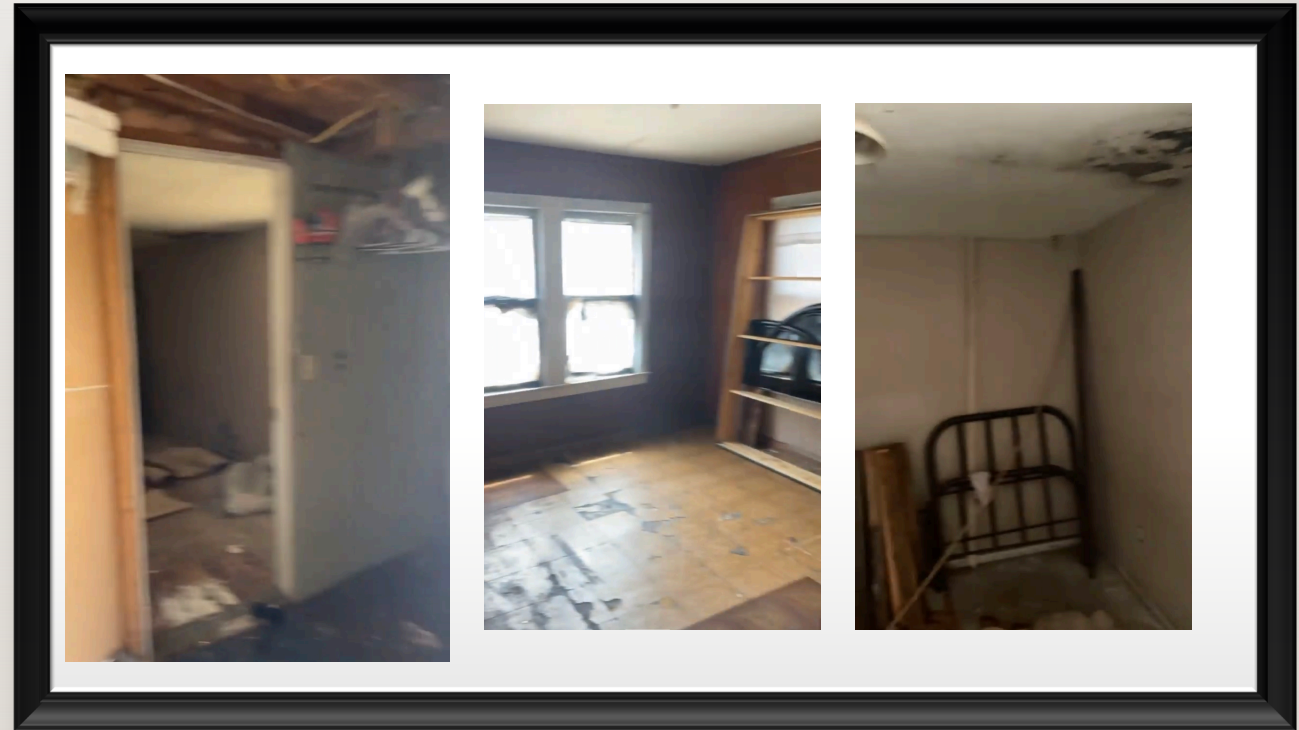
RESTORATION OF INTERIOR CONTINUED

- Remove any mold, damaged wood etc.
- Add new laundry area
- Bathroom- add new fixtures, tile, faucets etc.
- Remove all trash, furniture, cars, and dispose of all unwanted items that were left – will take 3 dumpsters and 5 days of labor for demo crew
