## HISTORIC AND DESIGN REVIEW COMMISSION

December 1, 2021

**HDRC CASE NO:** 2021-537  
**ADDRESS:** 312 W AGARITA AVE  
**LEGAL DESCRIPTION:** NCB 3058 BLK 5 LOT 8 W 6 FT OF 9 & E 10 FT OF 7  
**ZONING:** R-5  
**CITY COUNCIL DIST.:** 1  
**DISTRICT:** Monte Vista Historic District  
**APPLICANT:** Alan Neff/36square  
**OWNER:** Perry Balleza  
**TYPE OF WORK:** Demolition of accessory structure with new construction  
**APPLICATION RECEIVED:** October 19, 2021  
**60-DAY REVIEW:** Not applicable due to City Council Emergency Orders  
**CASE MANAGER:** Katie Totman  
**REQUEST:**

1. Demolition the existing rear accessory structure.
2. Construct a 2-story garage located at the rear of the property.

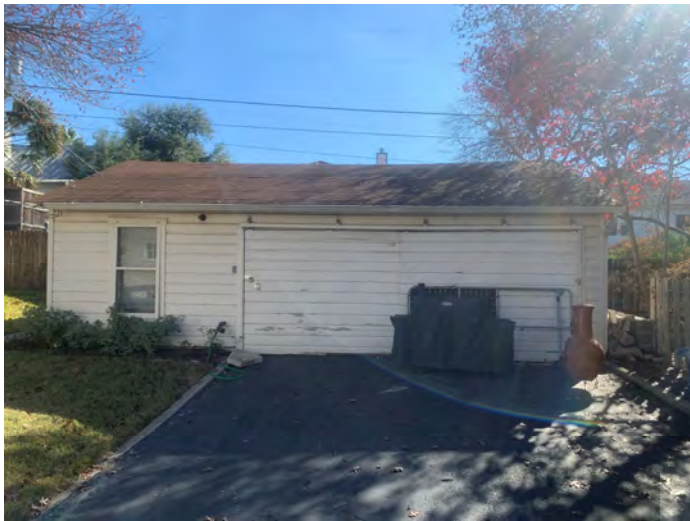
1. Existing garage/ accessory dwelling unit to be demolished (North facade)

The existing accessory dwelling unit and garage is not functional for the homeowners. The garage doors do not easily open and their cars do not fit within the existing garage. The very small efficiency apartment unit does not meet the spatial needs of the homeowners, requires significant repair, and does not possess a kitchen. The demolition of the accessory structure will allow for the new construction.

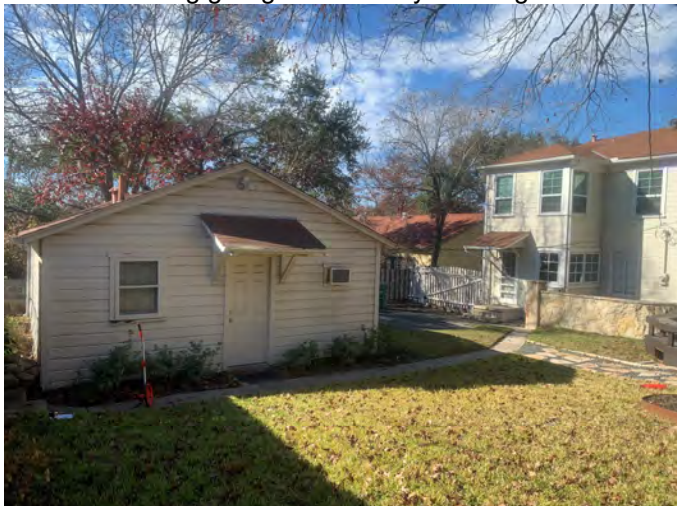
2. Existing garage/ accessory dwelling unit to be demolished (East facade)

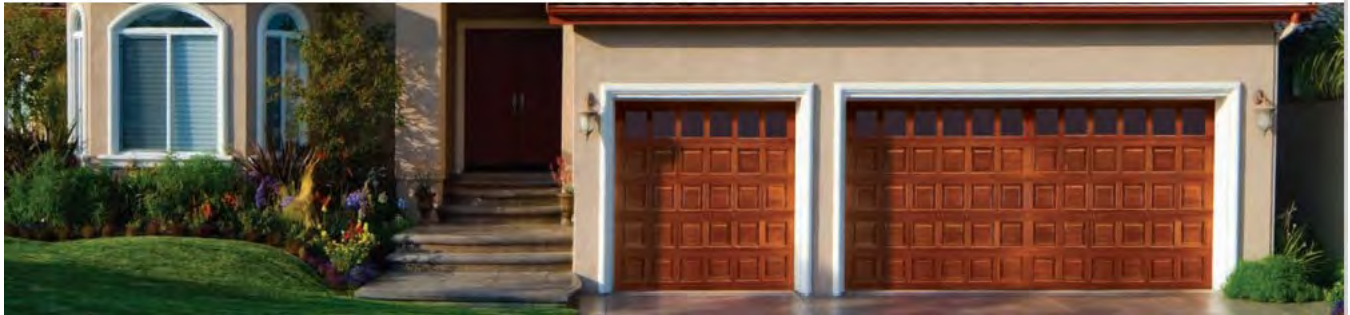
**Garage Doors:** Overhead Door Company Model 3260, 4x4, Paint Grade

Two separate 8'-0" wide garage doors with 4 horizontal sections and 4 raised panels in each section. The image below shows a stain grade wood door. I am proposing a painted door to minimize its impact from views from the street.

*Raised Panel design, Model 3260 (454), 5 sections/6 panels, plain short panel windows, custom stain finish*

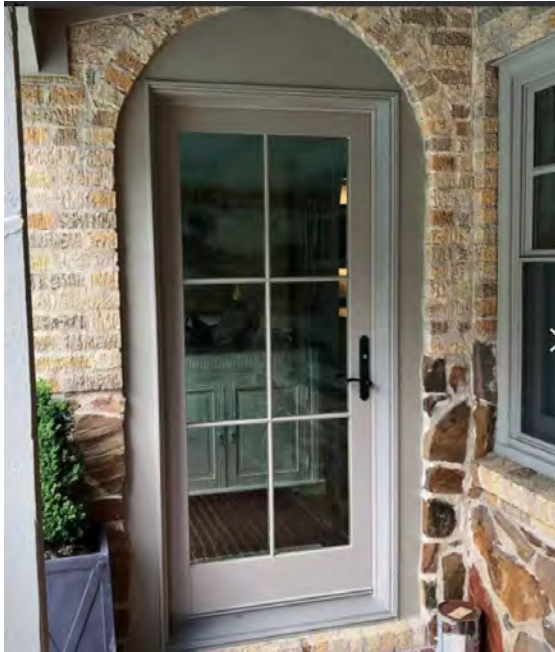
**Front Door:** Andersen Residential Entry Door: Straightline 102, Divided glass panes

There is one front door on the casita. The entry surround will be similar to the front entry of your main house, but will be slightly smaller in size. The front door will be solid wood, painted, and will have glass panes for light to the stairwell.

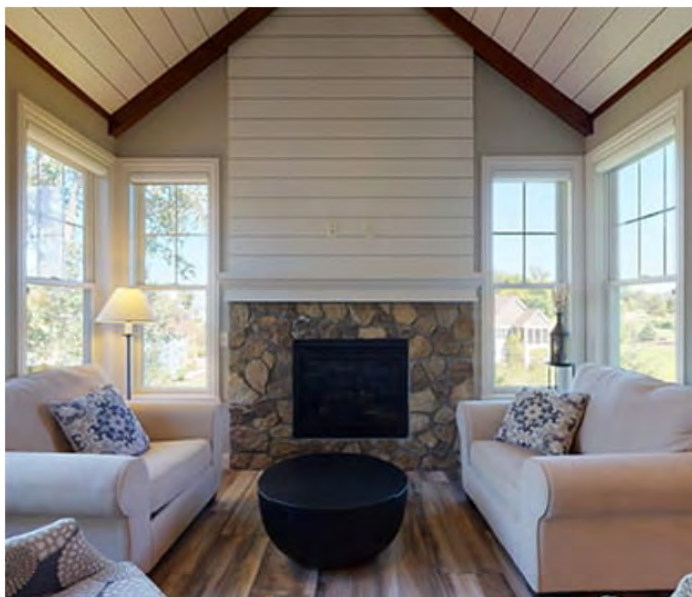
**Exterior Windows:** Andersen Windows: 200 Series Double Hung Window, White Vinyl Exterior, Clear Pine interior.

There are two different sized windows in the project. One is smaller for bathrooms, kitchen, and garage. I am proposing that the bottom and top sash both look like the top sash in this photo with 4 divided glass panes. This will closely resemble your main house windows but in a more modern window system.

The windows will open from the bottom and top, be solid wood, with an exterior vinyl cladding for durability. The interior will be clear sealed pine from the factory.
