# HISTORIC AND DESIGN REVIEW COMMISSION

**HDRC CASE NO:** 2022-095  
**ADDRESS:** 205 OSTROM  
**LEGAL DESCRIPTION:** NCB 6938 BLK LOT 1&2  
**ZONING:** R-4 CD, H  
**CITY COUNCIL DIST.:** 1  
**DISTRICT:** River Road Historic District  
**OWNER:** Stapleton Design & Build LLC, Stapleton Design & Build LLC  
**TYPE OF WORK:** Historic Tax Certification  
**APPLICATION RECEIVED:** February 04, 2022  
**60-DAY REVIEW:** Not applicable due to City Council Emergency Orders  
**CASE MANAGER:** Rachel Rettaliata  
**REQUEST:**

The applicant is requesting Historic Tax Certification for the property at 205 Ostrom.

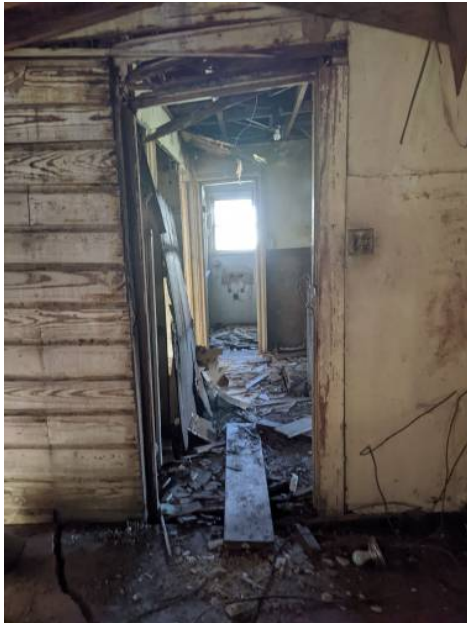
(1)

From old kitchen located in North wing to rear porch

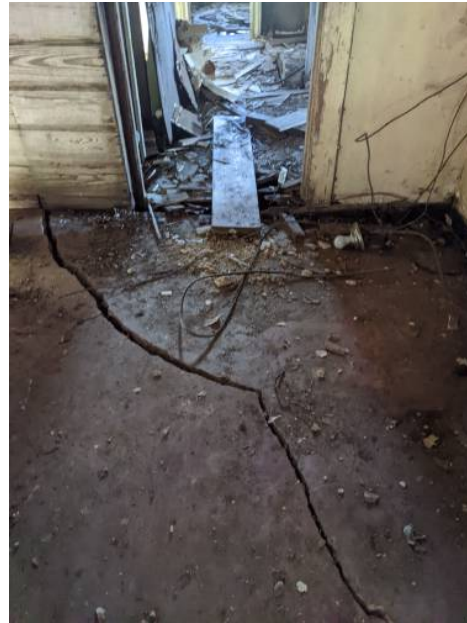
(2)

Rear porch behind Fireplace slab cracked in multiple places.

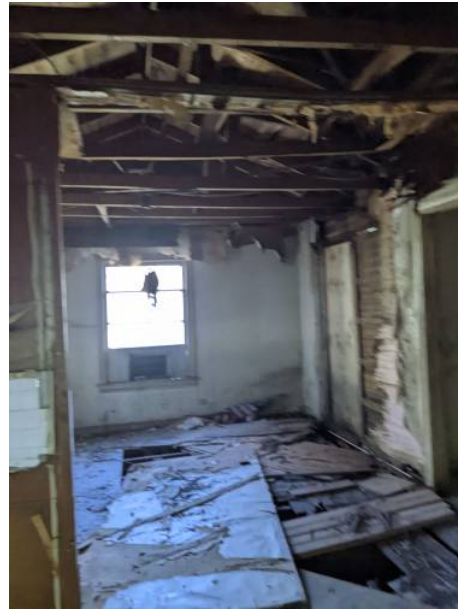
(6)

Old dining room floor completely rotted out here and ceiling down on floor. Joists in this area compromised.

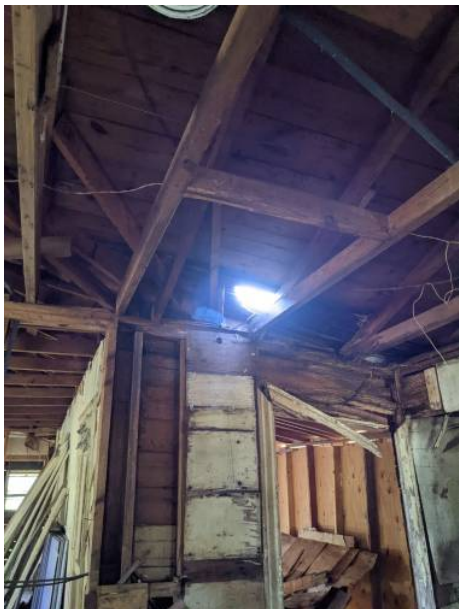
(7)

Daylight through valley of roof intersection old kitchen and back porch.

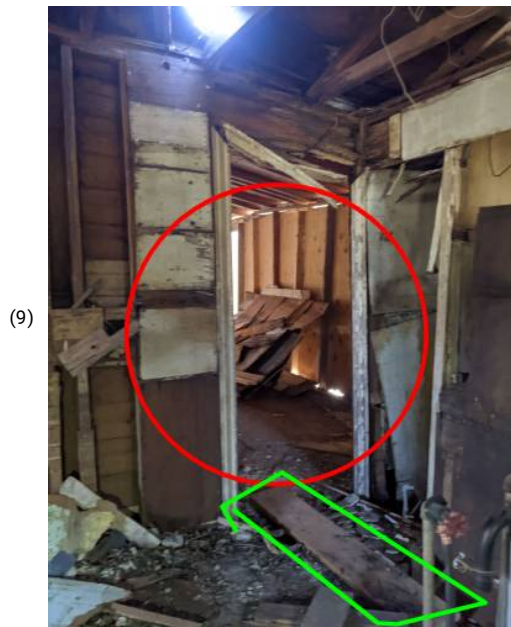
62.jpeg

Rear porch through this door from kitchen. Floor collapsed hence plank here in green.

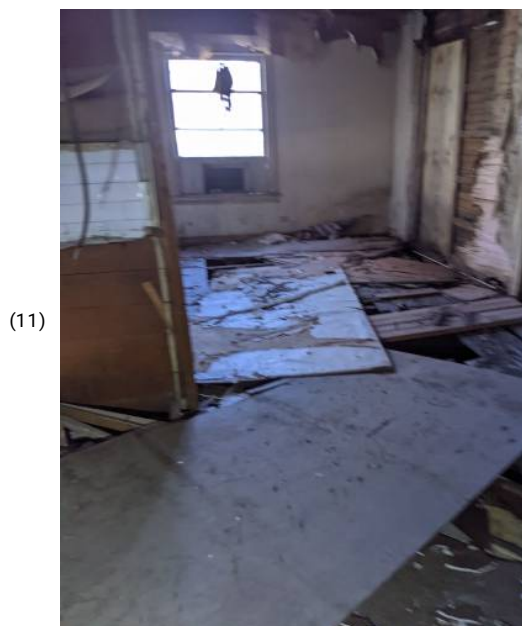
64.jpeg

North Eastern corner room wall ceiling and floor all compromised

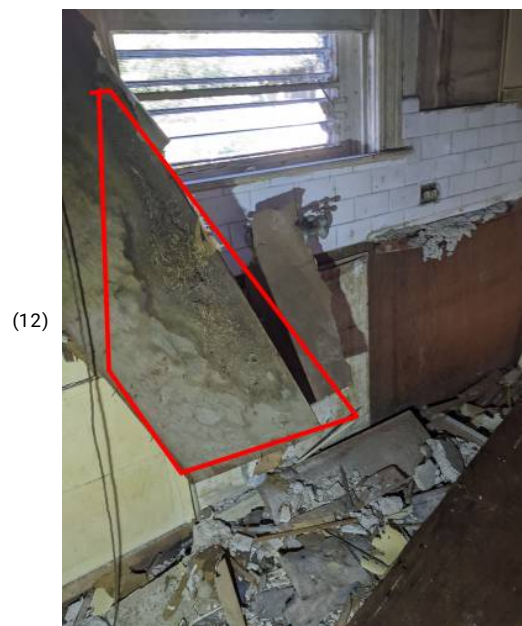
65.jpeg

Water damage shown from collapsed ceiling in kitchen.

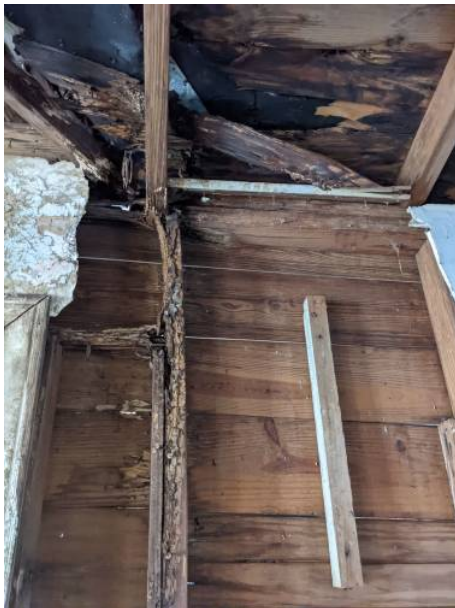
(23)

Most North Western corner of house studs integrity completely failed

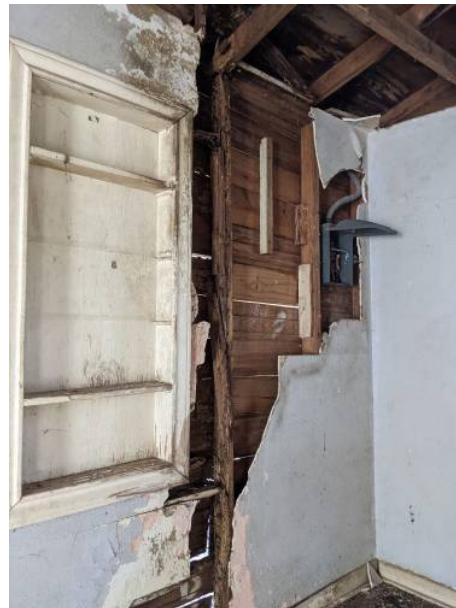
(24)

Electric disconnect panel on failed wall. Mismatched fuses service disconnected completely. Electrical service needs complete replacement.

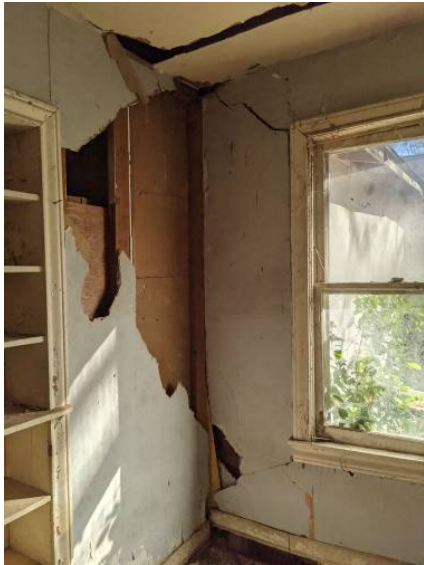
(25)

Most North western room. Walls failing floor failed, windows racked out of plumb open for years. No foundation support anymore here joists sitting on dirt

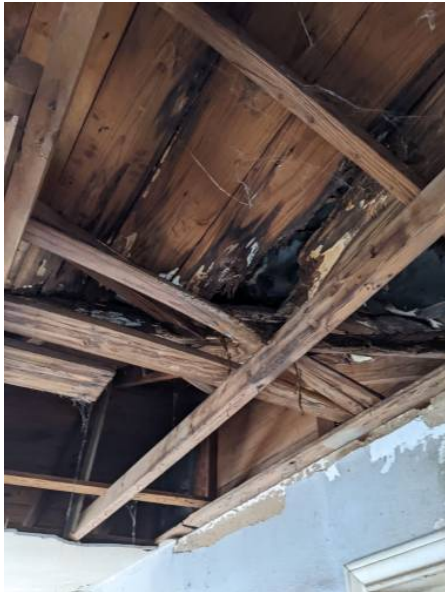
(29)

Most North western room. Roof structure failed.

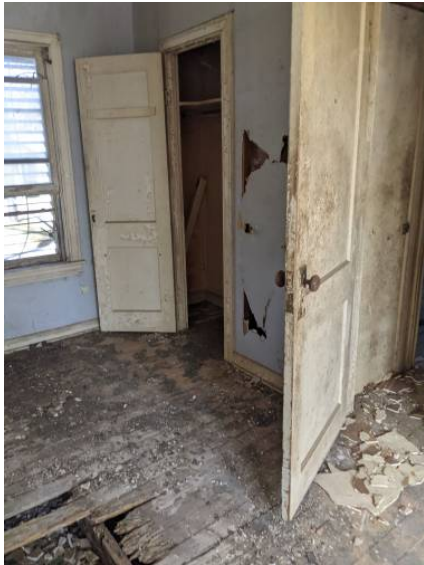
(33)

Most North western room. Walls failing floor failed, windows racked out of plumb open for years. No foundation support anymore here joists sitting on dirt

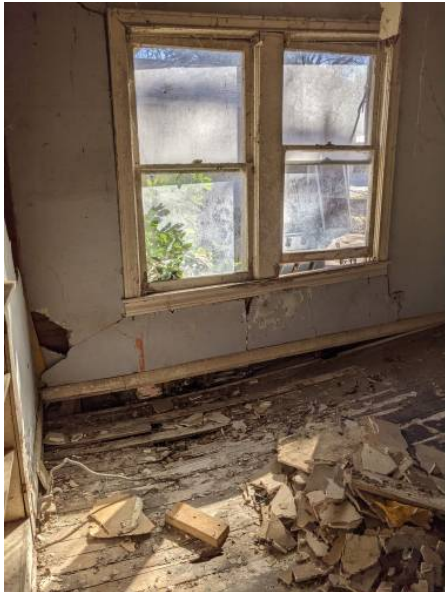
(37)

Most North western room. Walls failing floor failed, windows racked out of plumb open for years. No foundation support anymore here joists sitting on dirt

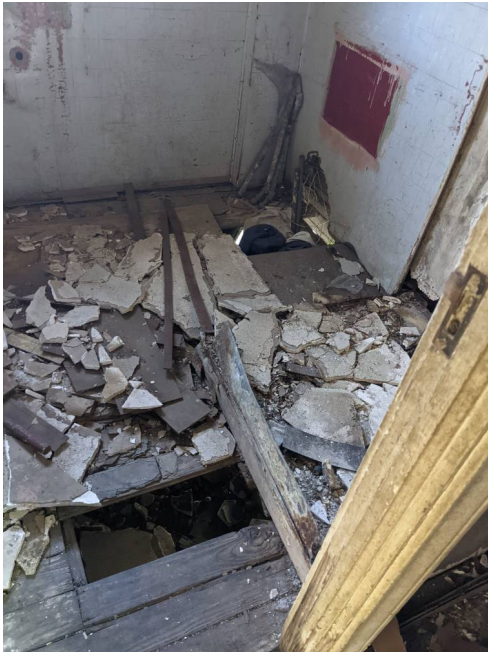
(41)

Created: Sat 15 Jan 20:24 2022  
Northern bathroom floor.

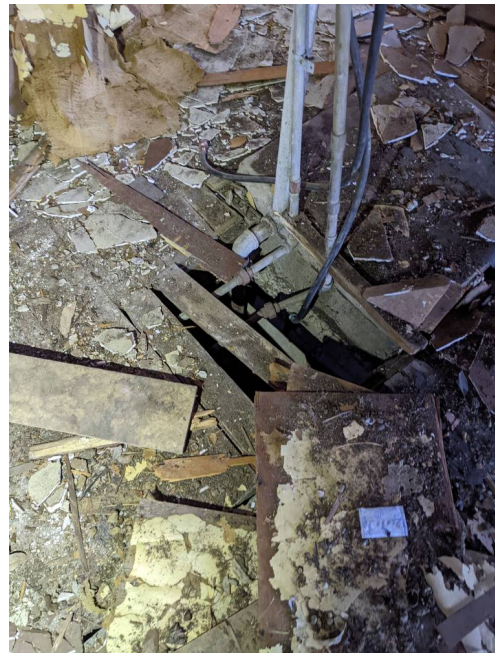
(44)

Created: Sat 15 Jan 20:24 2022  
Old kitchen floor down to dirt.

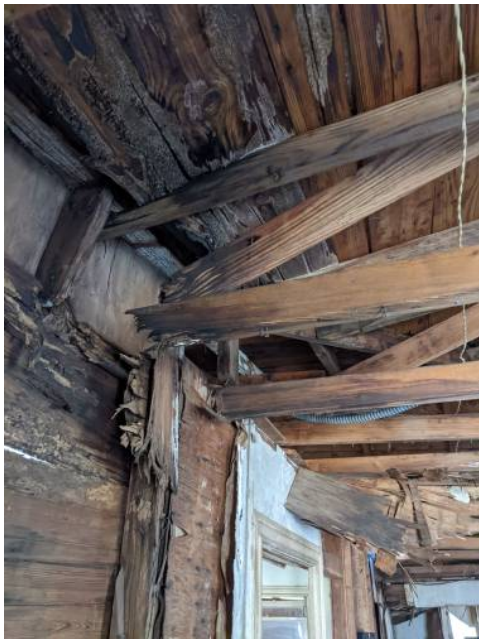
(53)

Kitchen to front porch rafters rotted completely here.

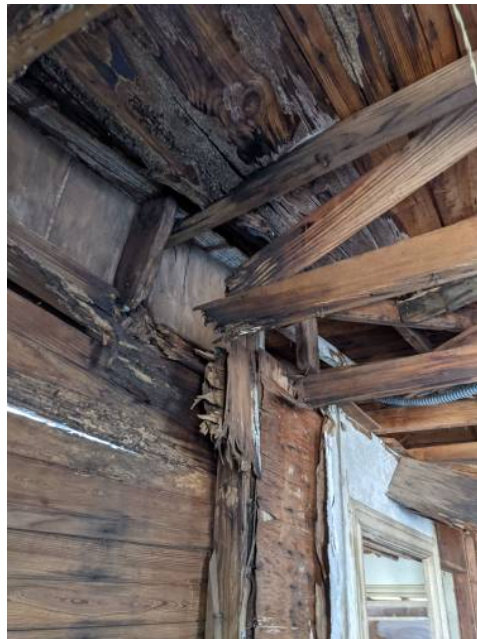
(54)

Kitchen to front porch rafters rotted completely here.

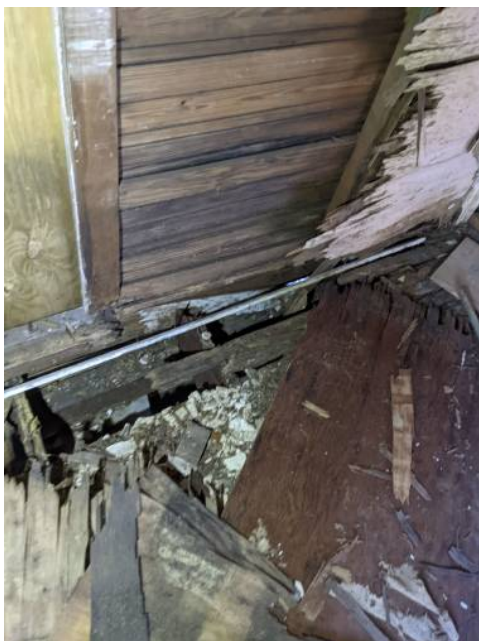
(55)

Kitchen to front porch floor rotted completely here.

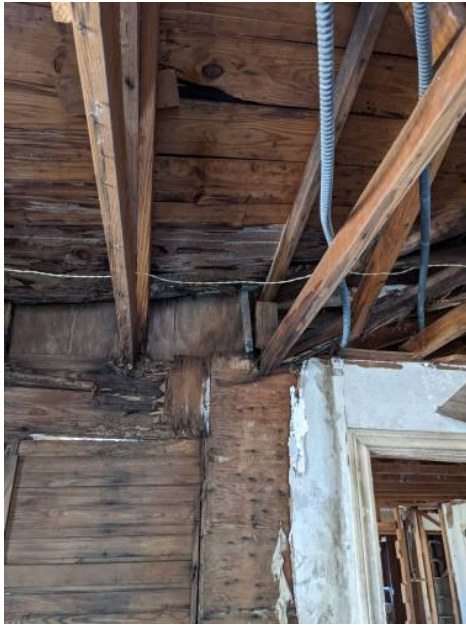
(57)

Kitchen to front porch rafters rotted completely here.

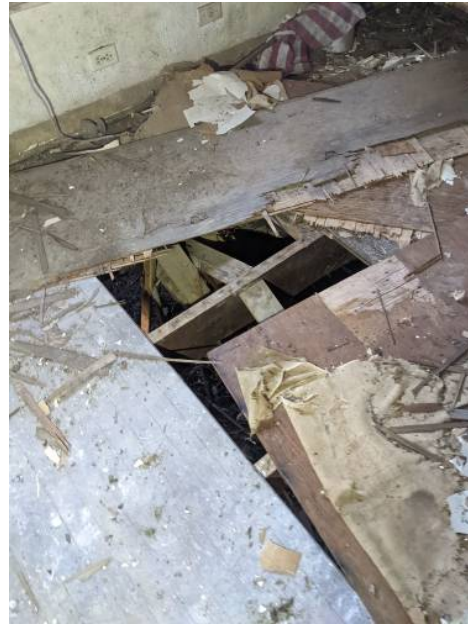
(58)

Ceiling collapsed on floor that had collapsed in kitchen area.

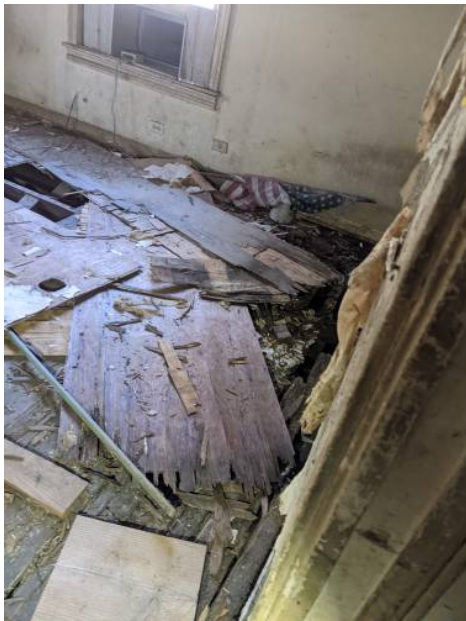
(63)

Created: Sat 15 Jan 20:24 2022  
Ceiling collapsed on rotted floor north Eastern room.

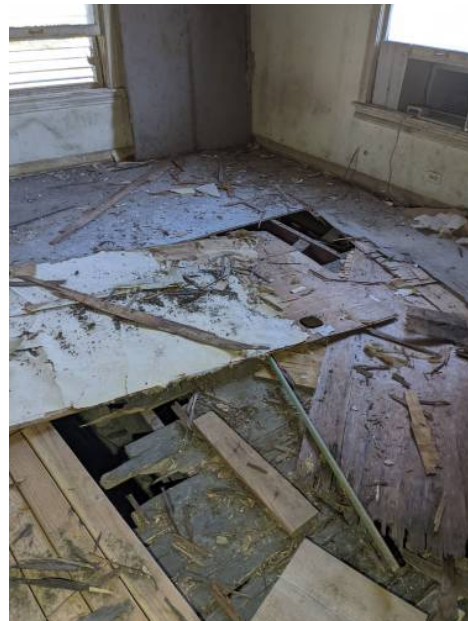
(64)

Created: Sat 15 Jan 20:24 2022  
Ceiling collapsed on rotted floor north Eastern room.

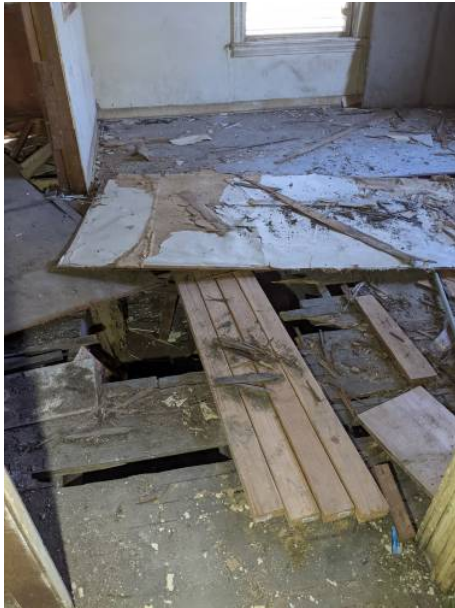
(65)

Ceiling collapsed on rotted floor north Eastern room.

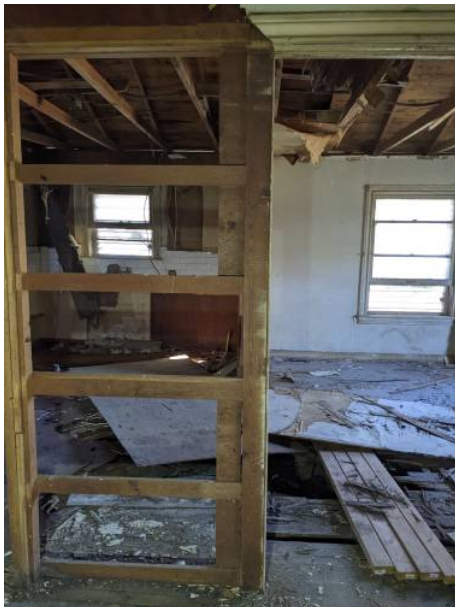
(67)

Ceiling collapsed on rotted floor north Eastern room View from living room to kitchen.

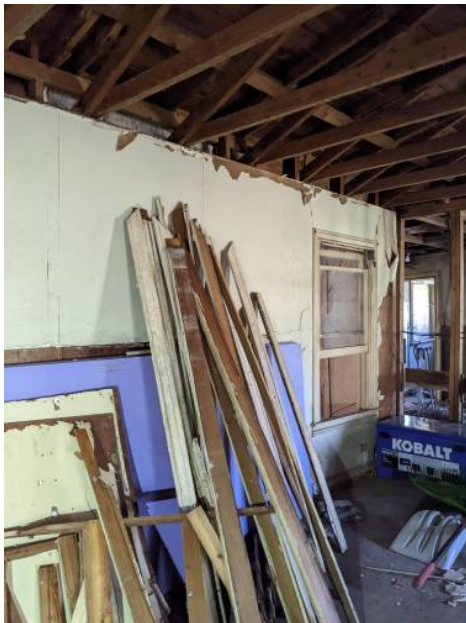
(71)

Fireplace surround missing old trim stacked up for recycling

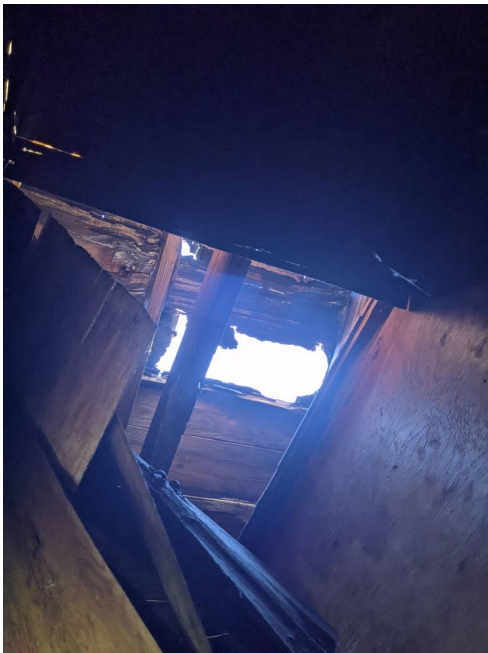
(75)

Created: Sat 15 Jan 20:24 2022  
Hole in roof over bathtub in South wing

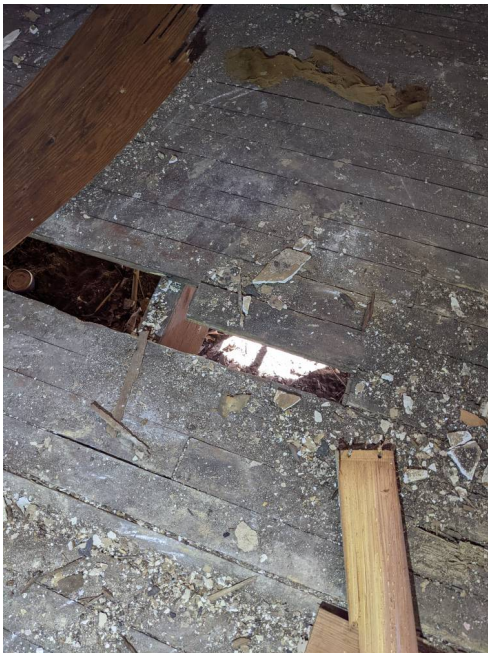
133.jpeg

Floor in south easterly wing rotten and collapsed.

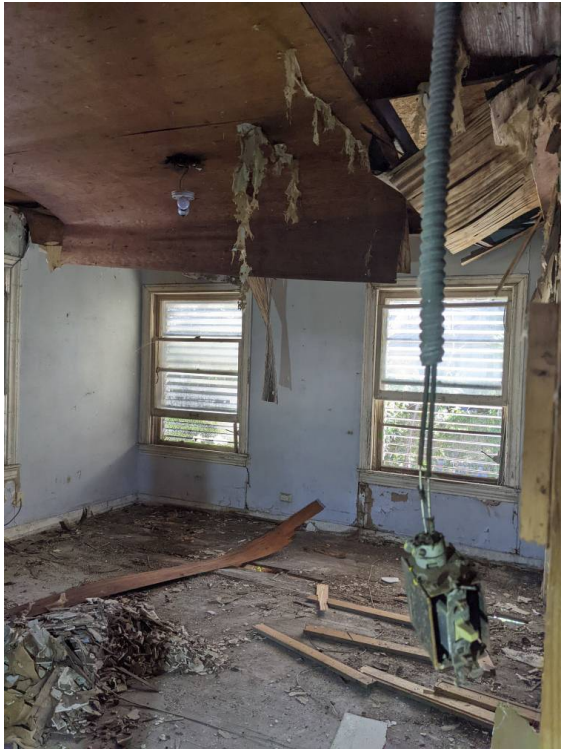
135.jpeg

Floor in south easterly wing rotten and collapsed as is ceiling and roof. Walls cracking.

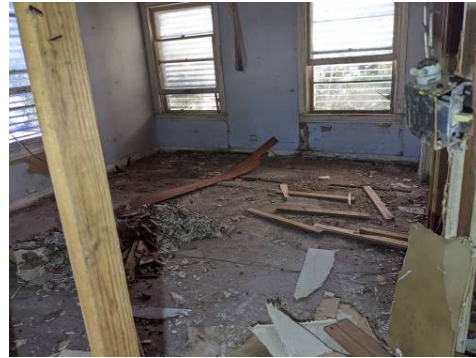
136.jpeg

Floor in south easterly wing rotten and collapsed as is ceiling and roof. Walls cracking.

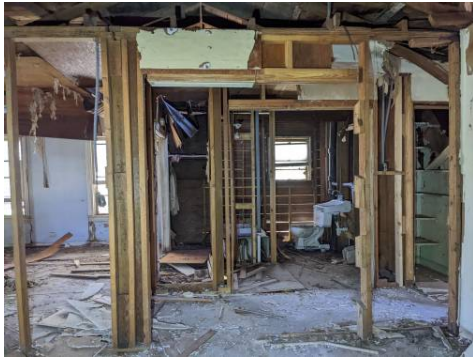
139.jpeg

View from living room towards south wing

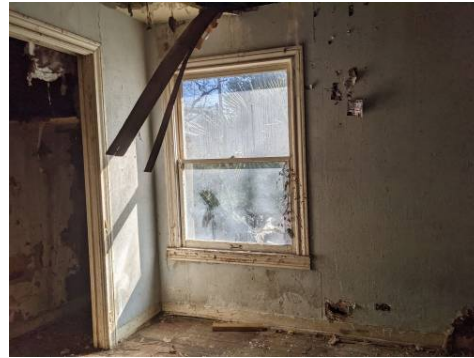
140.jpeg

South westerly rooms being removed floors walls roof ceilings compromised. Windows here are not matching the main house dimensions only the Gable window I assume this poorly added on extension stole the Gable and pushed it out we will reuse the Gable window back on the shorter leg here.

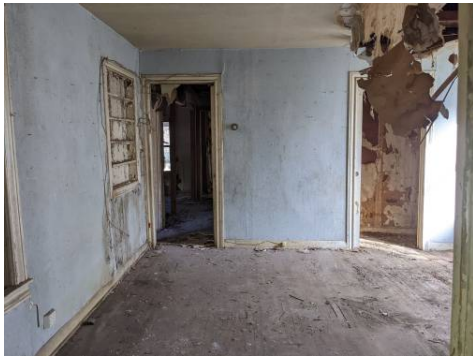
141.jpeg

South westerly rooms being removed floors walls roof ceilings compromised. Windows here are not matching the main house dimensions only the Gable window I assume this poorly added on extension stole the Gable and pushed it out we will reuse the Gable window back on the shorter leg here.

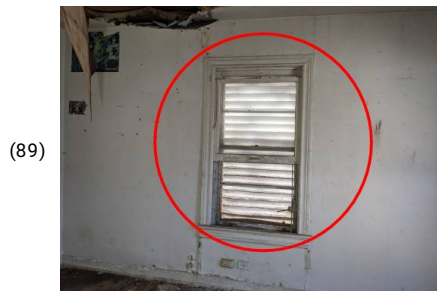
143.jpeg

South westerly rooms being removed floors walls roof ceilings compromised. Windows here are not matching the main house dimensions only the Gable window circled I assume this poorly added on extension stole the Gable and pushed it out we will reuse the Gable window back on the shorter leg here.

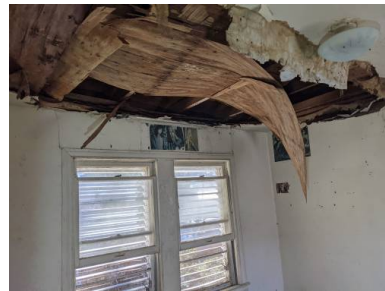
144.jpeg

South westerly rooms being removed floors walls roof ceilings compromised. Windows here are not matching the main house dimensions only the Gable window I assume this poorly added on extension stole the Gable and pushed it out we will reuse the Gable window back on the shorter leg here.

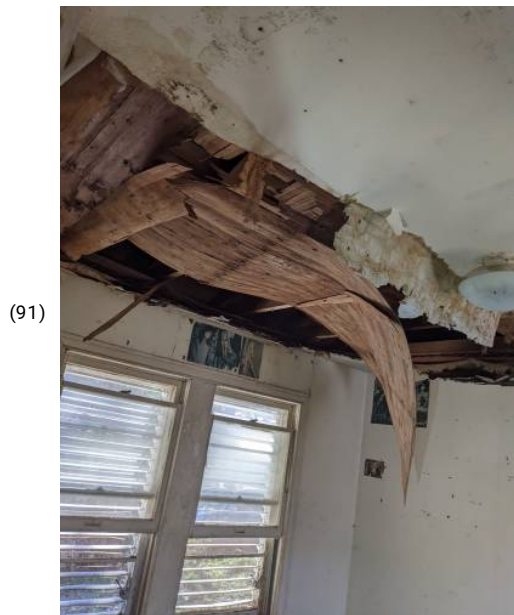
145.jpeg

South westerly rooms being removed floors walls roof ceilings compromised. Windows here are not matching the main house dimensions only the Gable window I assume this poorly added on extension stole the Gable and pushed it out we will reuse the Gable window back on the shorter leg here.

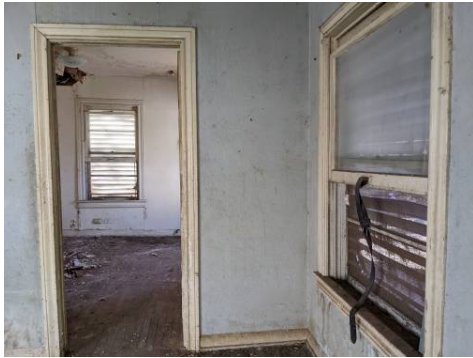
147.jpeg

South westerly rooms being removed floors walls roof ceilings compromised. Windows here are not matching the main house dimensions only the Gable window I assume this poorly added on extension stole the Gable and pushed it out we will reuse the Gable window back on the shorter leg here.

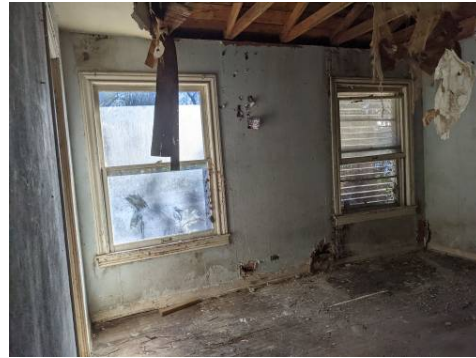
148.jpeg

South westerly rooms being removed floors walls roof ceilings compromised. Windows here are not matching the main house dimensions only the Gable window I assume this poorly added on extension stole the Gable and pushed it out we will reuse the Gable window back on the shorter leg here.

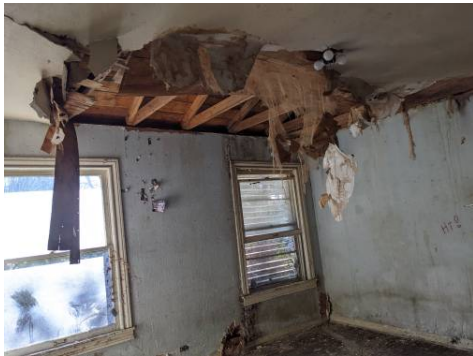
149.jpeg

South westerly rooms being removed floors walls roof ceilings compromised. Windows here are not matching the main house dimensions only the Gable window I assume this poorly added on extension stole the Gable and pushed it out we will reuse the Gable window back on the shorter leg here.

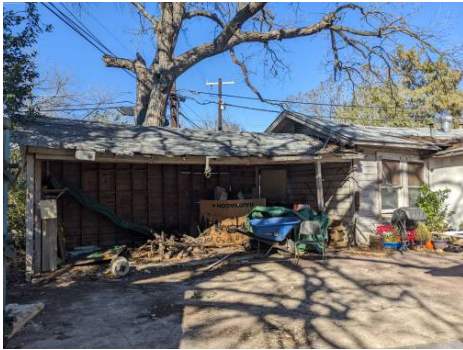
155.jpeg

Rear carport being removed.

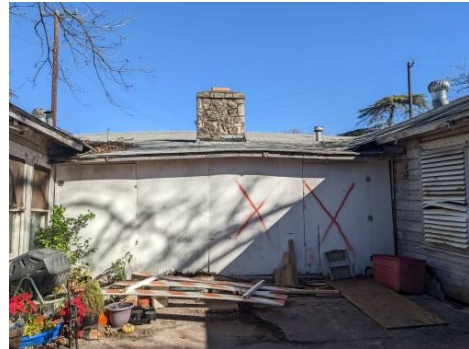
158.jpeg

Rear Porch that was enclosed post removal of the sliding doors. This will be opened up for rear deck fireplace access

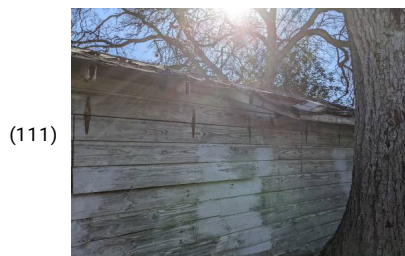
165.jpeg

Northern facade of carport joists failing and roof.

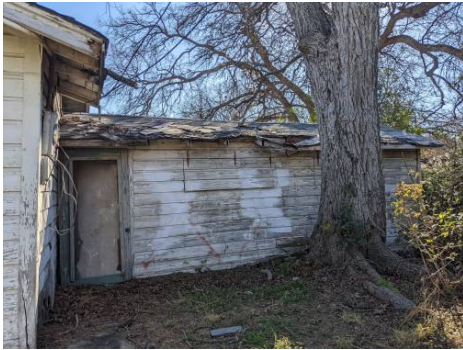
167.jpeg

Carport being removed.

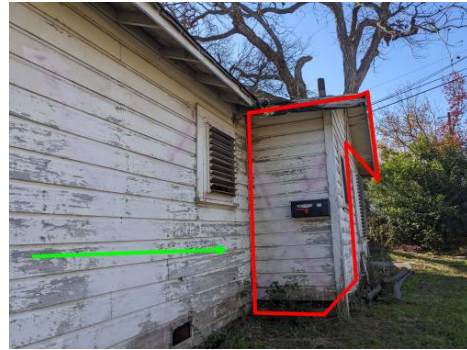
168.jpeg

Stub out red being removed wall shown by arrow  
will continue beyond

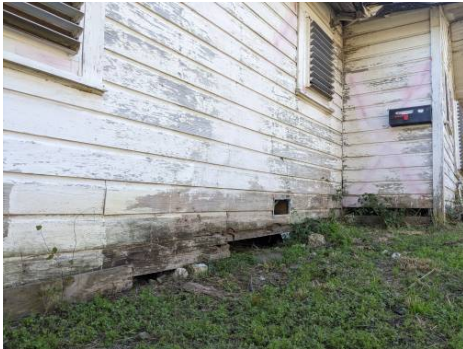
169.jpeg

Foundation on northern facade facing Magnolia  
failed in areas

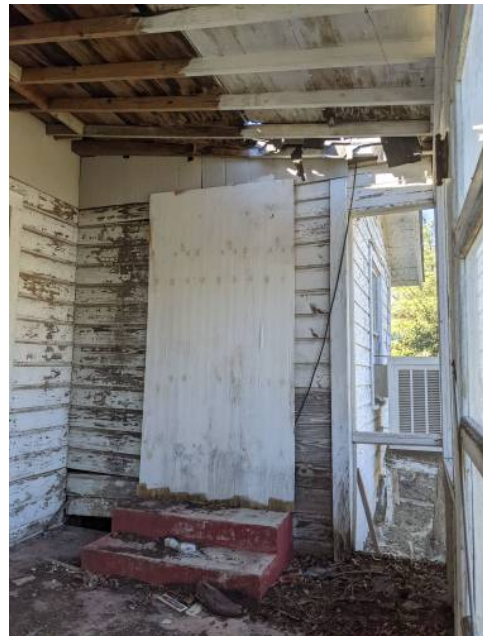
176.jpeg

North East Wing Side door from porch this wall is loose and ready to collapse.

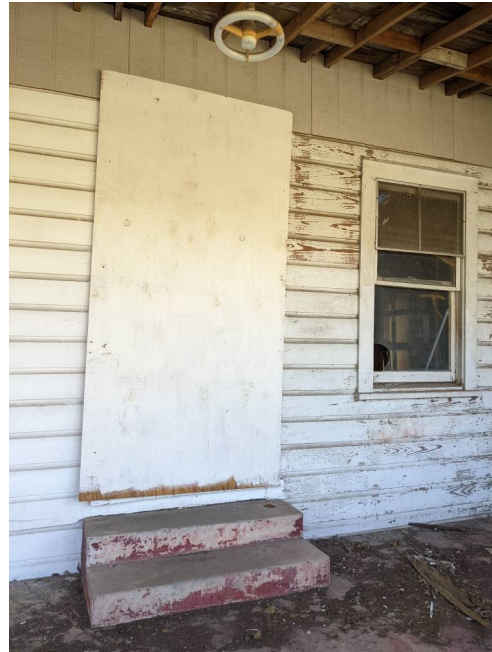
178.jpeg

Created: Sat 15 Jan 20:24 2022  
Original door removed by criminal.

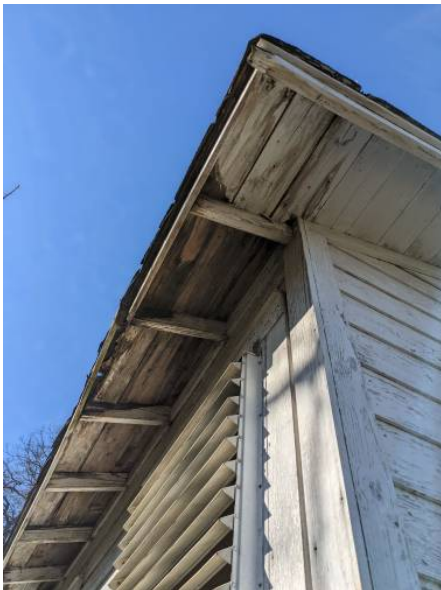
185.jpeg

Created: Sat 15 Jan 20:24 2022  
South east corner roof rotten

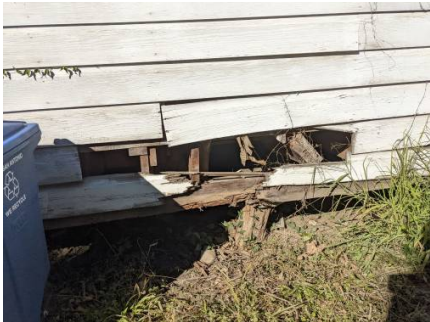
189.jpeg

Southern facade foundation and wall compromised.

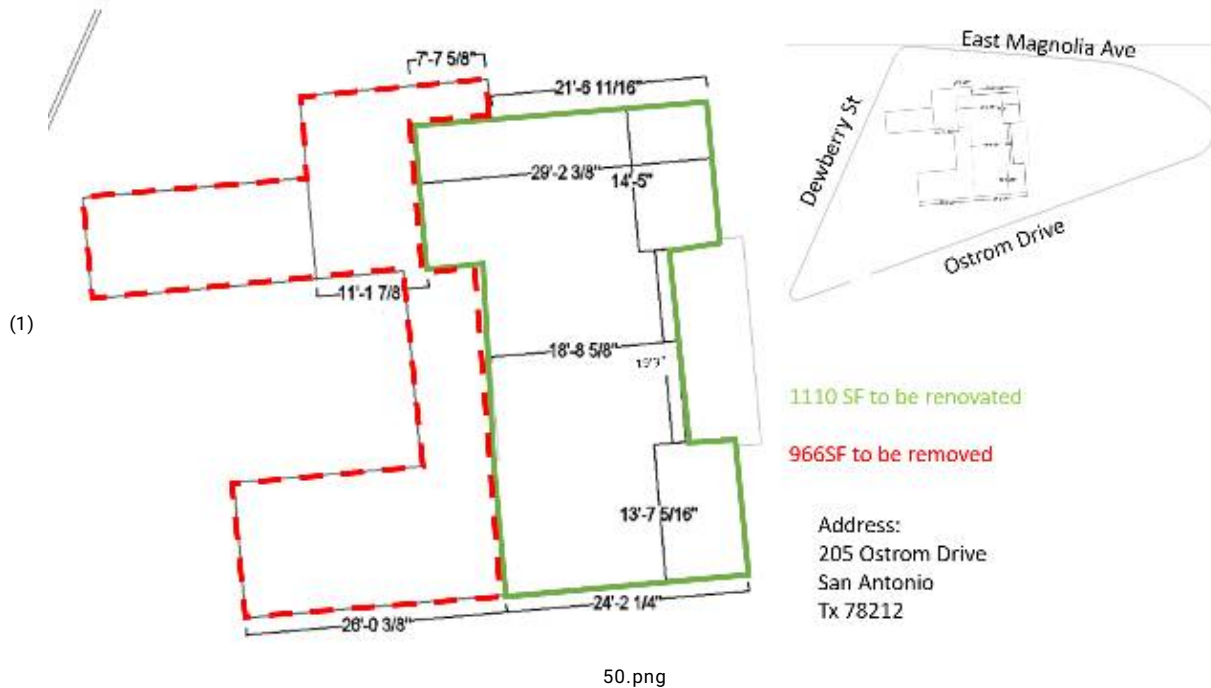
Overview of renovation in green and reduction/selective demo in red.

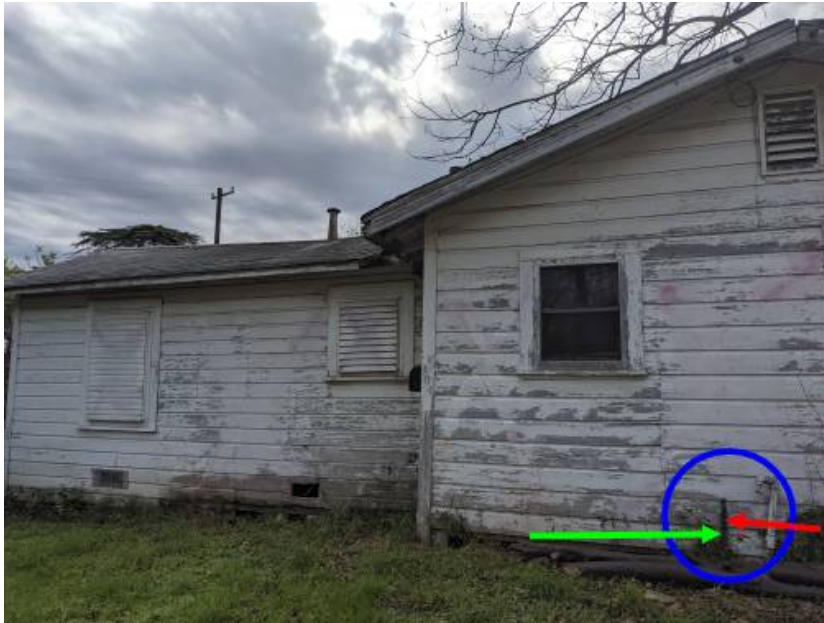
45.jpeg

North facade facing E Magnolia Ave  
Mark shown on house of location that we remove from.

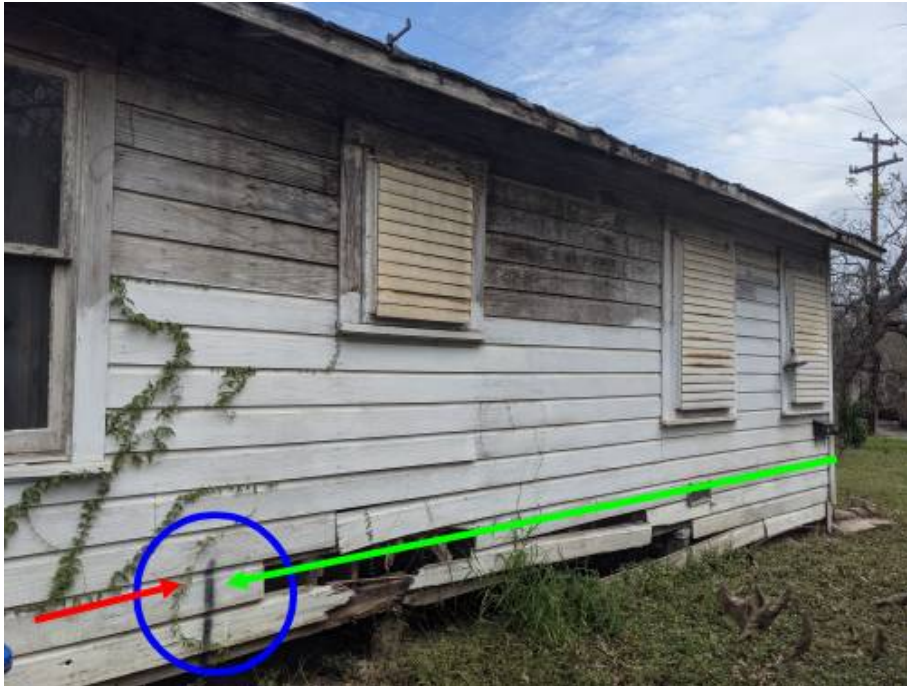
49.jpeg

South facade facing Ostrom Drive.  
Black spray paint marks location of remain and remove.

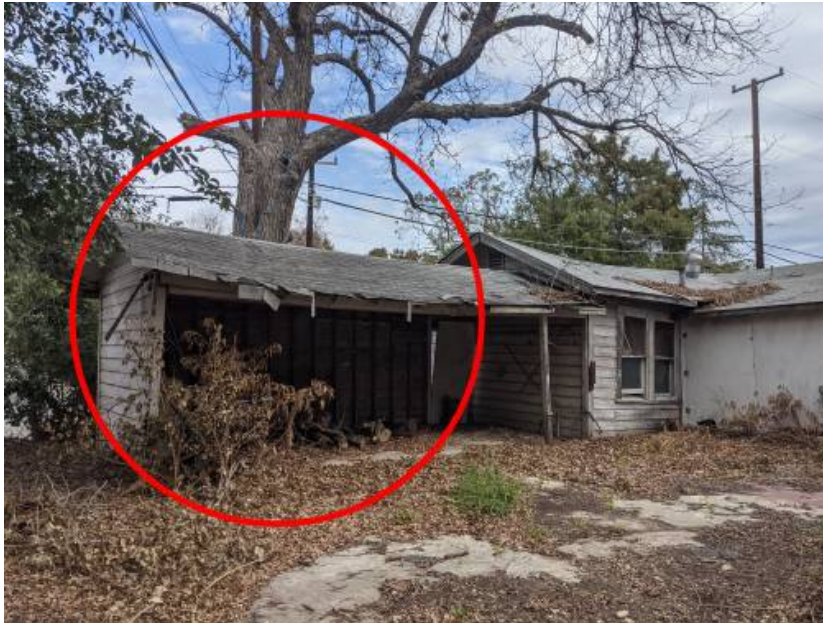
41.jpeg

Near the Tree (protect tree) on corner of Magnolia and Dewberry intersection  
Remove/demo carport save siding. This is the closest part of house to street little over 6ft from curb. No issues here fast removal.

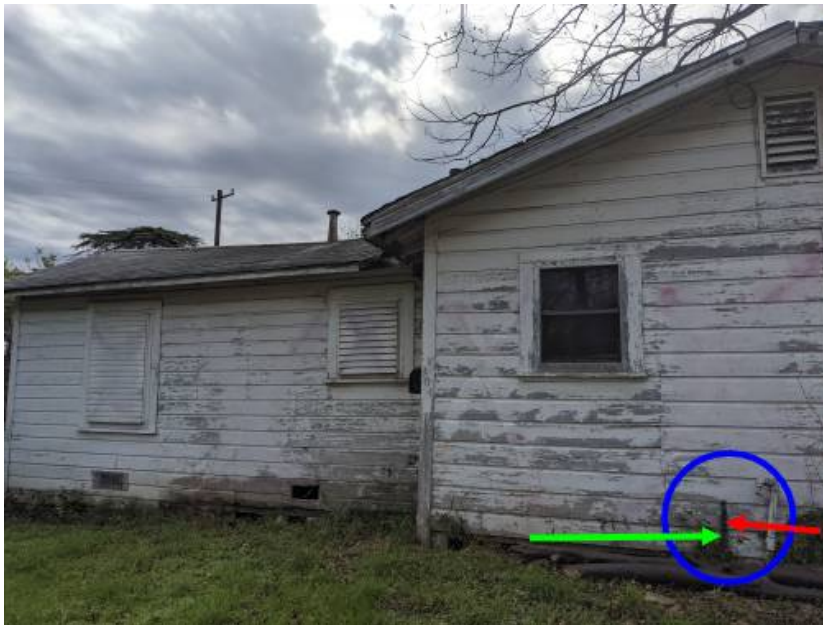
45.jpeg

Mark shown on house of location that we remove from.
