HISTORIC AND DESIGN REVIEW COMMISSION

April 19, 2023

HDRC CASE NO: 2022-091
COMMON NAME: Brackenridge Park, Lambert Beach
ADDRESS: 3700 N ST MARYS ST
LEGAL DESCRIPTION: NCB A49 PART OF A-2, A-4, A-52 (208 AC)
ZONING: R-6,HS
CITY COUNCIL DIST.: 2
LANDMARK: Individual Landmark
APPLICANT: Jamaal Moreno/City of San Antonio, PWD
OWNER: City of San Antonio
TYPE OF WORK: Phase 1 of FY17 Bond Improvements to Lambert Beach Area
APPLICATION RECEIVED: April 04, 2023
60-DAY REVIEW: Not applicable due to City Council emergency orders
CASE MANAGER: Cory Edwards
REQUEST:

The applicant is requesting a Certificate of Appropriateness for approval to construct improvements to the Lambert Beach area in Brackenridge Park as Phase I of the FY17 Bond Project. Request items include:

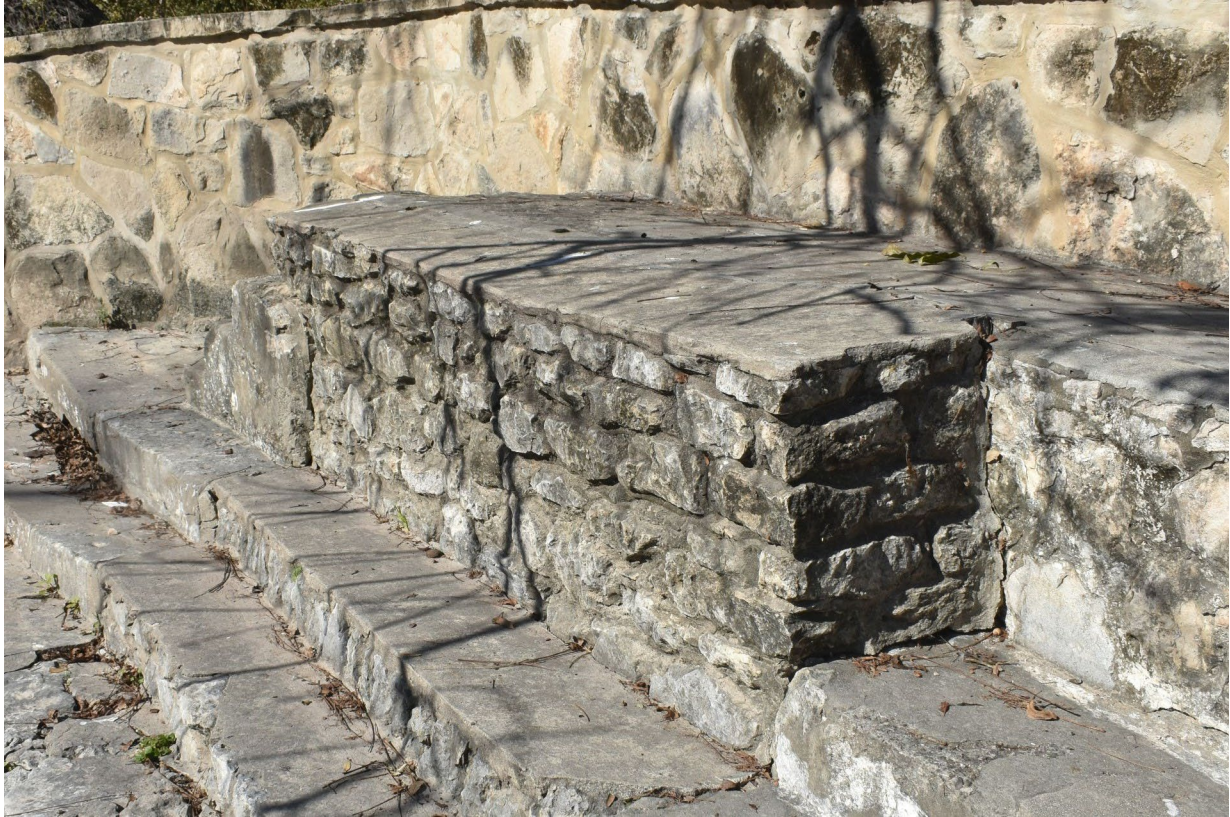
stairs and consists of steps constructed of large slabs of roughly tooled masonry laid in a horizontal pattern. Section C is the lower portion of the staircase that provides direct access to the river. This section is constructed of roughly tooled smaller limestone units set in lime-cement grout, with much of the treads covered with a cement skim coat. This section also includes a low platform likely constructed at the same time as the rest of Section C (Image 10). It may have been an anchor point for a diving board or the rope suspension footbridge that once spanned the river at this location (Nau 2022, 3–4). The lowest portions of Section C are submerged depending on water level. Section D is at the upper west end of the lower section of stairs and consists of a small platform formed by masonry units over a portion of Section C. The horizontal surface is constructed of several large limestone units and is faced with smaller regularly coursed, roughly tooled limestone units. The resource's face is pulling away from Section C, indicating it is not joined with the lower section and was constructed separately (Image 11) (Nau 2022, 4).

Image 11. Detail of Section D. Photograph by CMEC, 2022.

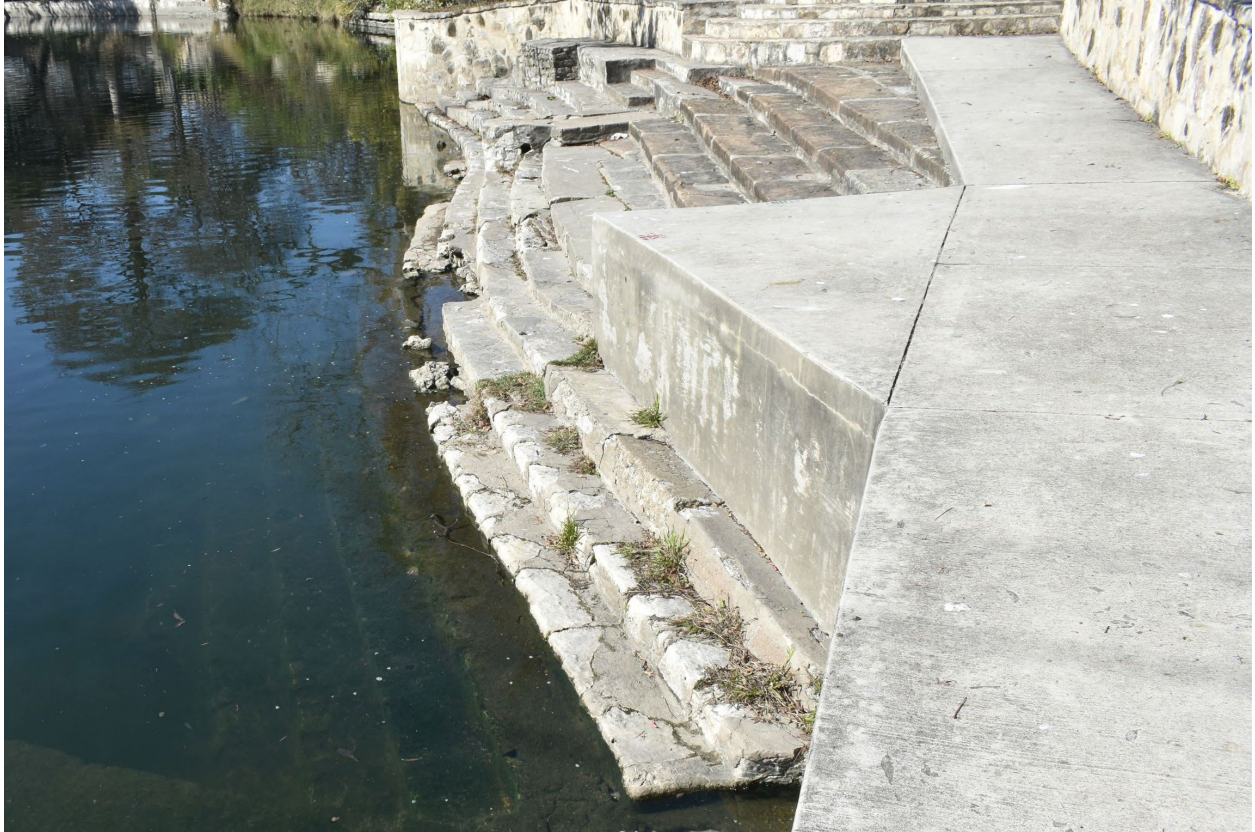
Sections E and F are 2002 modifications to the riverbank retaining wall (E) and walkway (F). As originally constructed, the west end of Section C extended and curved around to the Pump House #1 outlet, with the riverbank retaining wall originally set back approximately 10 feet from the river's edge (Image 12). In 2002, the riverbank retaining wall (E) at this end of Section C was repositioned to the river's edge atop the steps and the bank behind the new wall filled. The steps below this area are extant but submerged. The stepped river-level walkway (F) originally from Section B east to the lenticular truss bridge was overlaid with a sloped concrete sidewalk and extended to Section A. A concrete platform was constructed over Sections B and C where the stairs join with the walkway (Image 13).

Image 13. Detail of submerged Section C and Section F walkway extension and platform. Photograph by CMEC, 2022.

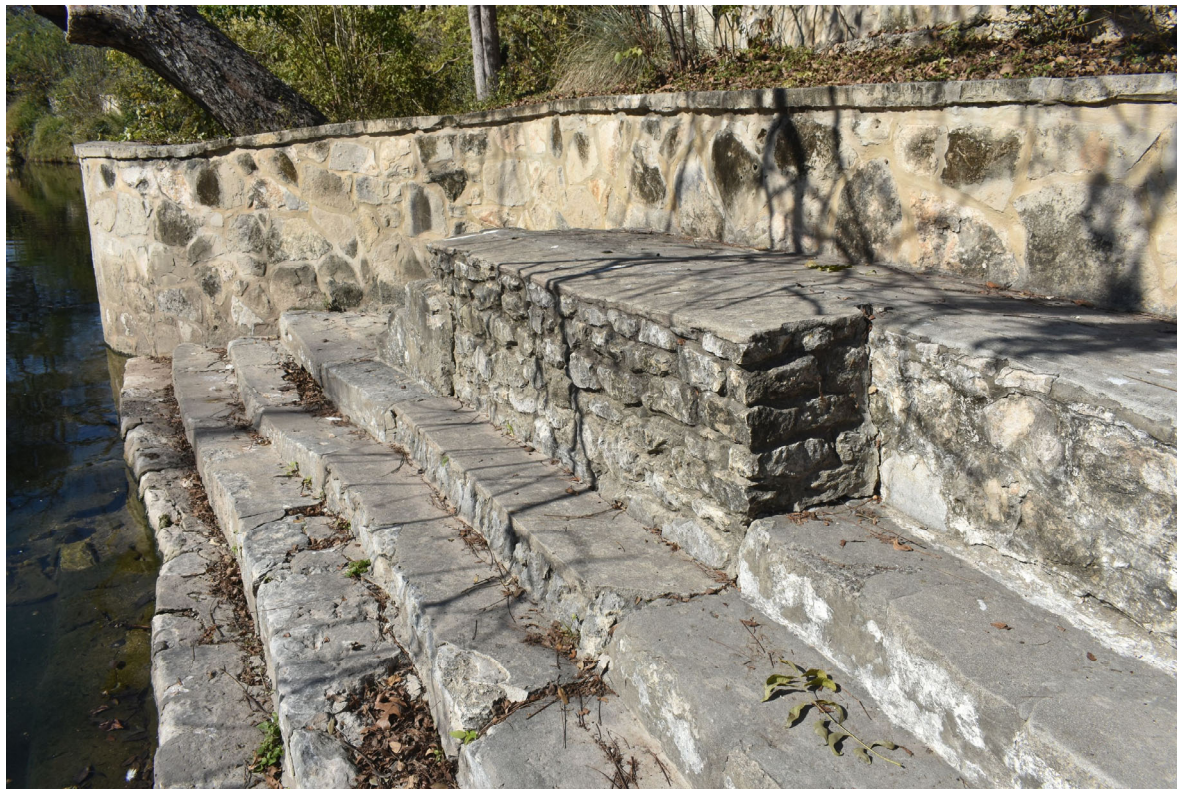
Detail of stone rubble
platform addition (D) and
modified wall (E); view facing
northwest

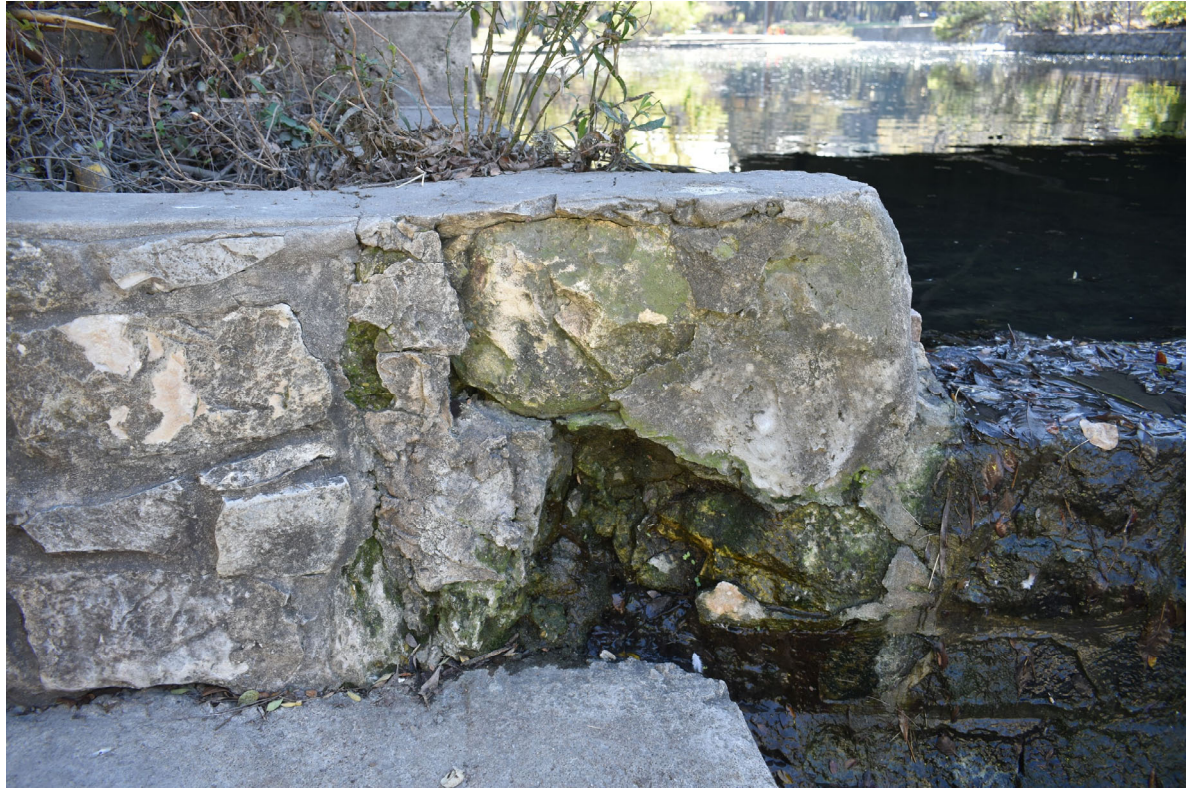
Detail of joint with Resource
B1-6; view facing south

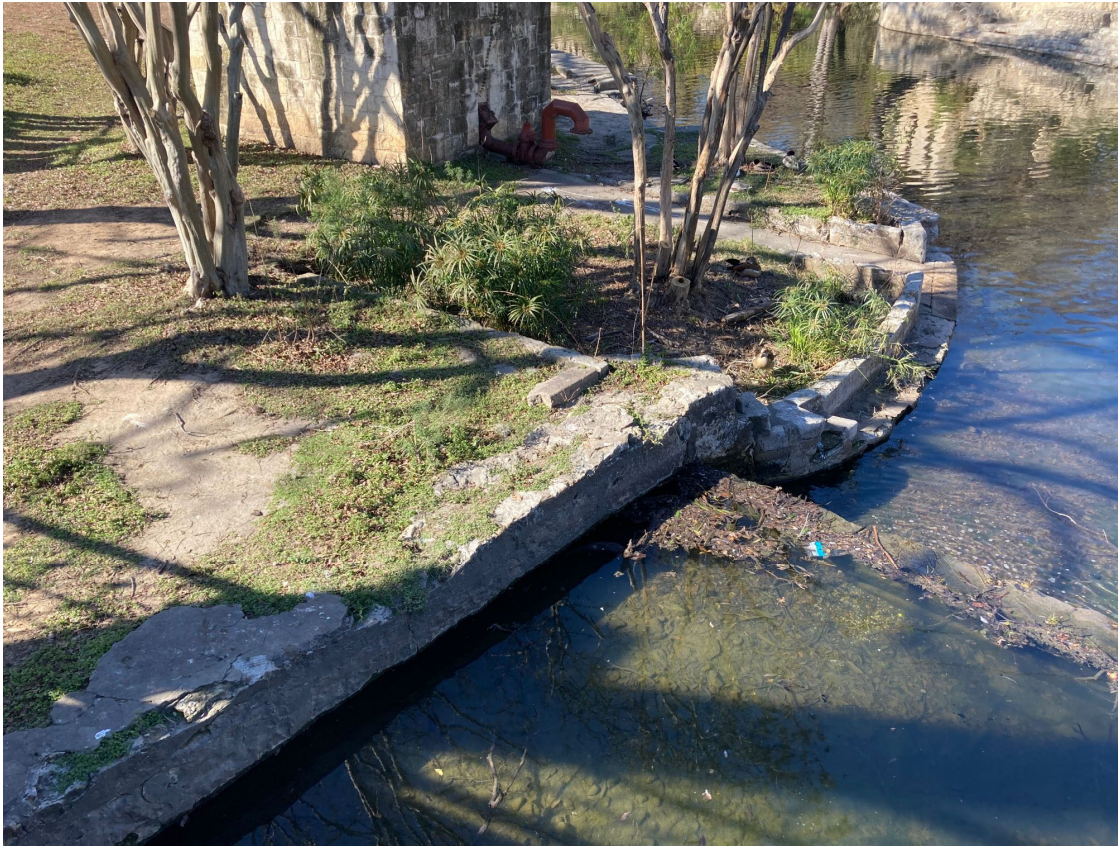
View facing
northwest

Type: Structure	Exterior materials: stone	Primary roof type: N/A	Alterations: The resource has deteriorated
Style: Rustic			
Form: Irregular	Porch: N/A

Resource B1-68 is a slew and river channel wall constructed at an unknown date. A slew, or slough, is a shallow wetland adjacent to a larger body of water such as a river. The Lambert Beach slew is formed behind the dam (B1-6) and is held by adjacent river channel retaining walls. The walls are constructed of uncoursed flat limestone and are in very poor condition. A metal fleur-de-lis is embedded in the wall's surface.

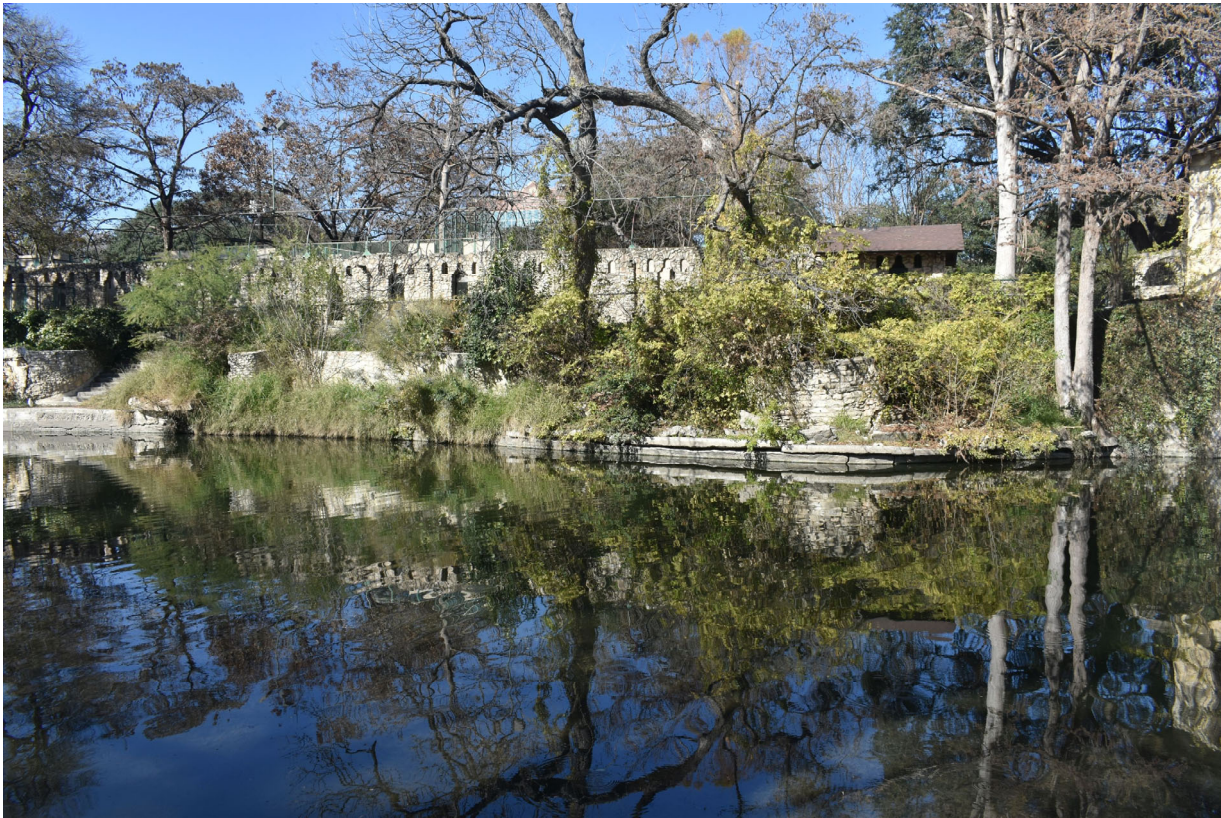
Overview, Pump House 1 on right, Staircase 3 on left; view facing north

Type: Structure	Exterior materials: stone	Primary roof type: N/A	Alterations: overgrown; poor state of repair
Style: No style			
Form: Linear	Porch: N/A

Resource B1-72 are a stone wingwall attached to Pump House #1 and a river channel wall both constructed in 1877 as part of the Pump House #1 project. The wingwall is currently obscured by overgrowth and its condition is unknown. The river channel wall extends from Pump House #1 downriver to the first set of steps leading to the river. The wall is constructed of stone masonry with a concrete cap walkway. The walkway appears to be in very poor condition with sections that appear to have separated from the underlying wall. This river channel wall is partially obscured by overgrowth, is not accessible, and appears to be partially covered by the crumbled remnants of the adjacent riverbank wall B1-73.

Although the wingwall is not visible there is no evidence indicating its historic integrity has been compromised and its contributing status to the Brackenridge Park Historic District is affirmed. The river channel wall must be considered in context of its function and the expectation that such resources are expected to wear with the action of the river. Although the wall's walkway is currently in a state of disrepair and is partially overgrown, these conditions are reversible. Neither the resource's design nor its relationship with surrounding historic resources has changed and it is still capable of communicating its role as both a recreational and engineering feature. The resource retains its original materials and is clearly distinct from related historic resources B1-2, B1-70, B1-71, and B1-73. The resource retains sufficient physical and historical integrity under Criterion A in the area of Entertainment/Recreation for its association with the development and design of Brackenridge Park and Criterion C in the area of Engineering for its association with water delivery to communicate its historical significance. Its contributing status to the Brackenridge Park Historic District is affirmed.

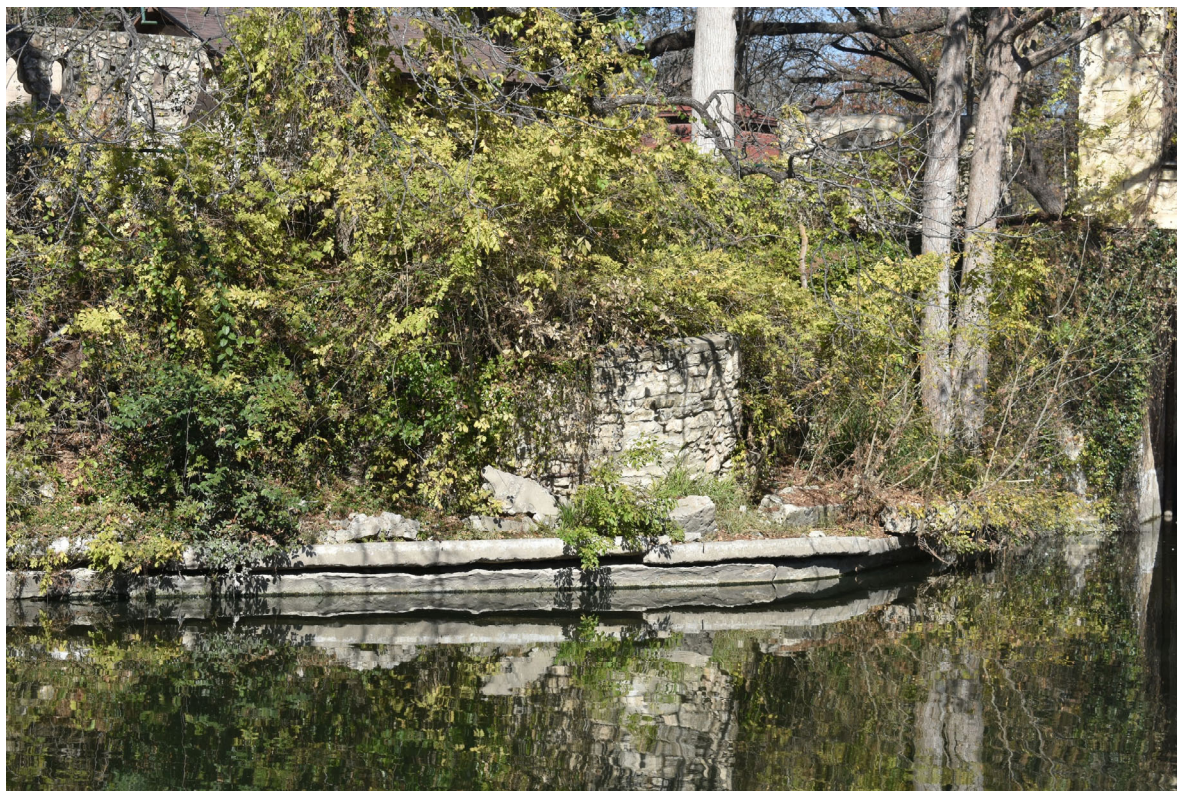
Detail 1 of 5 from Pump
House #1 to Staircase 3; view
facing north

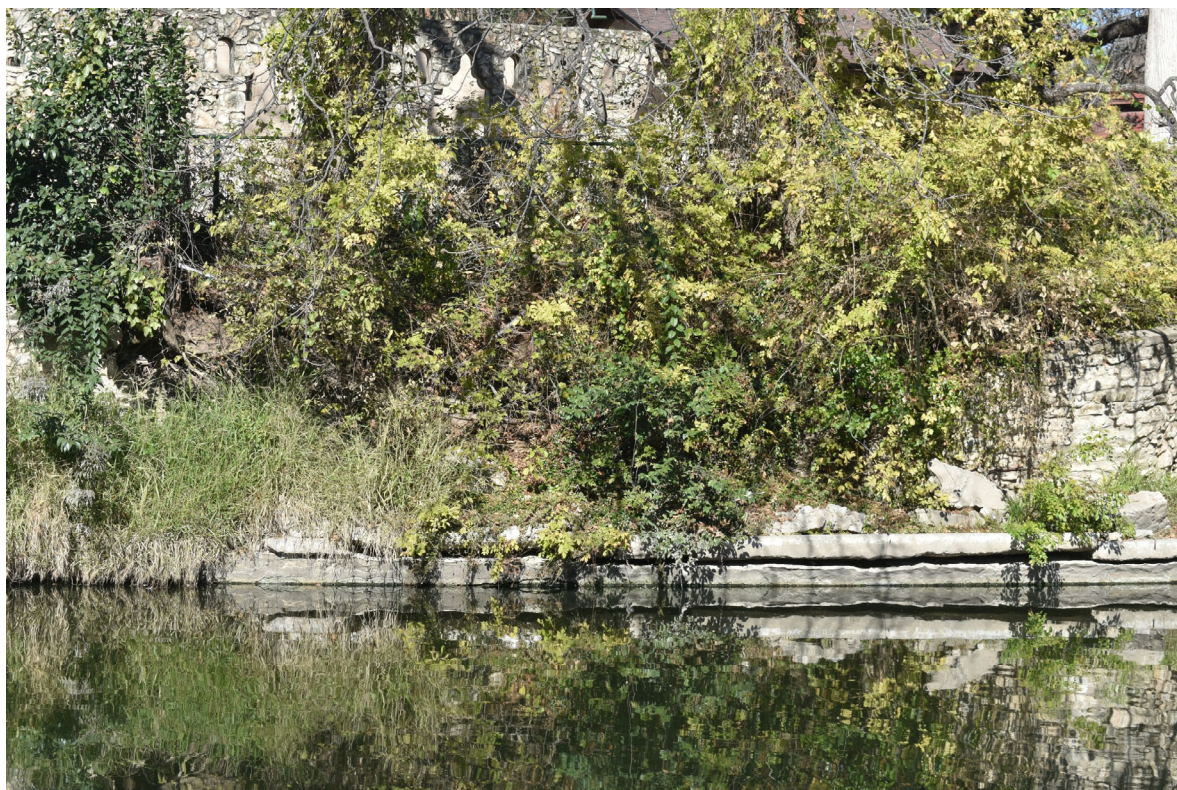
Detail 2 of 5 from Pump
House 1 to Staircase 3; view
facing north

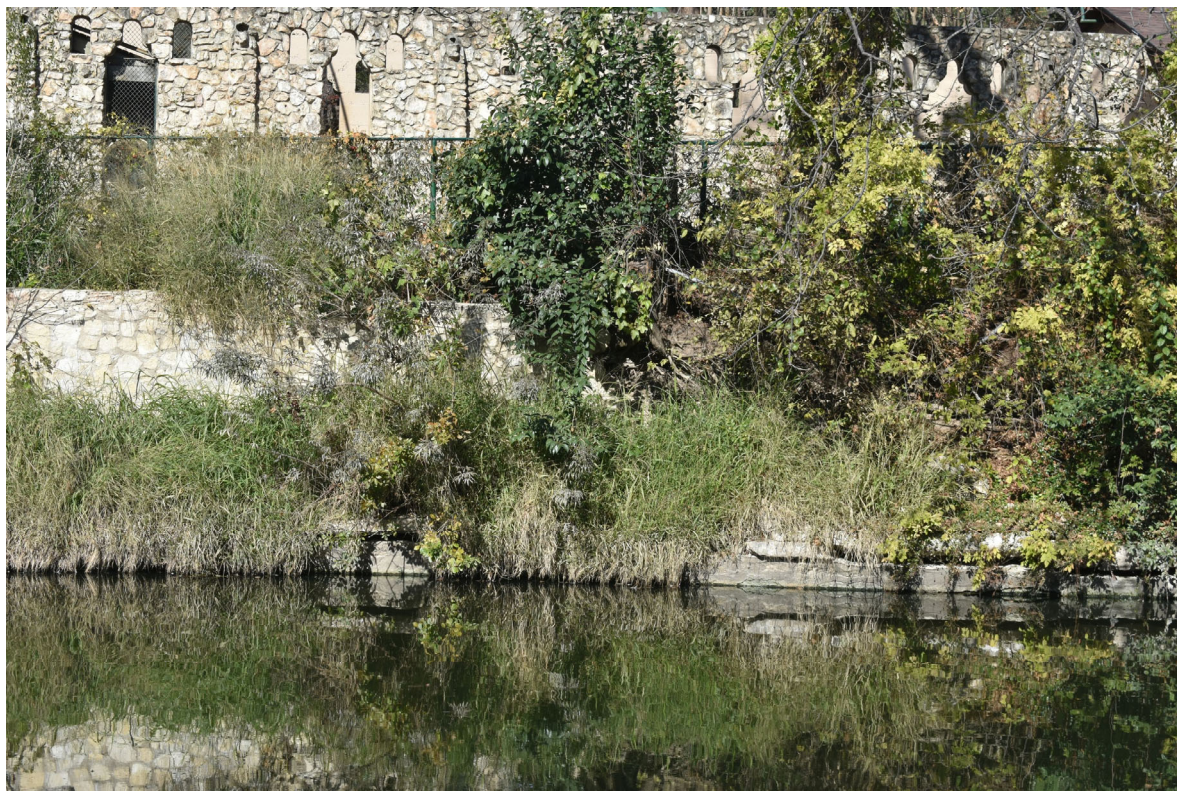
Detail 3 of 5 from Pump
House 1 to Staircase 3; view
facing north

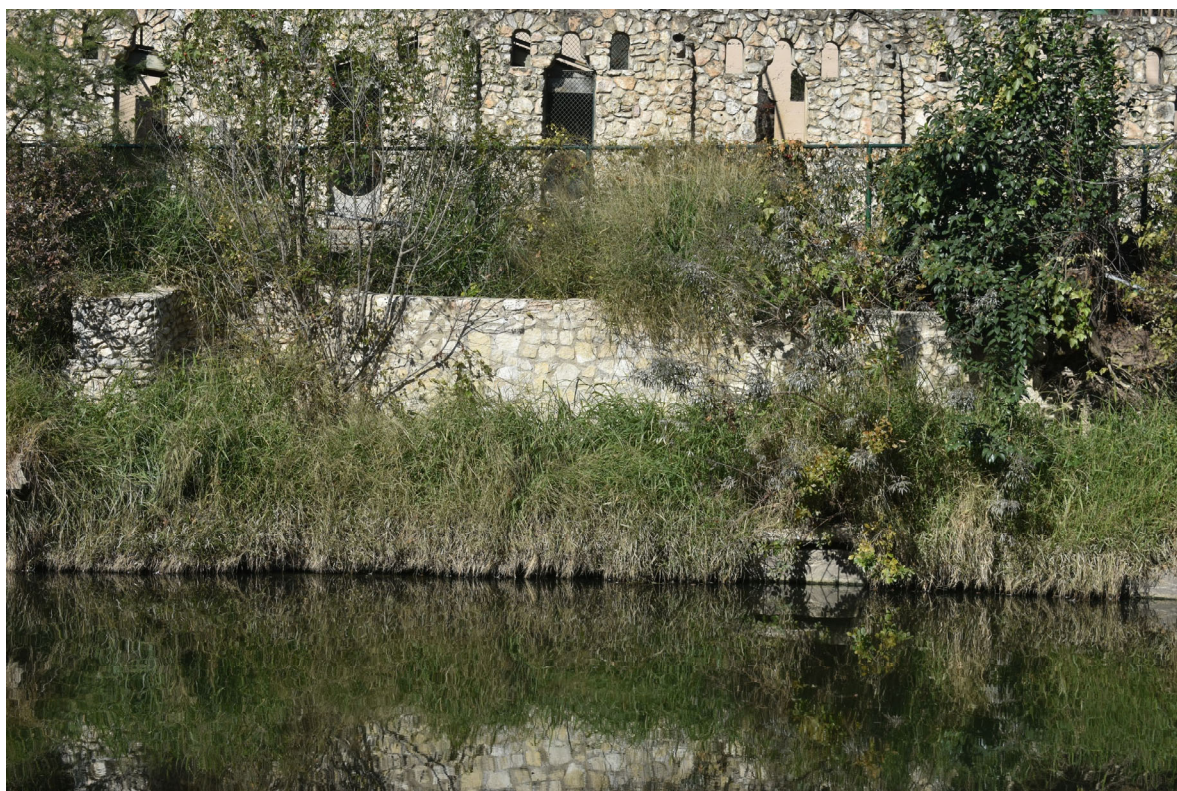
Detail 4 of 5 from Pump
House 1 to Staircase 3; view
facing north

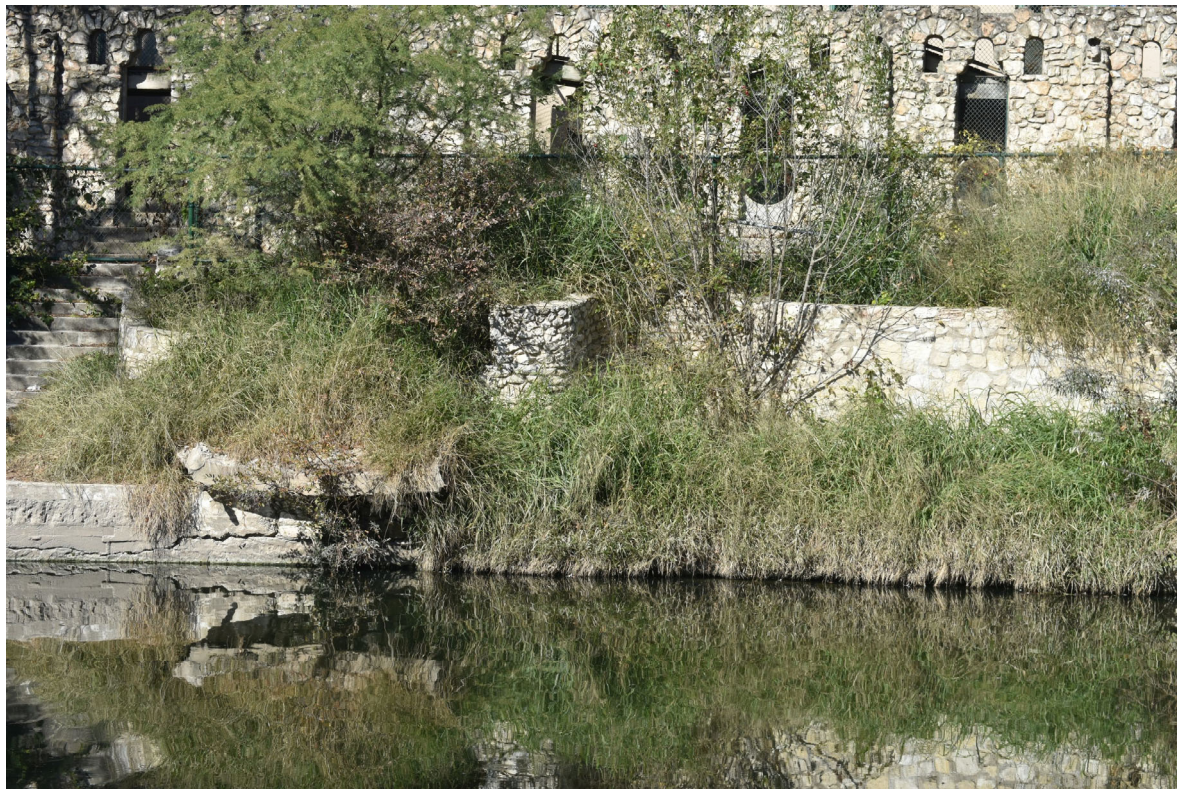
Detail 5 of 5 from Pump
House 1 to Staircase 3; view
facing north

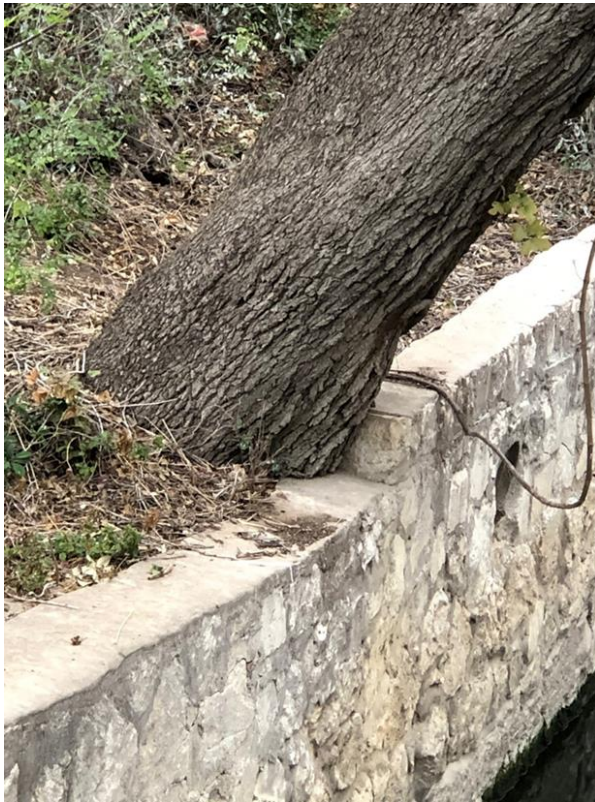
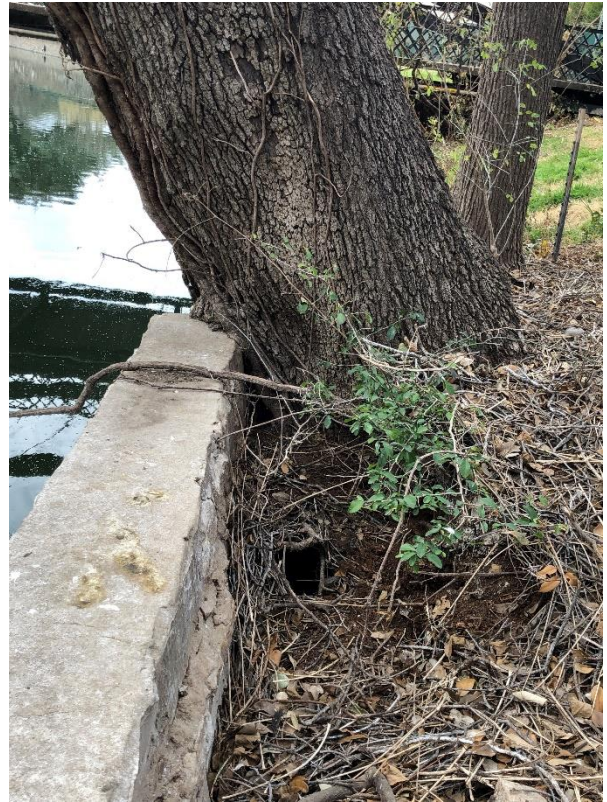
Figures 1 & 2: Tree No. 95, 32-inch Live Oak proposed to be removed. Proximity to Cultural Resource: 0 inches.

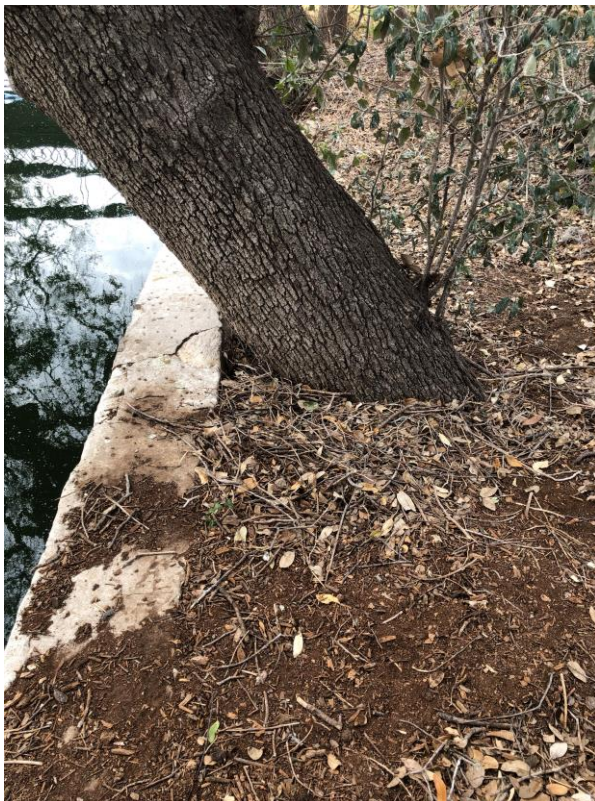
Figure 3: Tree No. 97, 22-inch Live Oak proposed to be removed. Proximity to Cultural Resource: 3 inches

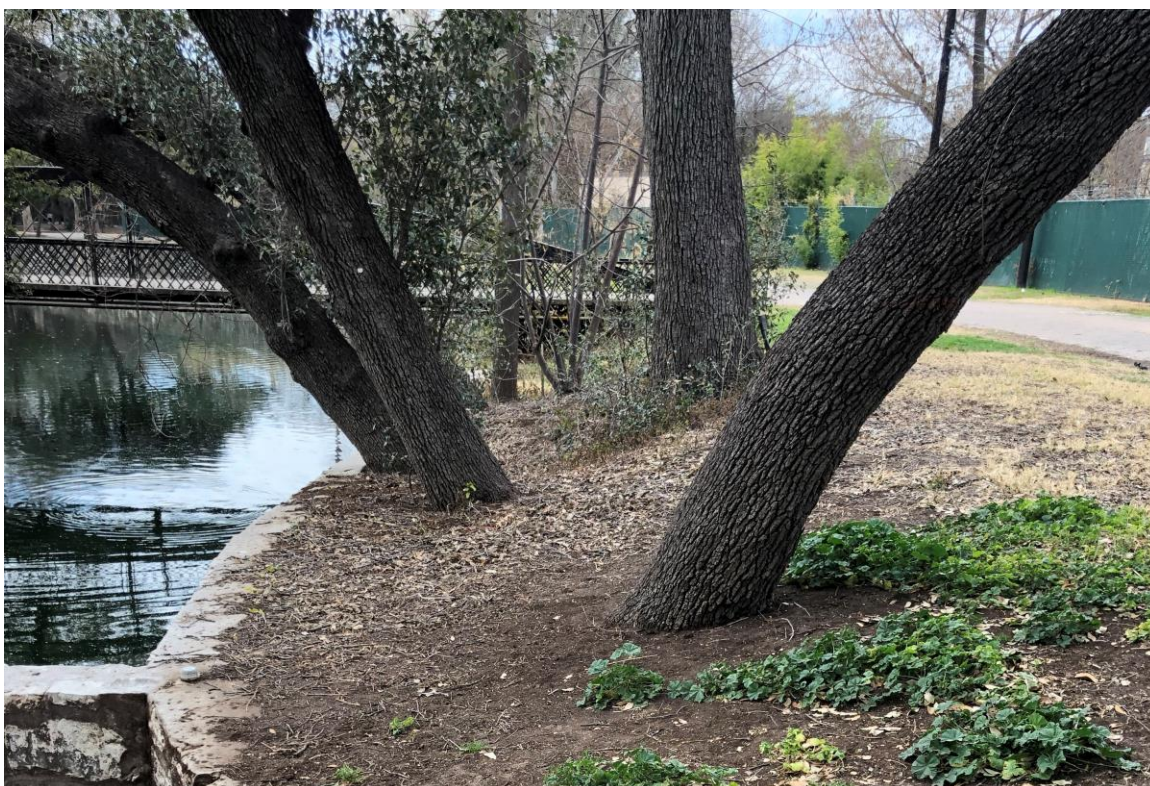
*Figure 5: Foreground – Tree No. 99, 16-inch live oak proposed to be removed. Proximity to Cultural Resource: Less than 5 feet.
Background – (L to R) Tree No. 97, Tree No. 98, both proposed to be removed, Tree No. 96 proposed to be preserved.*

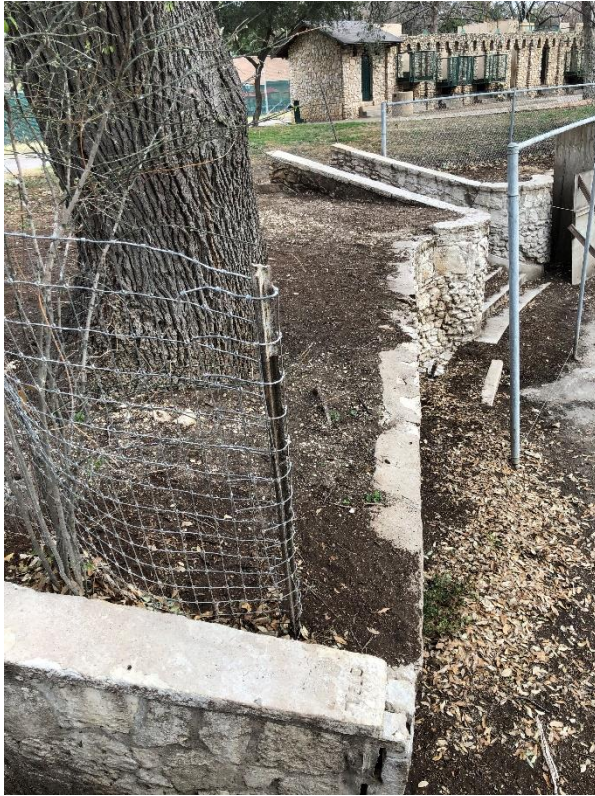
Figures 6 and 7: Tree No. 100, 37-inch Live Oak proposed to be removed. Proximity to original position of Cultural Resource (severe lean): less than 15 inches

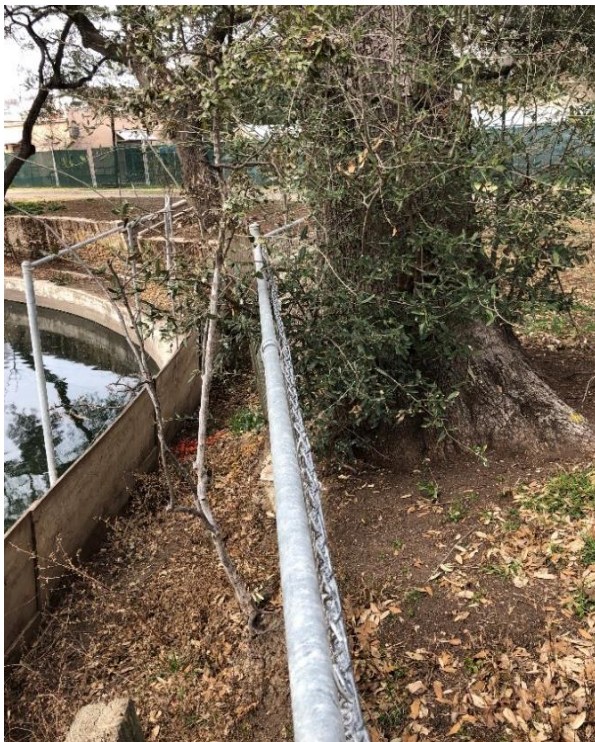
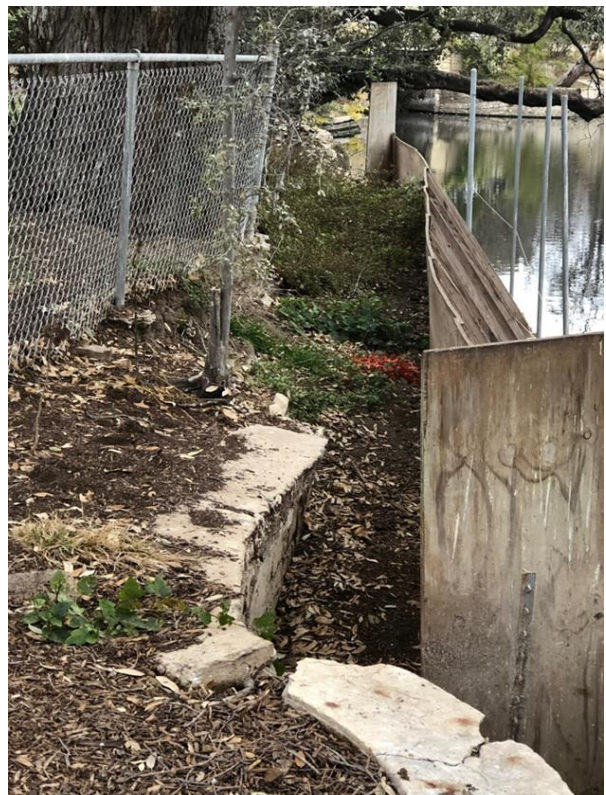
Figures 8 and 9: Tree No. 101, 44-inch Live Oak proposed to be relocated approximately 15-20 feet further away from river than current location. Proximity to original position of Cultural Resource (demolished): less than 18 inches.

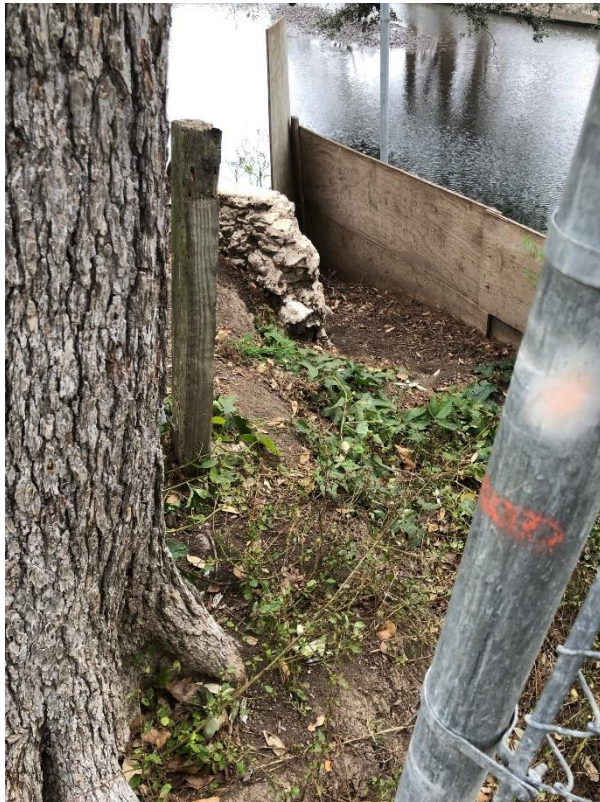
Figure 10: Tree No. 102, 18-inch Cedar Elm proposed to be removed. Proximity to original position of Cultural Resource(demolished): less than 3 feet.

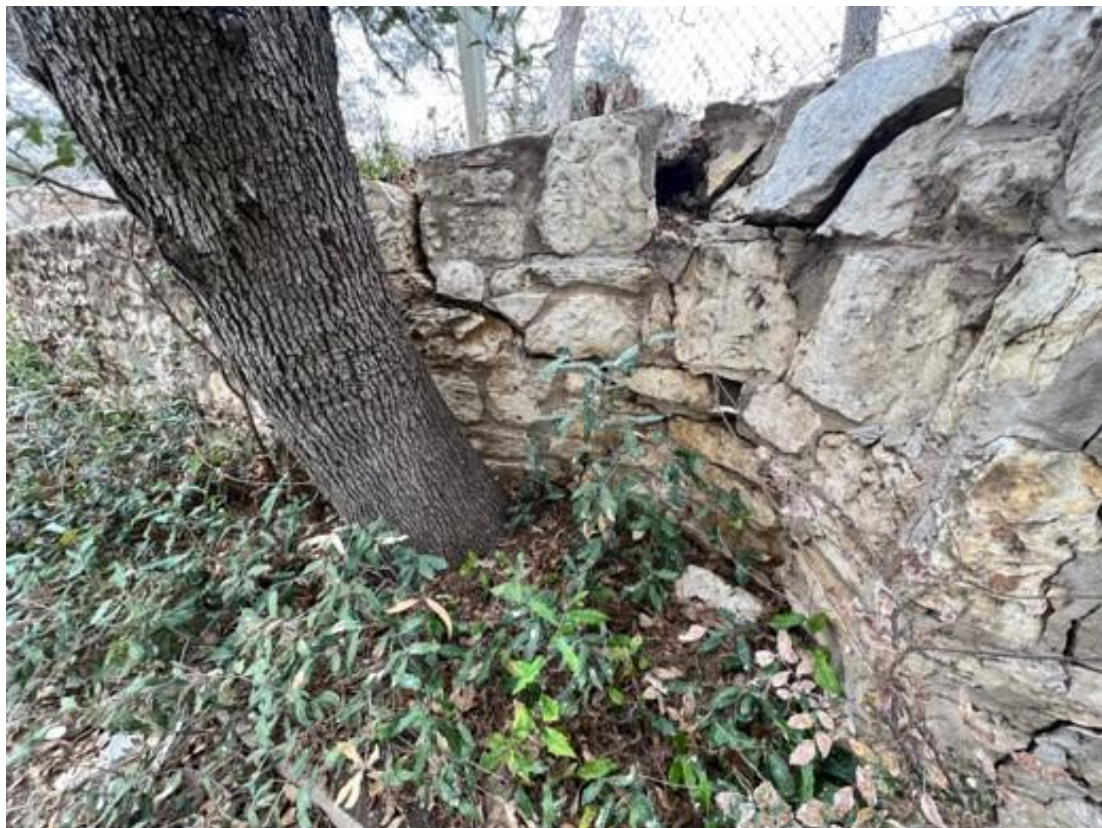
Figure 11: Tree No. 134, 16-inch Live Oak proposed to be removed. Proximity to Cultural Resource: 0 inches.

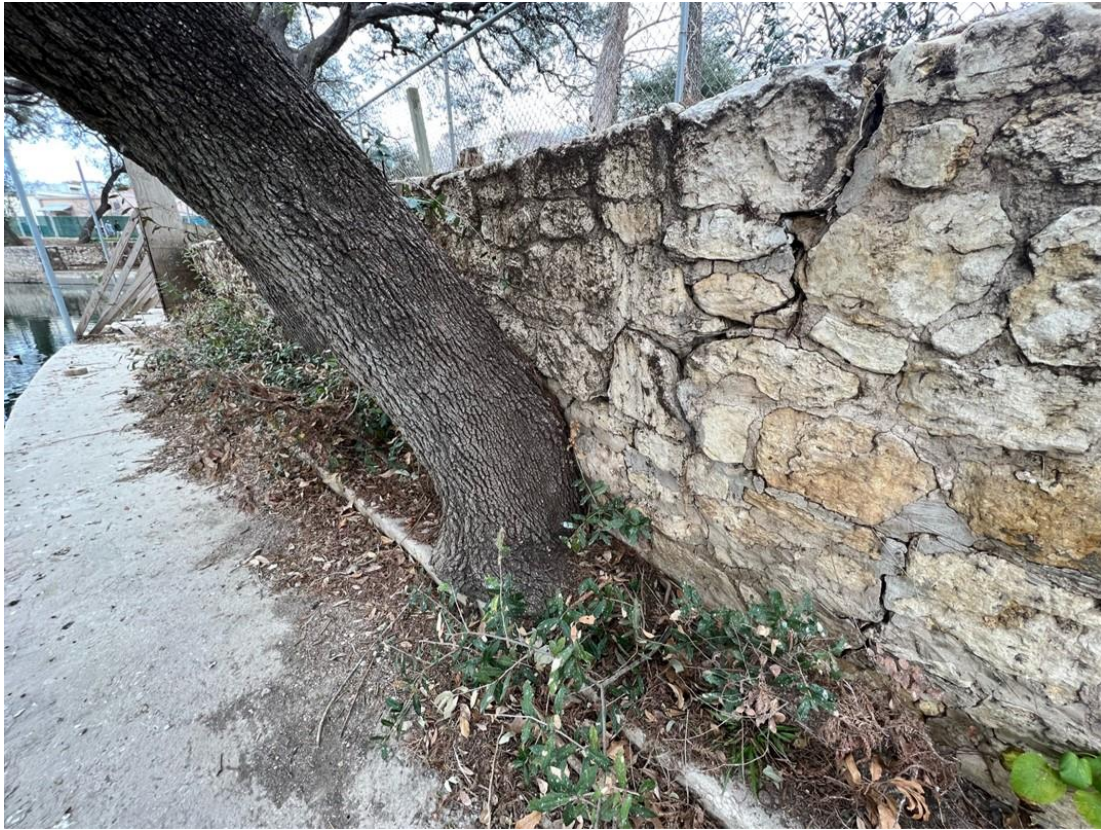
Figure 12: Tree No. 135, 15-inch Live Oak proposed to be removed. Proximity to Cultural Resource: 0 inches.

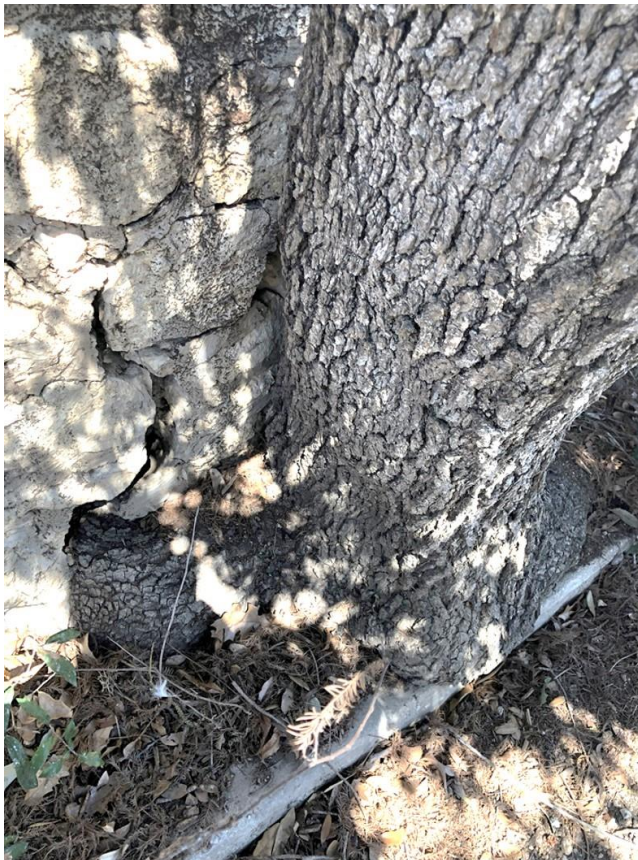
Figure 13: Tree No. 135, 15-inch Live Oak proposed to be removed. Proximity to Cultural Resource: 0 inches.

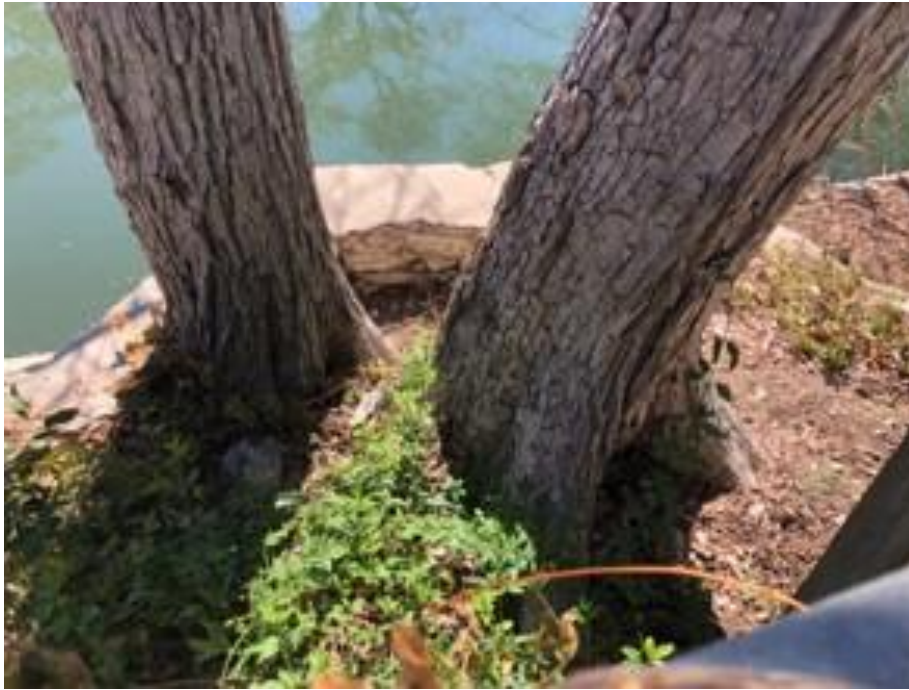
Figure 16: (L to R) Tree Nos. 138, 16-inch Cedar Elm, and 137, a 17-inch Cedar Elm, proposed to be removed. Proximity to Cultural Resource: 1-3 inches.

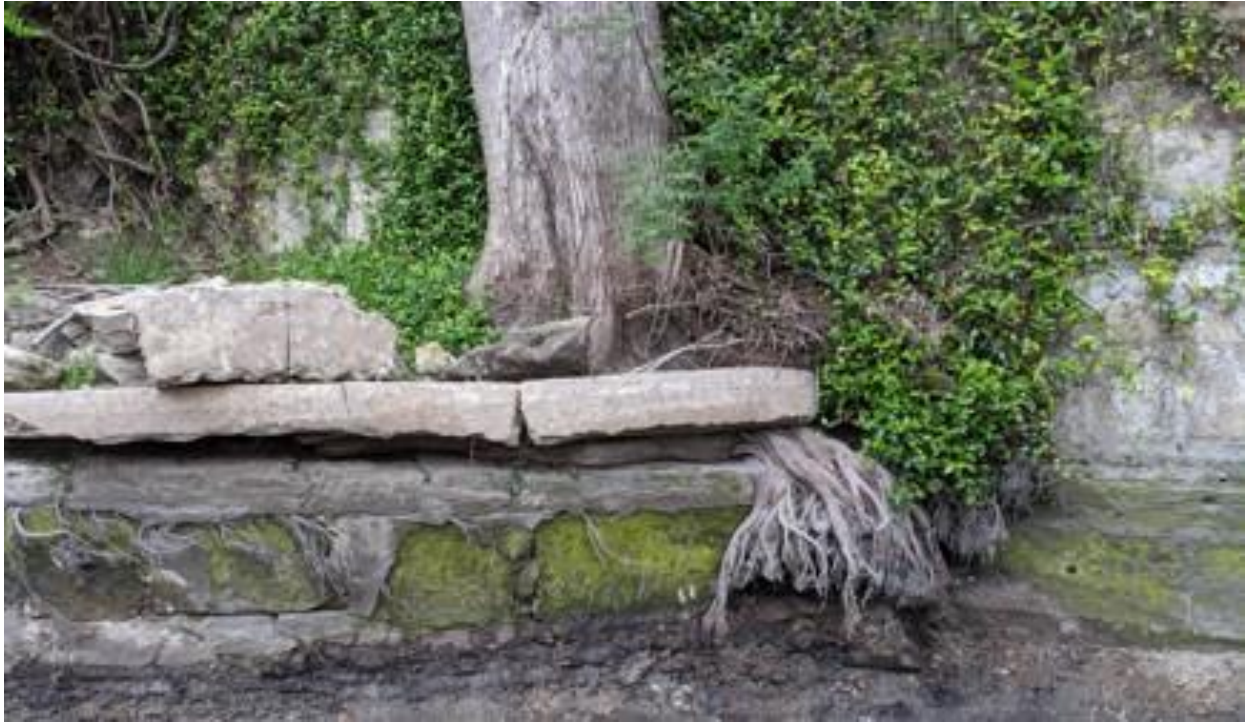
Figure 18: Tree No. 141, 27-inch Bald Cypress proposed to be removed. Proximity to Cultural Resource: 0 inches.

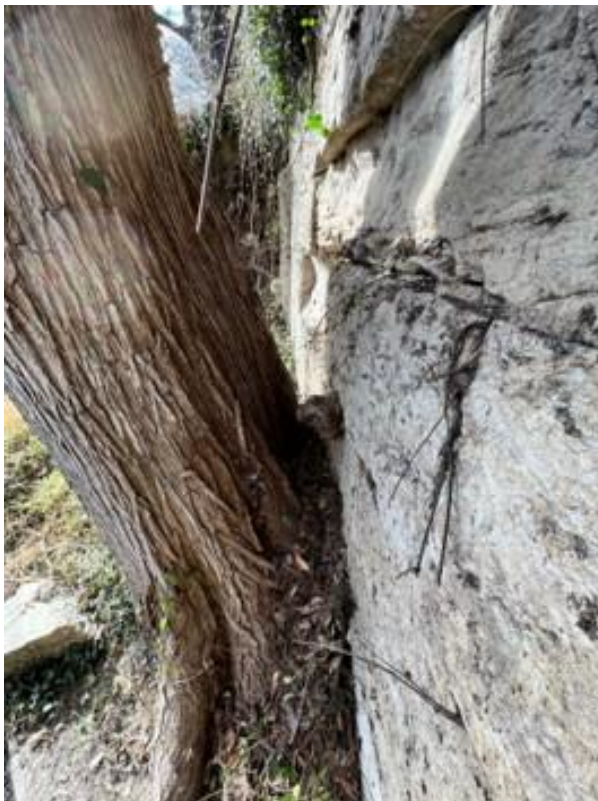
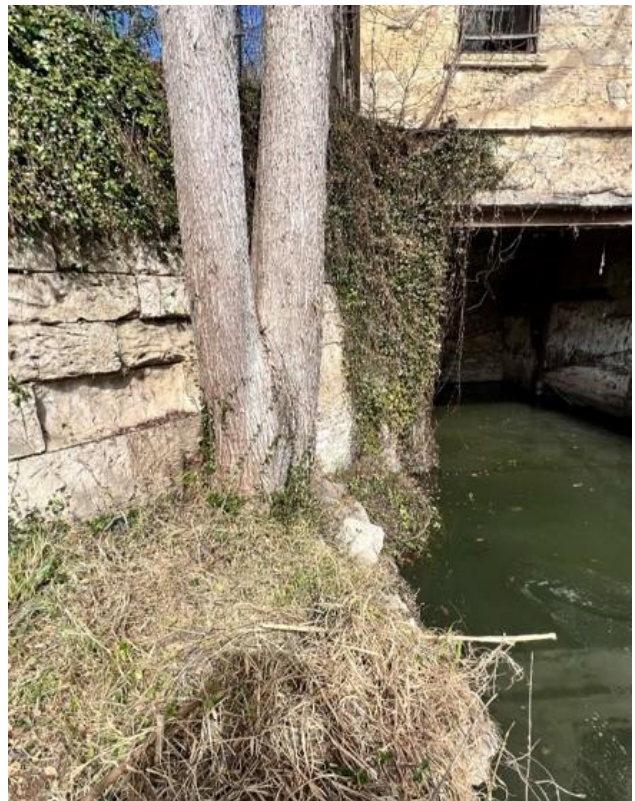
Figure 19 and 20: Tree No. 141, 27-inch Bald Cypress proposed to be removed. Proximity to Cultural Resource: 0 inches.

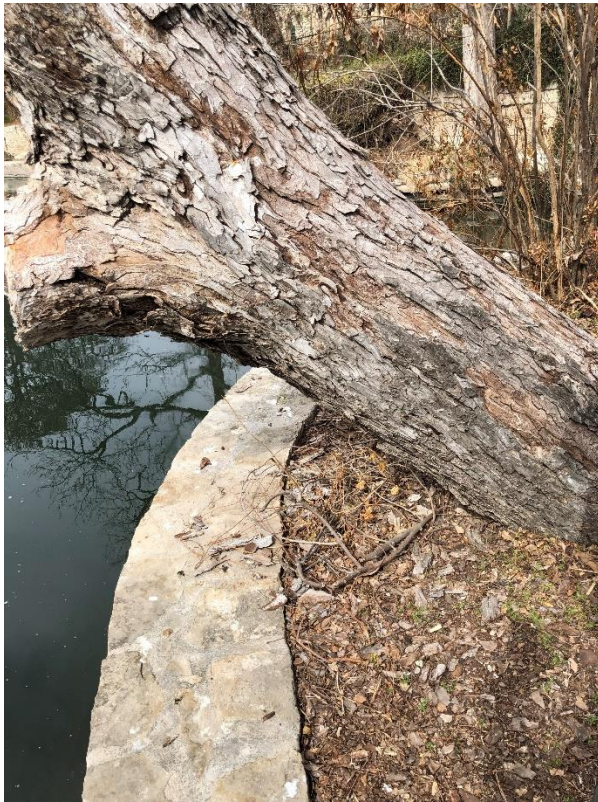
Figure 21: Tree No. 142, 20-inch Pecan proposed to be removed. Proximity to Cultural Resources: 6 inches to 5 feet

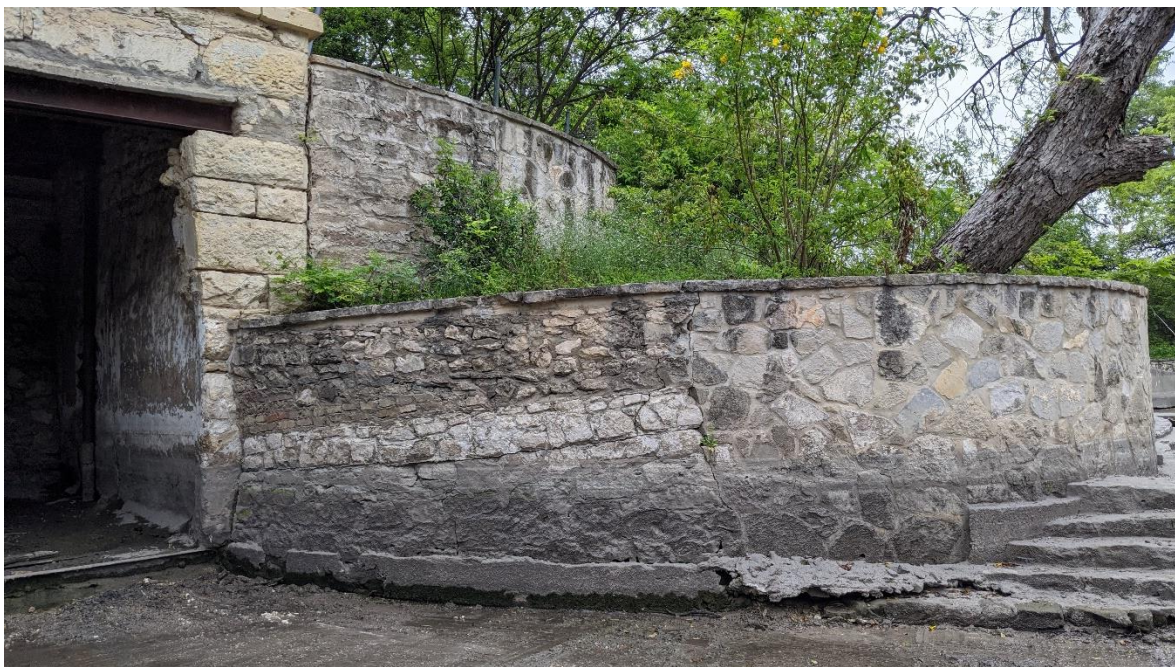
Figure 22: Tree No. 142, 20-inch Pecan proposed to be removed. Proximity to Cultural Resources: 6 inches to 5 feet
