HISTORIC AND DESIGN REVIEW COMMISSION

April 19, 2023

HDRC CASE NO: 2022-091
COMMON NAME: Brackenridge Park, Lambert Beach
ADDRESS: 3700 N ST MARYS ST
LEGAL DESCRIPTION: NCB A49 PART OF A-2, A-4, A-52 (208 AC)
ZONING: R-6,HS
CITY COUNCIL DIST.: 2
LANDMARK: Individual Landmark
APPLICANT: Jamaal Moreno/City of San Antonio, PWD
OWNER: City of San Antonio
TYPE OF WORK: Phase 1 of FY17 Bond Improvements to Lambert Beach Area
APPLICATION RECEIVED: April 04, 2023
60-DAY REVIEW: Not applicable due to City Council emergency orders
CASE MANAGER: Cory Edwards
REQUEST:

The applicant is requesting a Certificate of Appropriateness for approval to construct improvements to the Lambert Beach area in Brackenridge Park as Phase I of the FY17 Bond Project. Request items include:

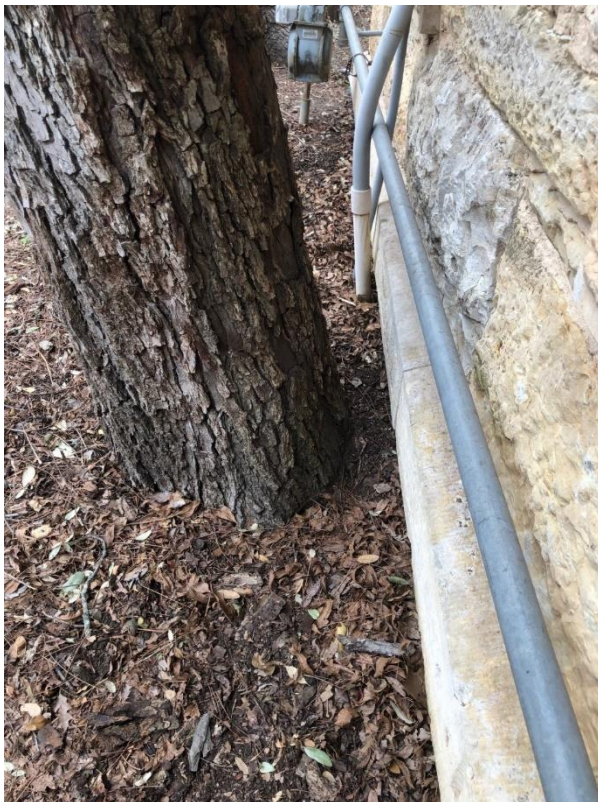
Figure 24: Tree No. 107, 18-inch Black Walnut proposed to be removed. Proximity to Cultural Resource: 3 inches.
