HISTORIC AND DESIGN REVIEW COMMISSION

April 19, 2023

HDRC CASE NO: 2022-091
COMMON NAME: Brackenridge Park, Lambert Beach
ADDRESS: 3700 N ST MARYS ST
LEGAL DESCRIPTION: NCB A49 PART OF A-2, A-4, A-52 (208 AC)
ZONING: R-6,HS
CITY COUNCIL DIST.: 2
LANDMARK: Individual Landmark
APPLICANT: Jamaal Moreno/City of San Antonio, PWD
OWNER: City of San Antonio
TYPE OF WORK: Phase 1 of FY17 Bond Improvements to Lambert Beach Area
APPLICATION RECEIVED: April 04, 2023
60-DAY REVIEW: Not applicable due to City Council emergency orders
CASE MANAGER: Cory Edwards
REQUEST:

The applicant is requesting a Certificate of Appropriateness for approval to construct improvements to the Lambert Beach area in Brackenridge Park as Phase I of the FY17 Bond Project. Request items include:

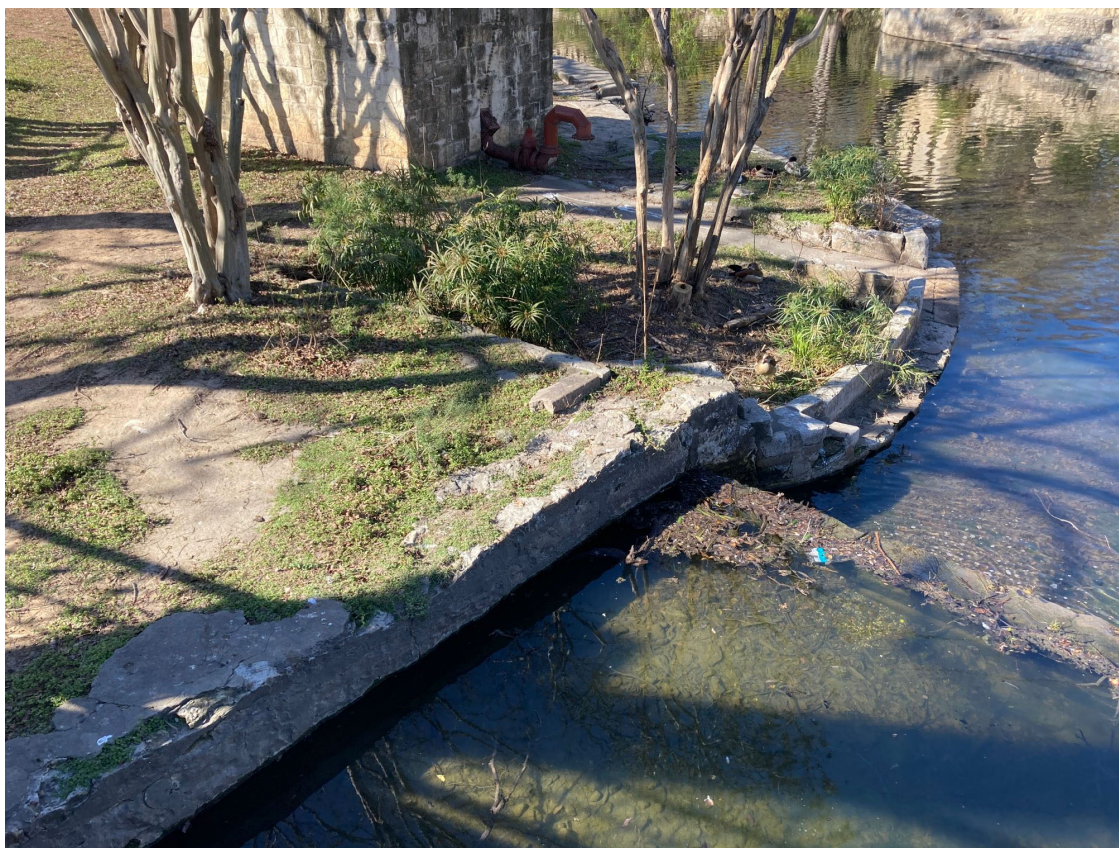
View facing
northwest

Resource B1-68 is a slew and river channel wall constructed at an unknown date. A slew, or slough, is a shallow wetland adjacent to a larger body of water such as a river. The Lambert Beach slew is formed behind the dam (B1-6) and is held by adjacent river channel retaining walls. The walls are constructed of uncoursed flat limestone and are in very poor condition. A metal fleur-de-lis is embedded in the wall's surface.

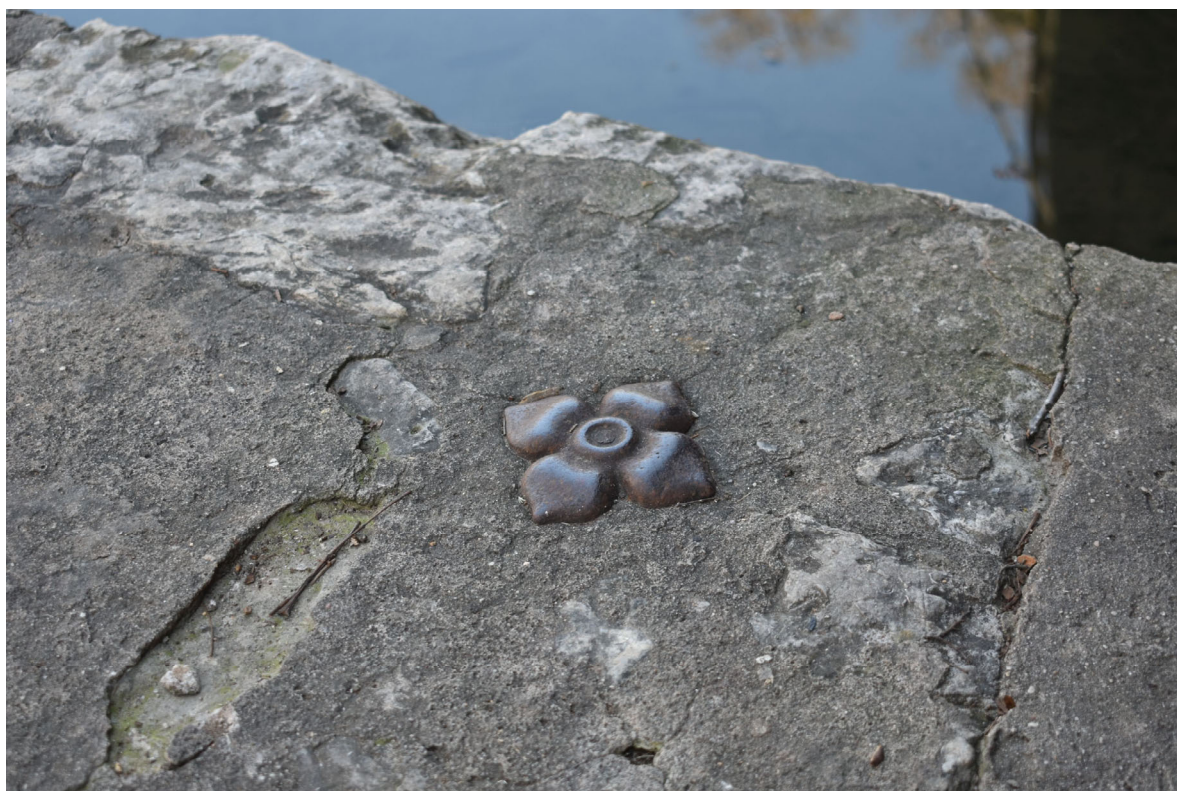
Detail of metal fleur-de-lis;
view facing east

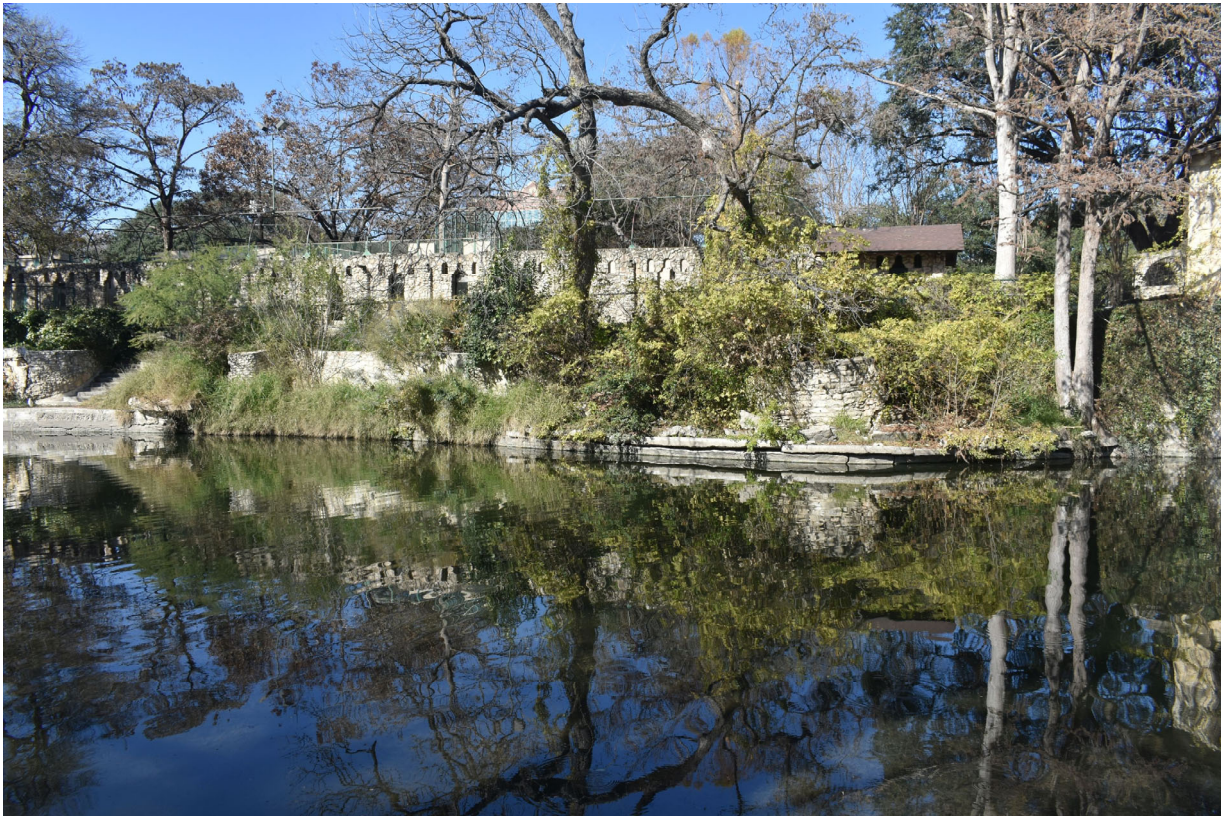
Overview, Pump House 1 on right, Staircase 3 on left; view facing north

Resource B1-72 are a stone wingwall attached to Pump House #1 and a river channel wall both constructed in 1877 as part of the Pump House #1 project. The wingwall is currently obscured by overgrowth and its condition is unknown. The river channel wall extends from Pump House #1 downriver to the first set of steps leading to the river. The wall is constructed of stone masonry with a concrete cap walkway. The walkway appears to be in very poor condition with sections that appear to have separated from the underlying wall. This river channel wall is partially obscured by overgrowth, is not accessible, and appears to be partially covered by the crumbled remnants of the adjacent riverbank wall B1-73.

Although the wingwall is not visible there is no evidence indicating its historic integrity has been compromised and its contributing status to the Brackenridge Park Historic District is affirmed. The river channel wall must be considered in context of its function and the expectation that such resources are expected to wear with the action of the river. Although the wall's walkway is currently in a state of disrepair and is partially overgrown, these conditions are reversible. Neither the resource's design nor its relationship with surrounding historic resources has changed and it is still capable of communicating its role as both a recreational and engineering feature. The resource retains its original materials and is clearly distinct from related historic resources B1-2, B1-70, B1-71, and B1-73. The resource retains sufficient physical and historical integrity under Criterion A in the area of Entertainment/Recreation for its association with the development and design of Brackenridge Park and Criterion C in the area of Engineering for its association with water delivery to communicate its historical significance. Its contributing status to the Brackenridge Park Historic District is affirmed.

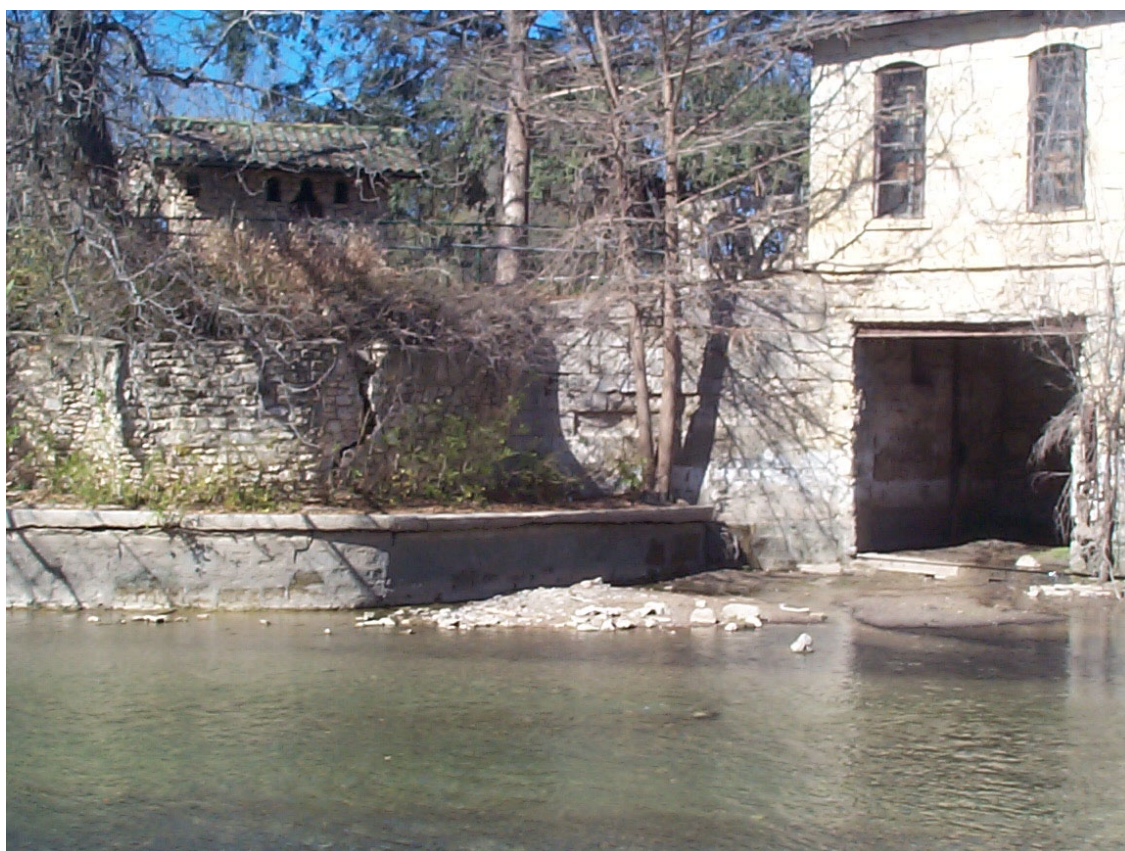
ca. 2002 photograph of
wingwall and river channel
wall; City of San Antonio
Public Works Department

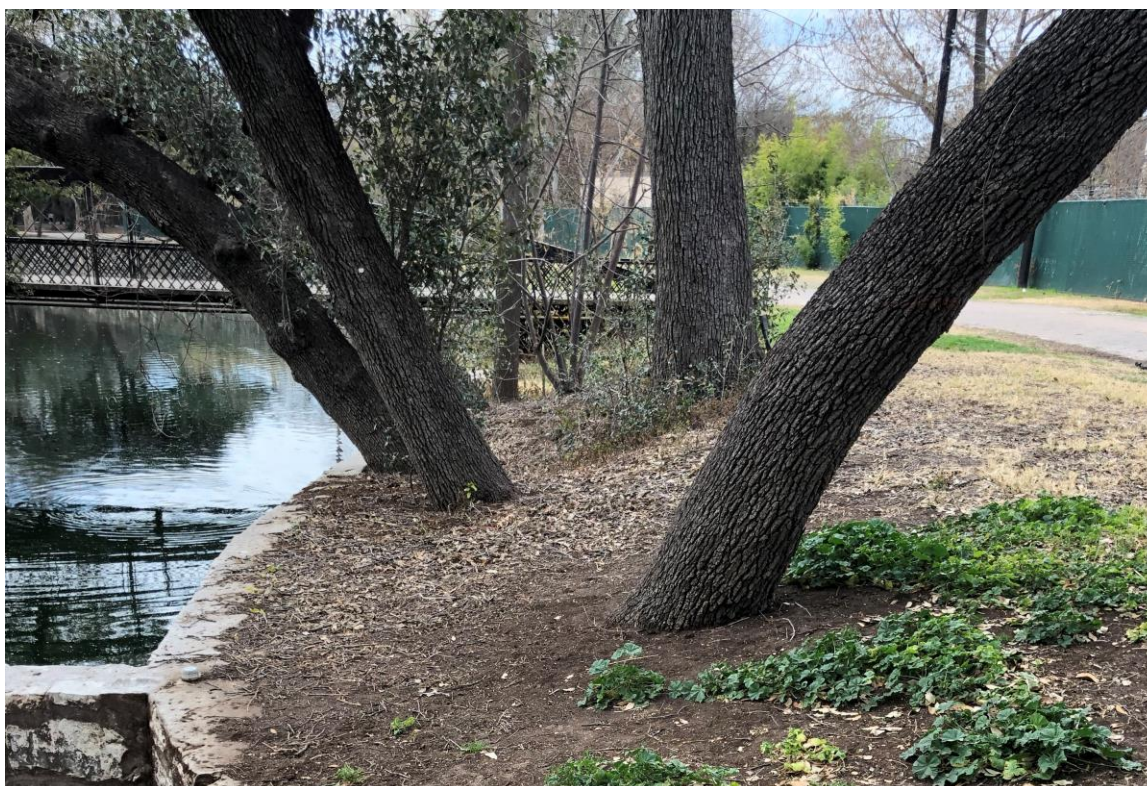
*Figure 5: Foreground – Tree No. 99, 16-inch live oak proposed to be removed. Proximity to Cultural Resource: Less than 5 feet.
Background – (L to R) Tree No. 97, Tree No. 98, both proposed to be removed, Tree No. 96 proposed to be preserved.*

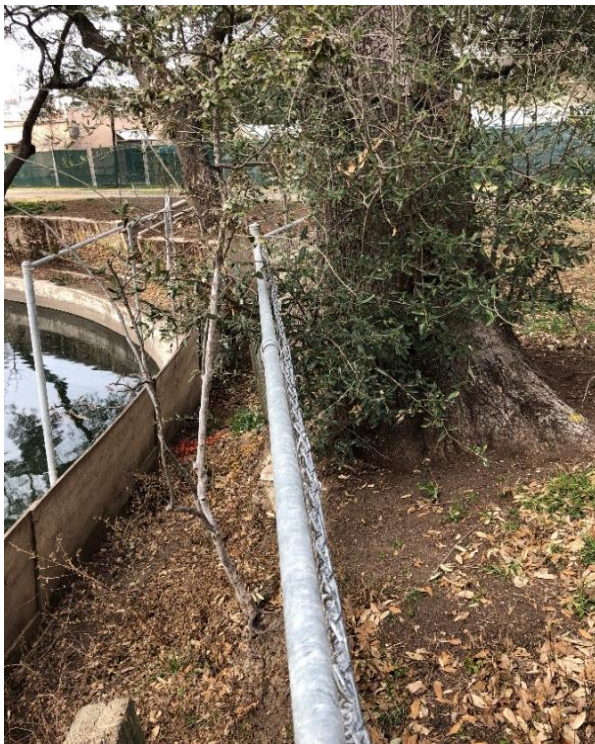
Figures 8 and 9: Tree No. 101, 44-inch Live Oak proposed to be relocated approximately 15-20 feet further away from river than current location. Proximity to original position of Cultural Resource (demolished): less than 18 inches.

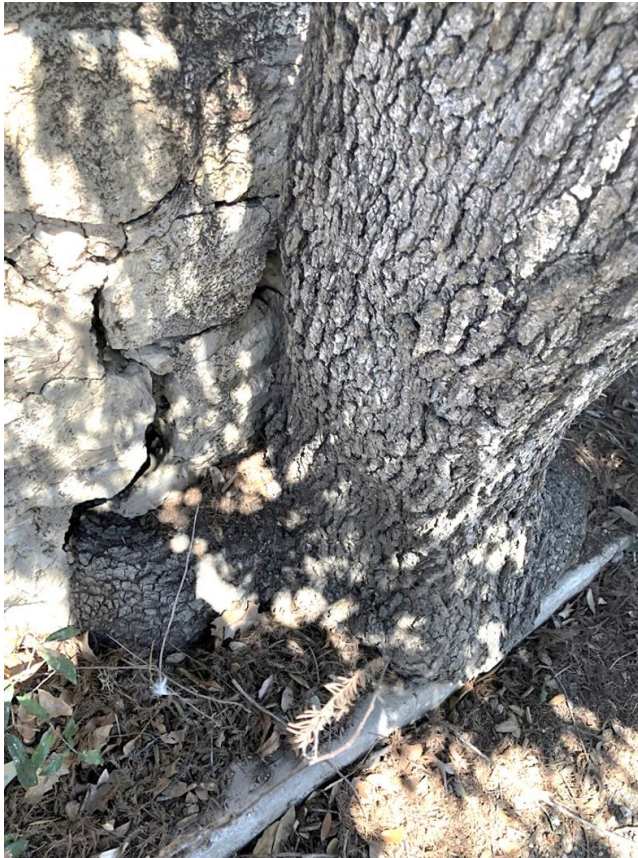
Figure 13: Tree No. 135, 15-inch Live Oak proposed to be removed. Proximity to Cultural Resource: 0 inches.

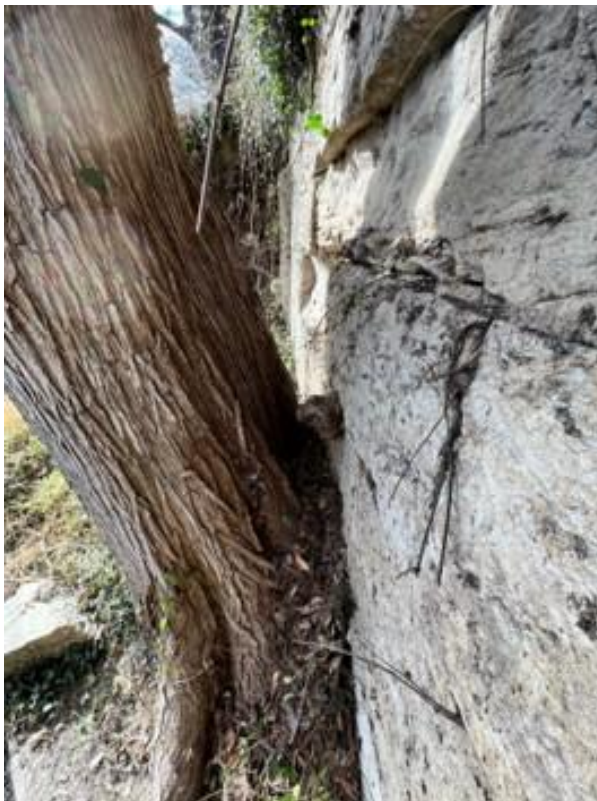
Figure 19 and 20: Tree No. 141, 27-inch Bald Cypress proposed to be removed. Proximity to Cultural Resource: 0 inches.
