HISTORIC AND DESIGN REVIEW COMMISSION

HDRC CASE NO: 2023-327
ADDRESS: 1023 N PINE ST
LEGAL DESCRIPTION: NCB 522 BLK 15 LOT 1 TO 18
ZONING: RM-4, H
CITY COUNCIL DIST.: 2
DISTRICT: Dignowity Hill Historic District
APPLICANT: Brian Sowell/WestEast Design Group, LLC
OWNER: Cathleen Crabb/CITY OF SAN ANTONIO
TYPE OF WORK: Demolition of four (4) structures and conceptual review of a schematic plan
APPLICATION RECEIVED: July 26, 2023
60-DAY REVIEW: Not applicable
CASE MANAGER: Rachel Rettaliata

1. A Certificate of Appropriateness for approval to demolish four (4) structures at the Ella Austin campus.
2. Conceptual approval of schematic replacement plans.

Ella Austin Community Center

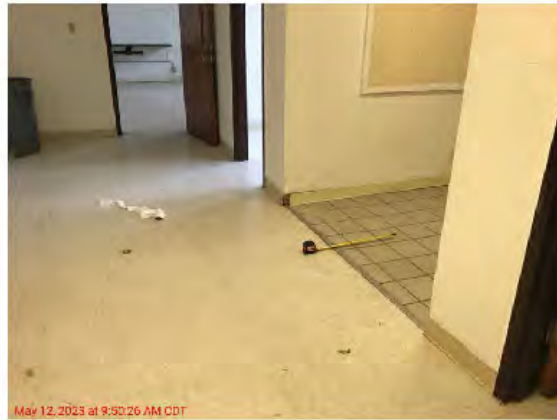
Issue #5 – OPEN (1/1)

Multiple foundational valleys w/in room from 1/2" approx to 2" + Red masonry 5 1/4-1/2" x 12wide cmu

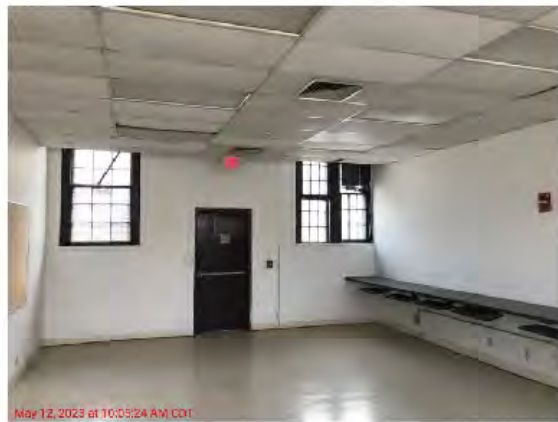
Issue #11 – OPEN (1/1)

Slab warped right to left or plan south high plan north low

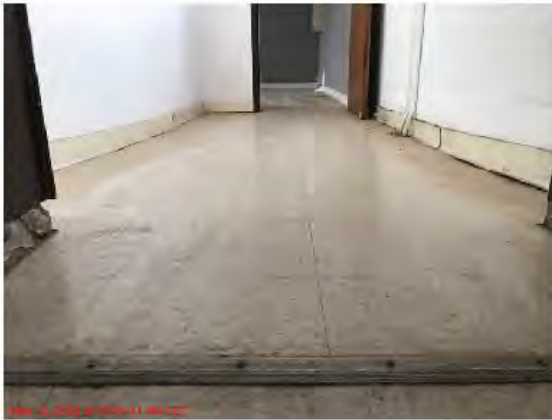
Issue #12 – OPEN (1/1)

15-16" deep joists at 3'-6" +/- spacing

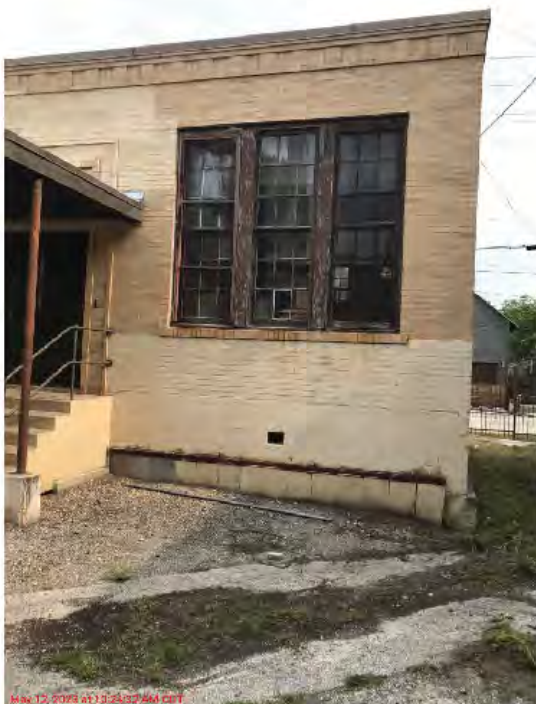
exposed earth retainers and beam soffit. looks to be post installed(around time of construction completion)

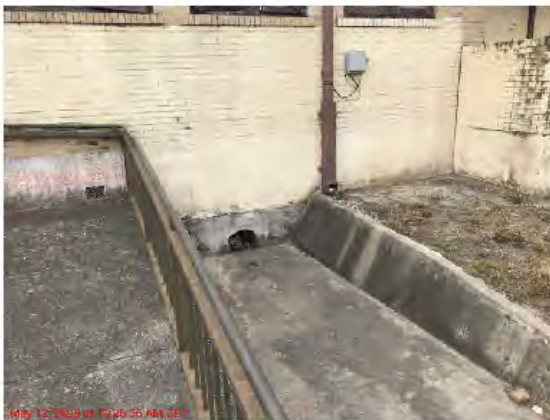
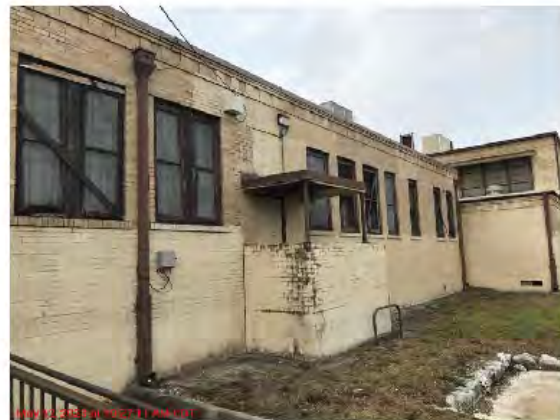
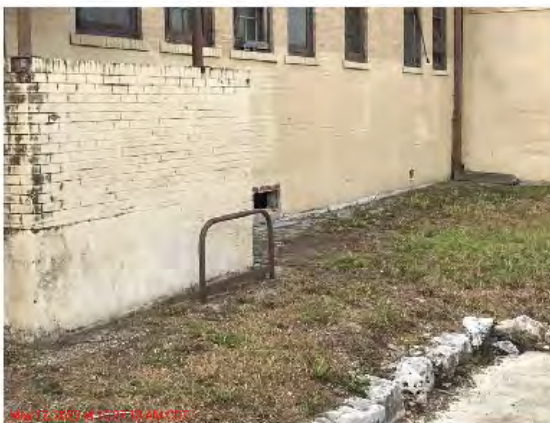
culvert to drain opening IN(?) to building crawlspace visual appears to show this. open area way further down building.
