# HISTORIC AND DESIGN REVIEW COMMISSION

**HDRC CASE NO:** 2022-563  
**ADDRESS:** 338 ARMY  
**LEGAL DESCRIPTION:** NCB 3855 BLK 1 LOT 6 & W 25 FT OF 5  
**ZONING:** RM-4 CD, H  
**CITY COUNCIL DIST.:** 2  
**DISTRICT:** Westfort Historic District  
**APPLICANT:** Read Ebersole/EBERSOLE READ & REBECCA  
**OWNER:** Read Ebersole/EBERSOLE READ & REBECCA  
**TYPE OF WORK:** Historic Tax Certification & Verification  
**APPLICATION RECEIVED:** November 28, 2022  
**60-DAY REVIEW:** Not applicable due to City Council Emergency Orders  
**CASE MANAGER:** Rachel Rettaliata

The applicant is requesting Historic Tax Certification & Verification for the property at 338 Army.

# Blue Knight Home Inspections, P.C.

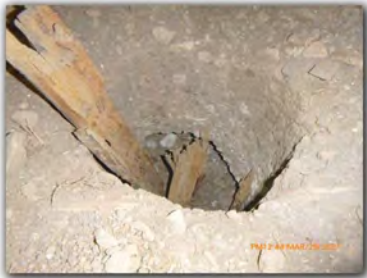
Hole located in crawl space where a pole was present.

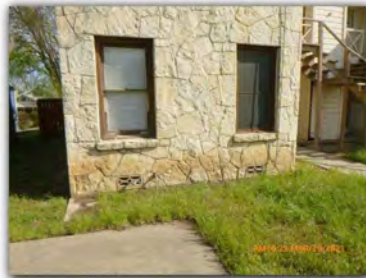
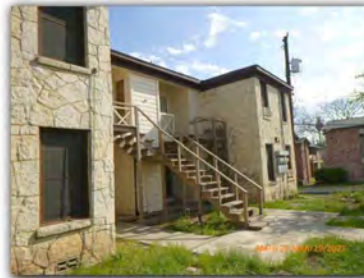
High grade along back side.

There are signs of water intrusion in crawl space, the company that did the foundation work should make sure grading is proper especially if they are going to warranty work. So grading needs to be corrected so that water is not allowed to enter crawl space.

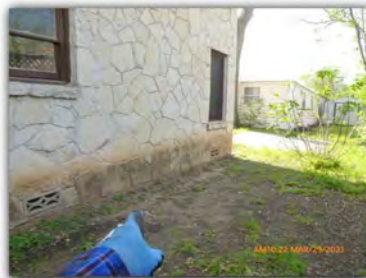
Erosion present along right side.

Would highly suggest correcting drainage as improper drainage can cause foundation problems and void foundation warranties.

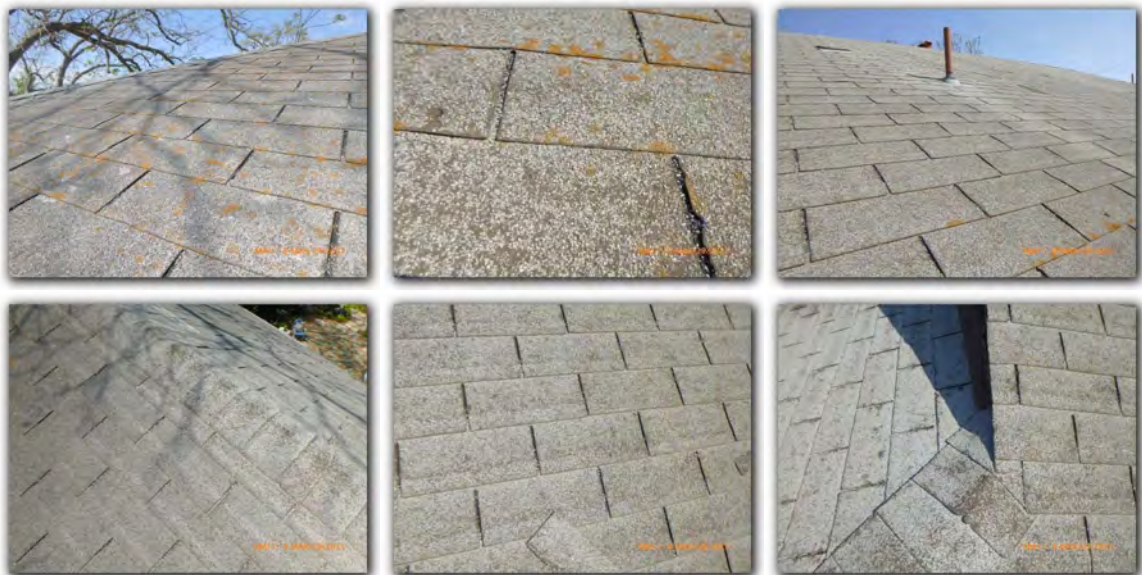
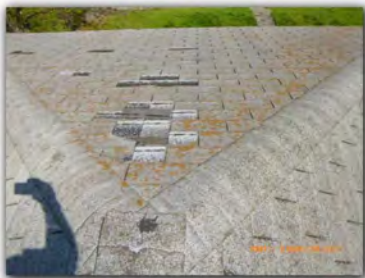
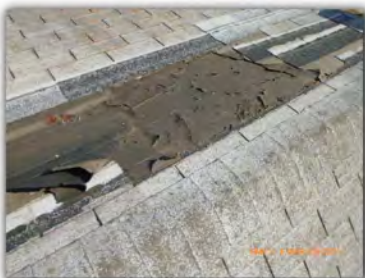
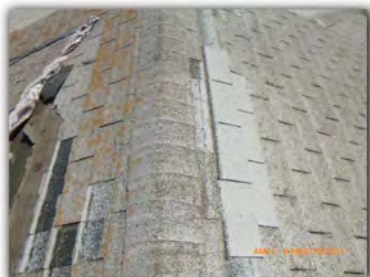
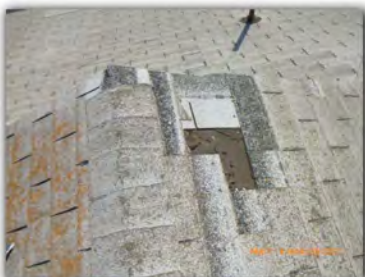
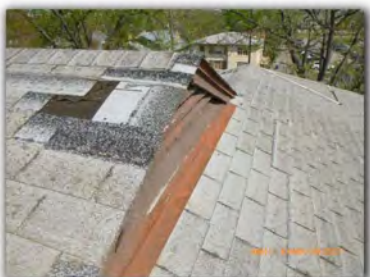
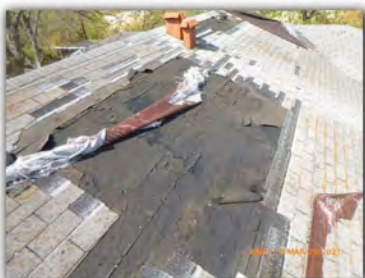
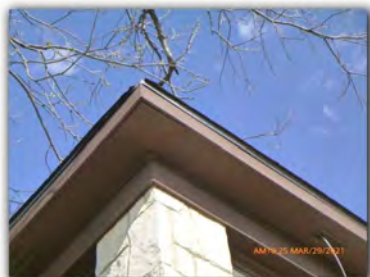
Roof is considered to be in Poor condition with major deficiencies.

Roof must be replaced, large amount of singles are missing, damaged and considerable amount of granular loss.

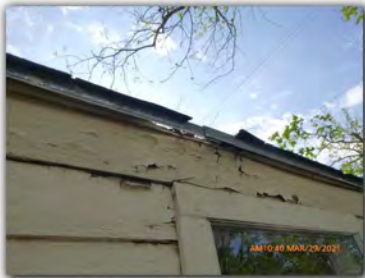
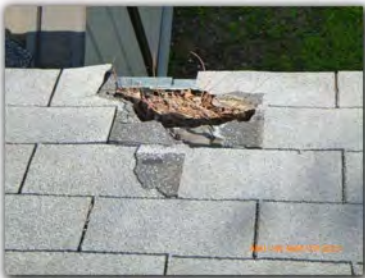
**Roof on detached shingles.**

Damaged shingle on back left side.

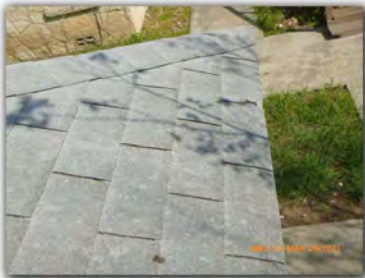
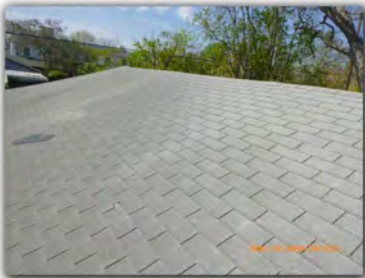
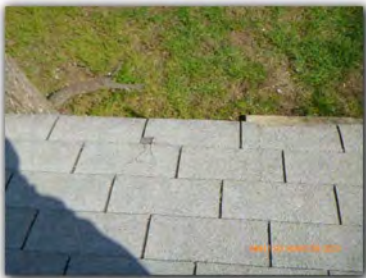
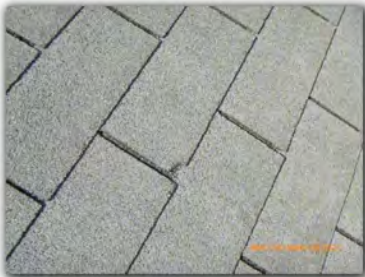
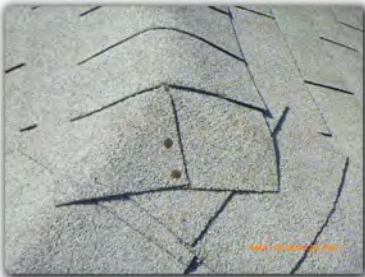
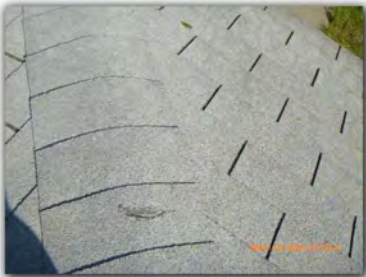
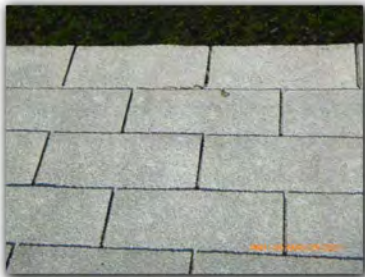
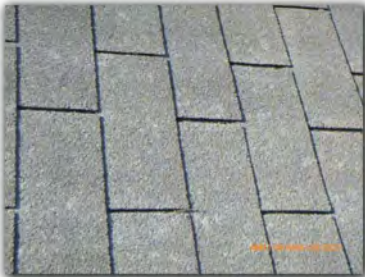
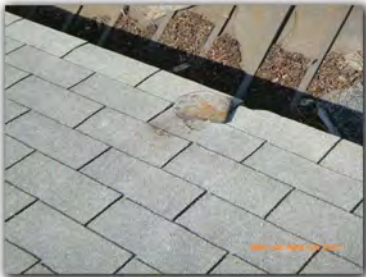
Roof is older, brittle and has granular loss present. Damage present from storms is present.

**ROOFING CONTRACTOR SHOULD BE CONSULTED PRIOR TO PURCHASE.**

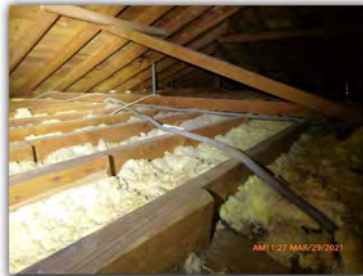
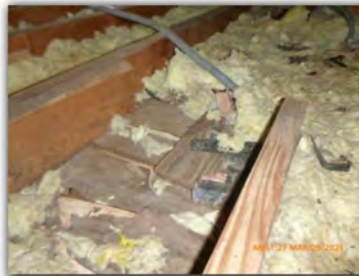
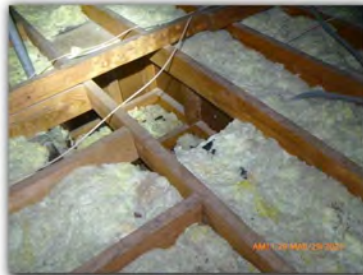
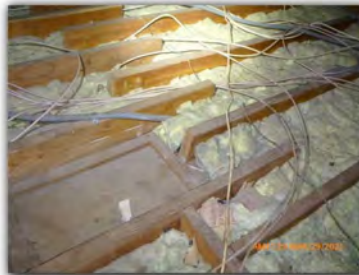
The level of ventilation should be improved, located soffit vents and just two gable vents. It is generally recommended that one square foot of free vent area be provided for every one hundred and fifty square feet of ceiling area. Proper ventilation will help to keep the house cooler during warm weather and extend the life of roofing materials. In colder climates, it will help reduce the potential for ice dams on the roof and condensation within the attic.

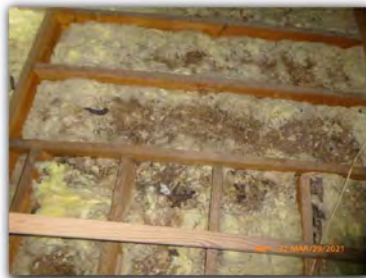
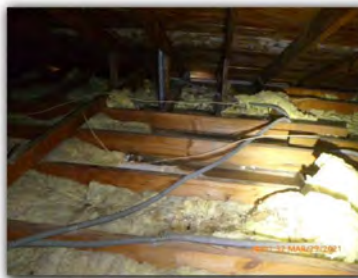
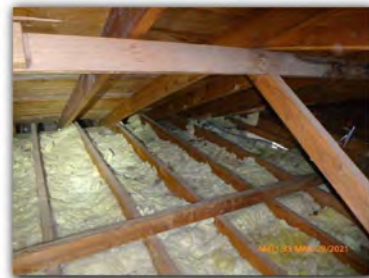
Insulation is missing, matted down and contaminated with urine and large piles of feces from vermin activity, highly suggest removing feces and insulation and sanitizing area prior adding new insulation.

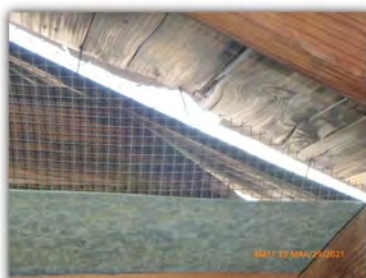
Screen is damaged and open, so vermin can access attic.

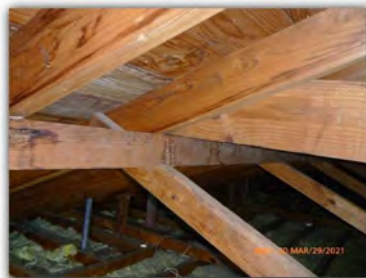
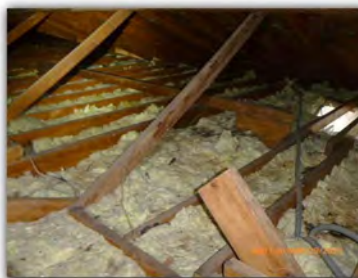
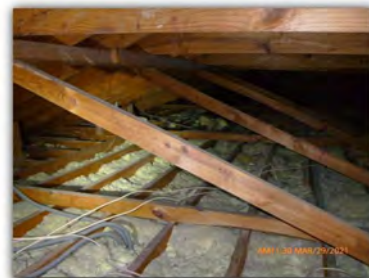
Party wall (fire stop) is not present in attic area, party walls are required as they help to slow the spread of fire from one unit to another.

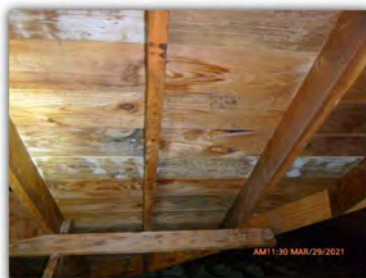
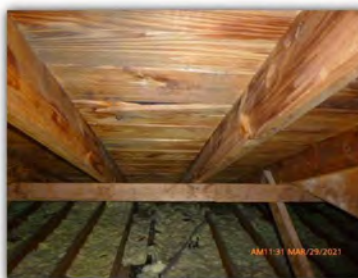
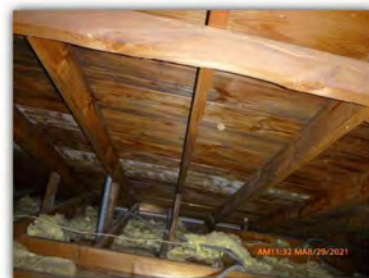
The purlins of the roof structure are under sized, ideally they should be the same size as the rafter they support, at time of construction this was allow, not allowed by today's standards. Missing adequate amount of purlin supports.

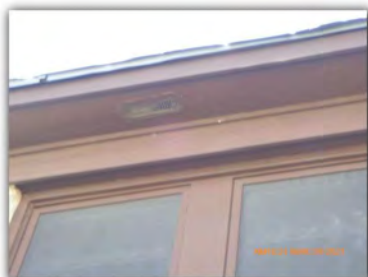
Soffit vents are clogged in some areas.

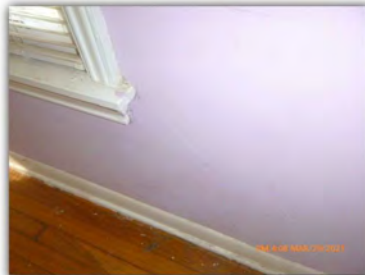
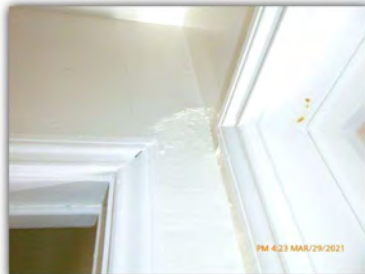
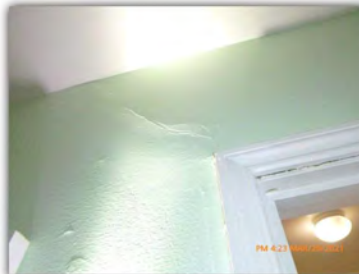
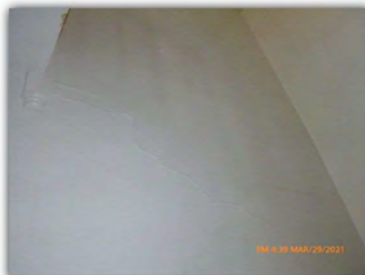
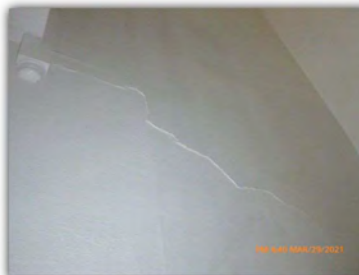
Settlement / movement cracks present throughout.  
Unit #1

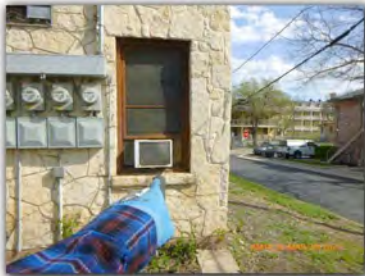
Dry rot present at back window.

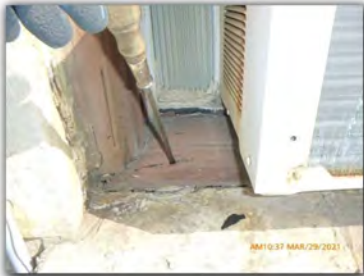
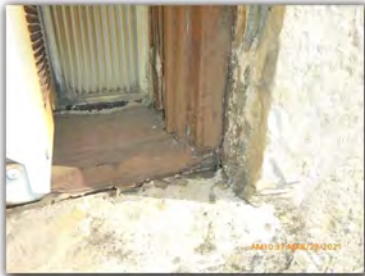
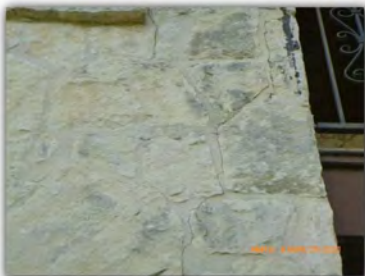
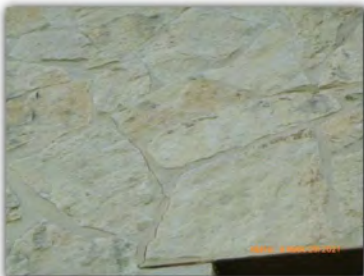
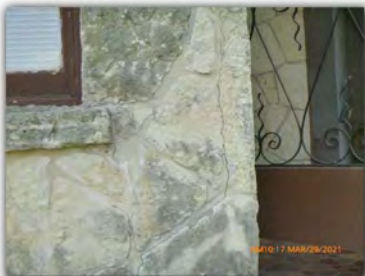
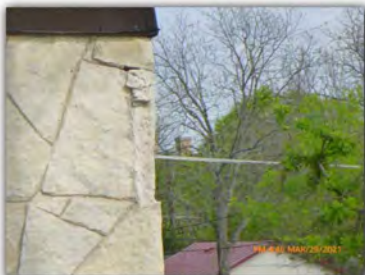
Some signs of settlement movement detected.

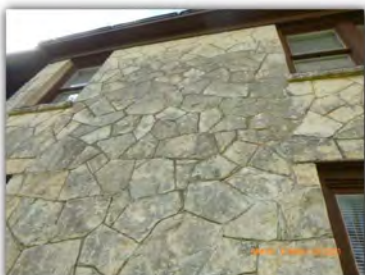
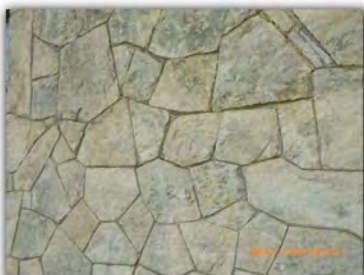
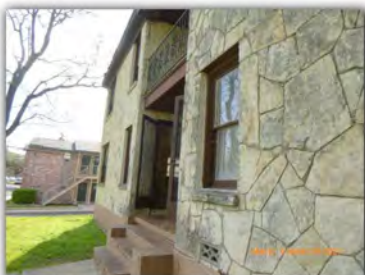
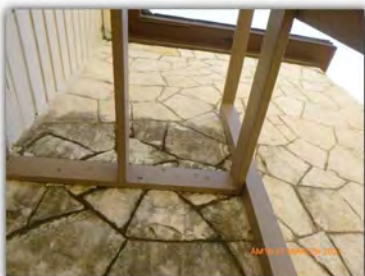
Suggest power washing stone as needed, some areas are missing grout, suggest re-pointing as

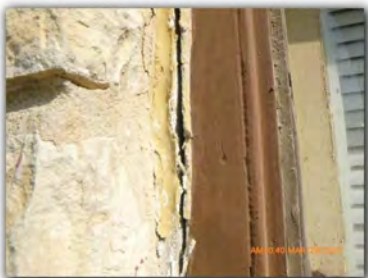
Suggest sealant around windows.

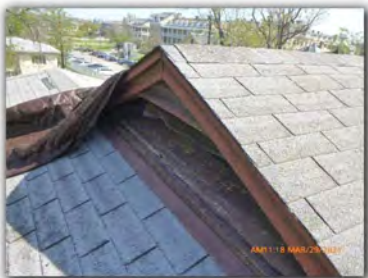
Dry rot present at gable vent trim, suggest repairing / replacing as needed.

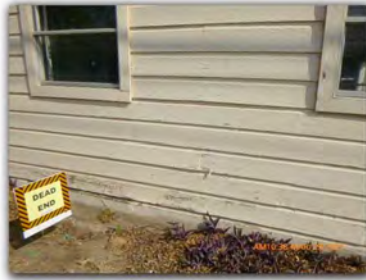
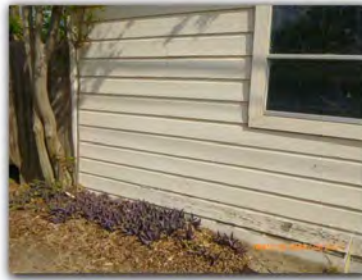
Siding on detached unit needs refinishing.

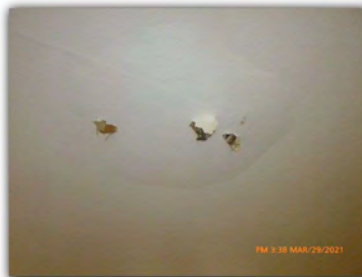
Unit #2 Bubble present at entry, this unit is under unit #4, which has a major water leak that appeared to come from roof.

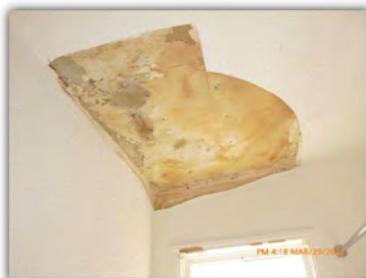
Unit #1 Microbial growth and missing texture in bathroom on ceiling.

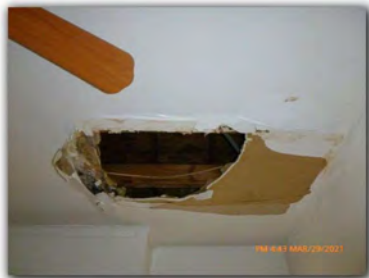
Large gaping opening in drywall.  
Unit #3

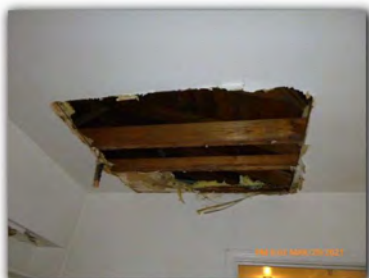
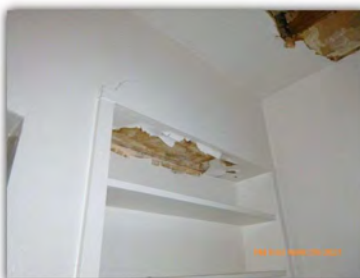
Unit #4 Large section of drywall missing and microbial growth close by at shelf area.

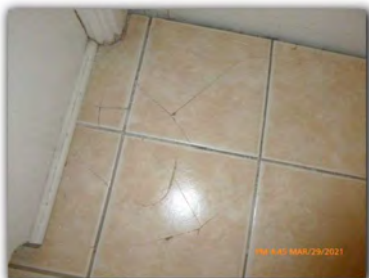
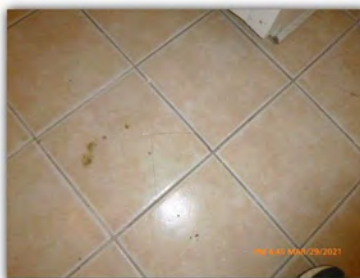
Cracked tiles at kitchen area of unit #3, may not of had backer board installed decking.

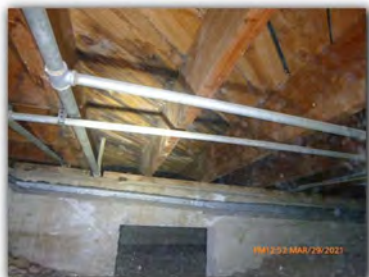
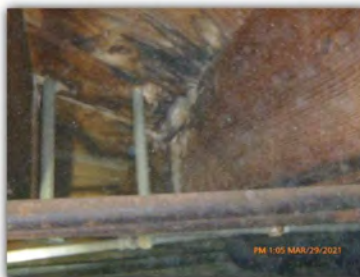
Sub-flooring is water damaged under both bathrooms.

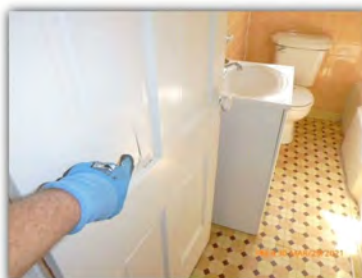
Unit #1 does not latch at bathroom and door is damaged.

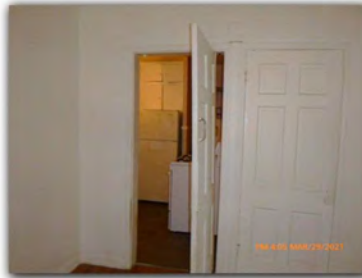
Unit #2 Butlers door off top spindle (does not open and close properly).

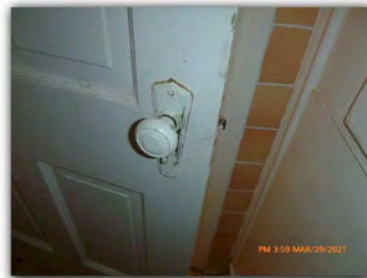
Hardware is older.

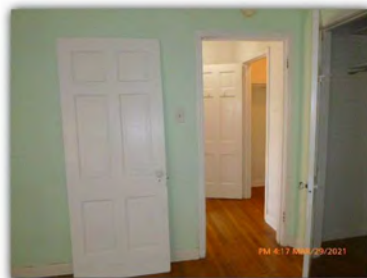
Bedroom entry at unit #1 entry not installed.

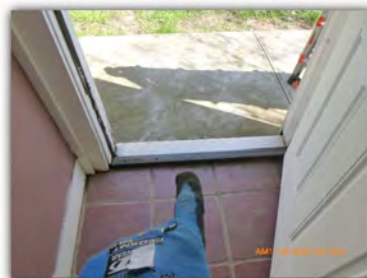
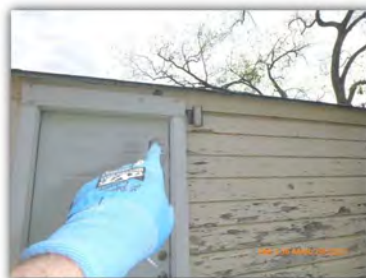
Unit #5 Threshold is loose and not properly supported and door rubs on frame.

All are missing weather stripping and door sweeps.

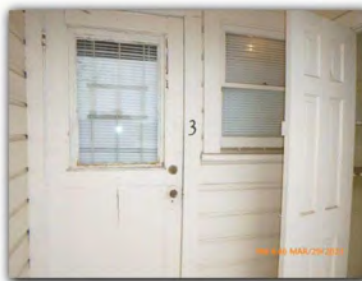
Back door has water damage and is hard to open and close at unit #3.

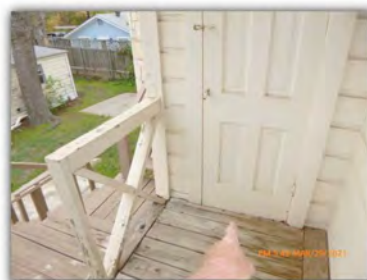
Unable to open balcony closet door next to unit #4.

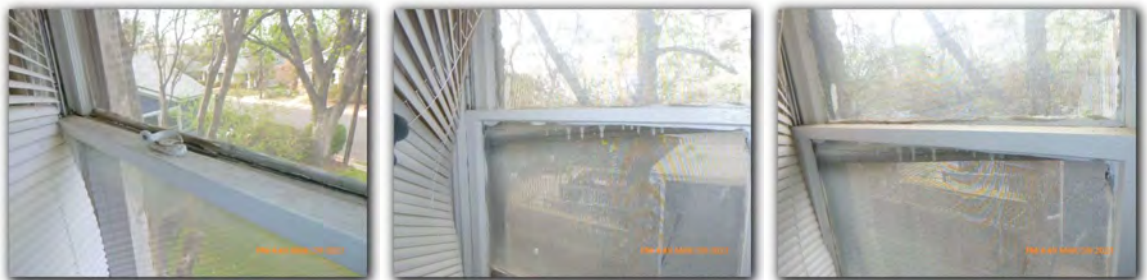
Unit#2

Several cracked windows are present at unit #3.  
Missing locks.

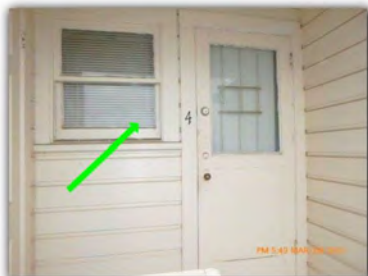
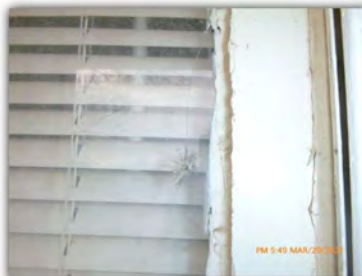
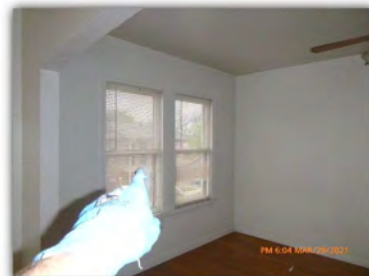
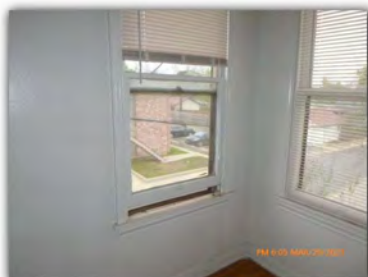
Unit#3

Cracked window at back bedroom and kitchen window and bedroom.

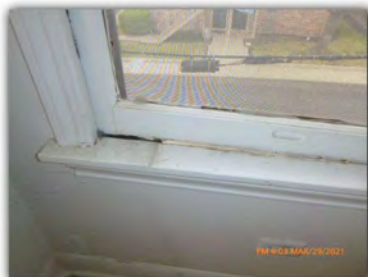
Front living room window does not close all the way.

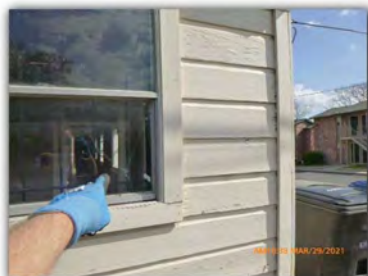
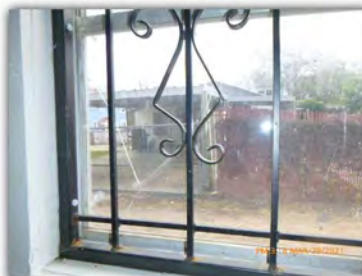
Unit#4

Cracked window at back bedroom.

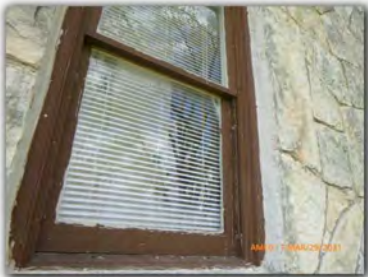
Safety glass etchings were not observed on the glass within the windows at back doors and all windows next to back doors & unit #3 & unit #1 next to front entry and front balcony door. This glass is required for windows close to the floor or in hazardous locations and is generally identified by an etching in the corner of the glass pane.

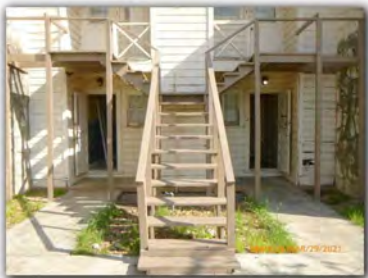
Risers on steps should be enclosed to prevent tripping.

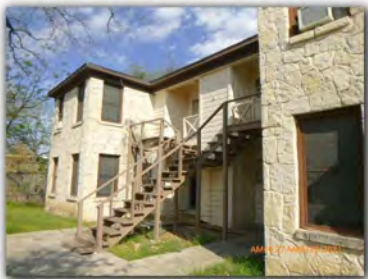
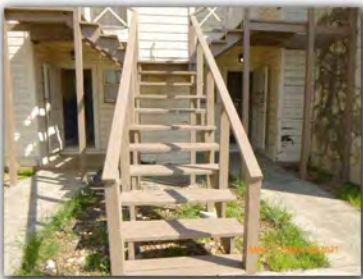
Recommend steps have grippable hand rails and hand stop at ends and spindles no more than 4" apart.

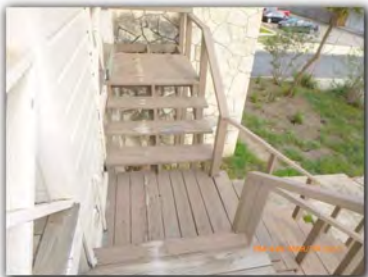
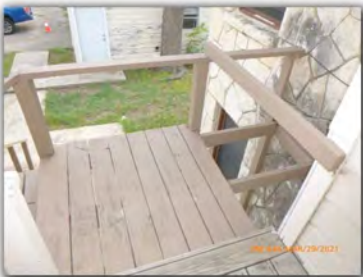
Highly suggest replacing back decking / balcony landing areas and steps as they are not safe, openings. Missing grippable hand rails.

Licensed contractor should give estimate of replacement.

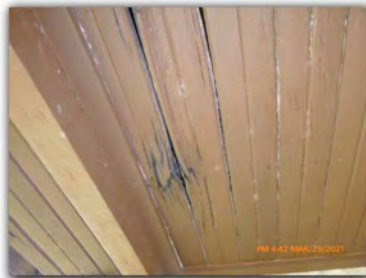
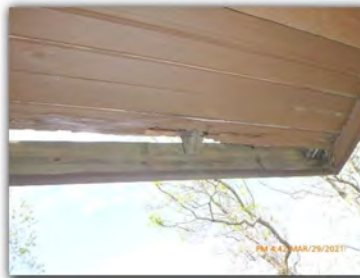
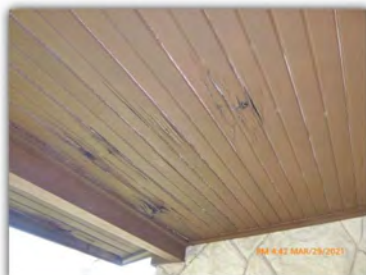
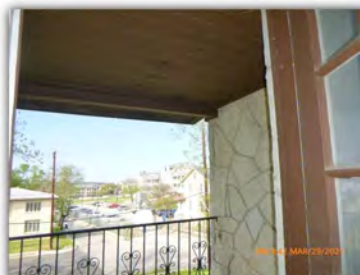
Water damage present on balcony ceiling

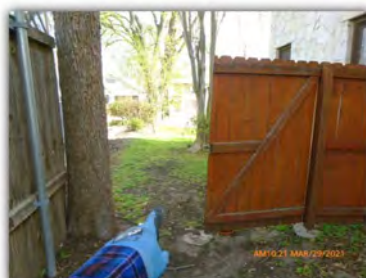
Missing gate on right side.

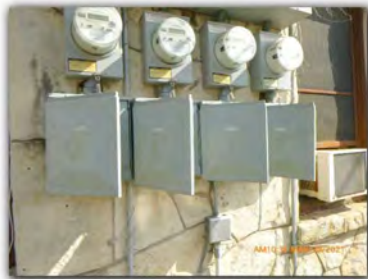
Numbering on panels has faded.

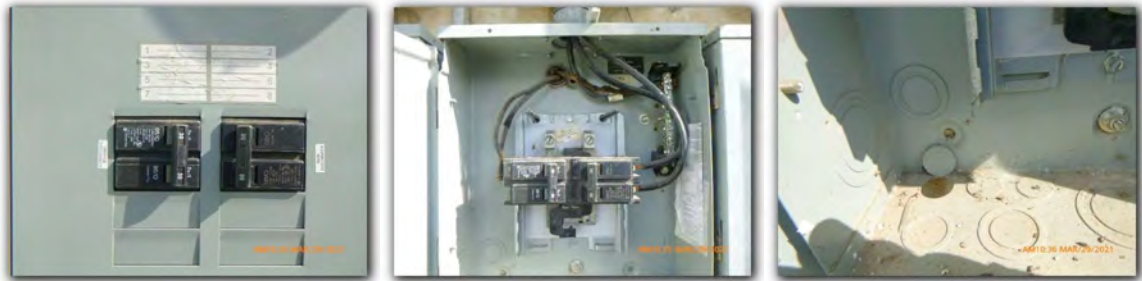
Panel #4:

Opening should be sealed.

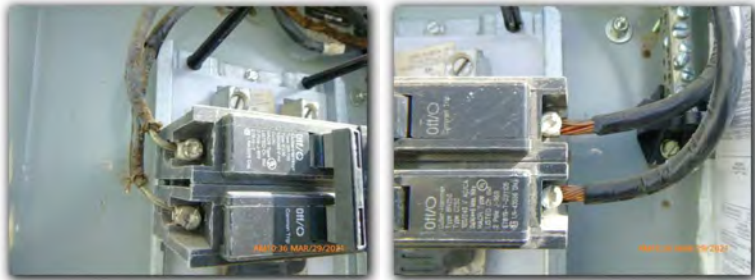
Sheathing on wire trimmed to mush.

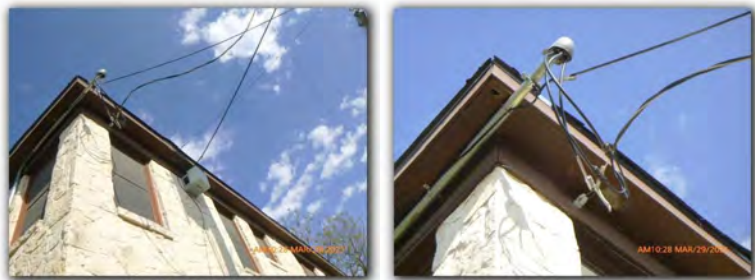
Mast should extend past roof through eve, supply wire can rub on edge of metal drip edge flashing and possibly electrify flashing, this could be dangerous.

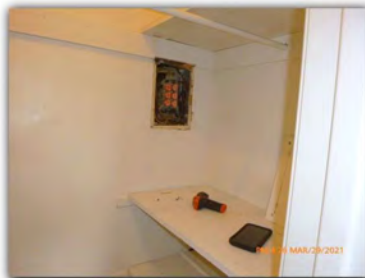
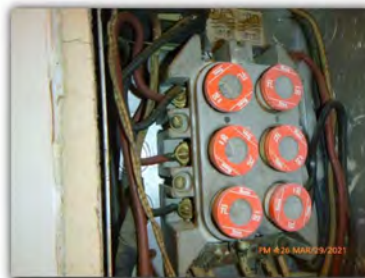
Panels are located in clothes closets, this location is not longer allowed, however not required to re-locate unless replacing panel.

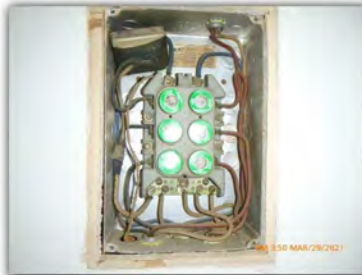
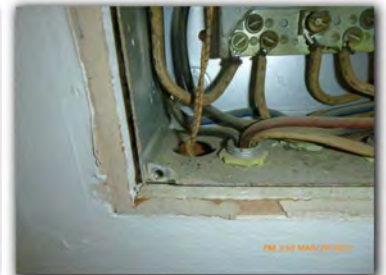
Unit#2

Open knockout needs to be filled.

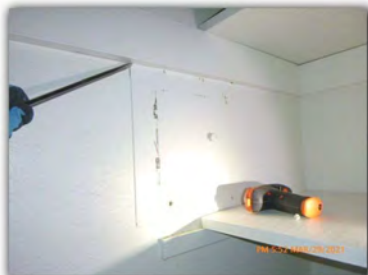
Unit#3

Not able to remove cover as it is stuck under shelf.

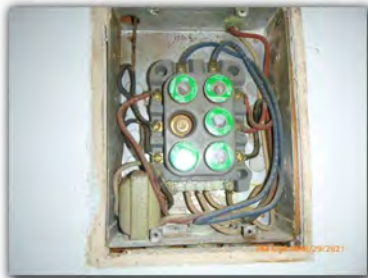
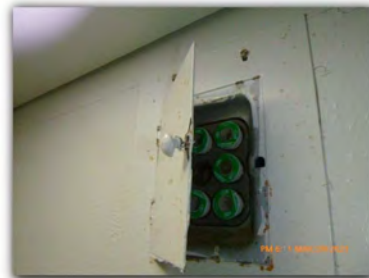
Door knob is damaged at sub panel.

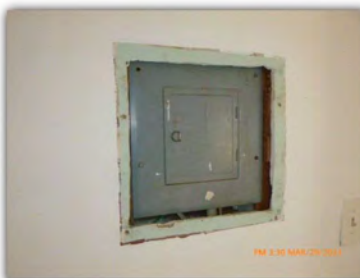
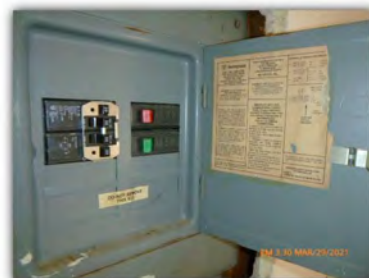
Unit#5

Unit is in an improper location (not properly accessible installed over a commode). Drywall should be trimmed back.

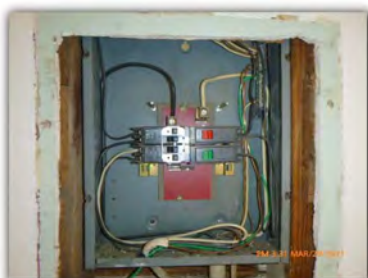
White wire need to be labeled.

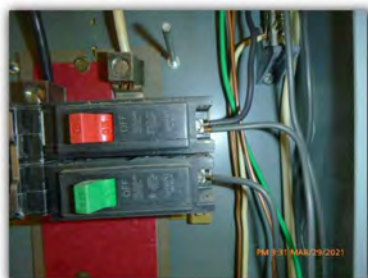
Double lugging (more than 1 wire to a breaker), this can cause overheating of breakers and can be corrected by adding a breaker.

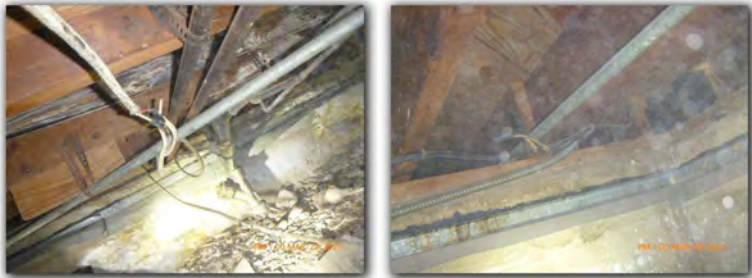
Open wires splices should be run in junction boxes.

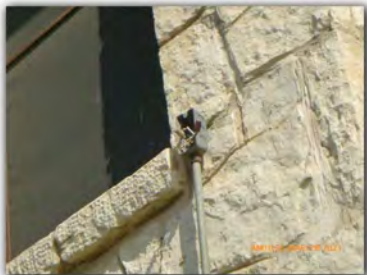
Missing junction box cover.

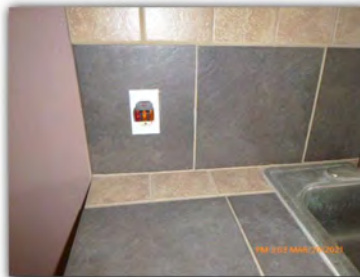
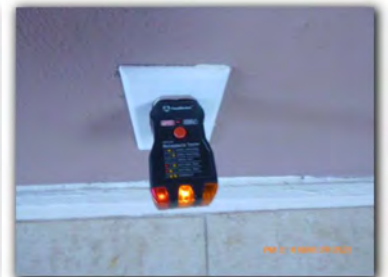
Open ground receptacles and reverse polarity at unit #5 throughout.

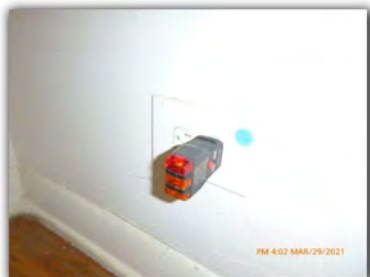
Reverse polarity at unit #2.

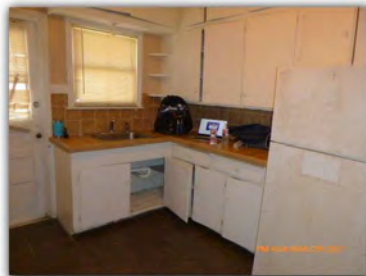
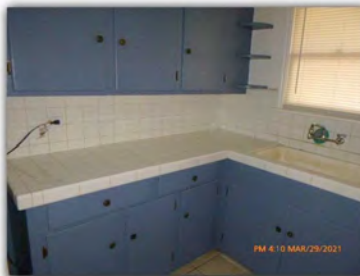
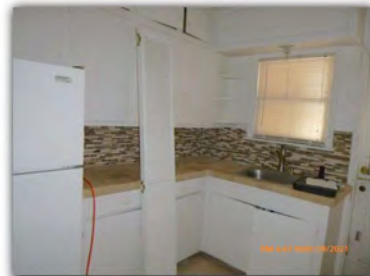
Missing adequate number of receptacles at kitchen area (all units).

6 / 12 rule not in place at all bedrooms of all units (lacking proper number of receptacles).

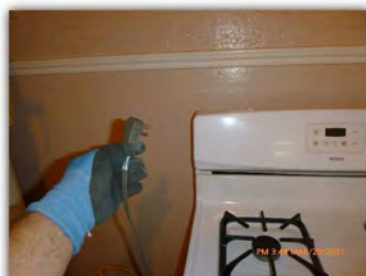
Missing receptacles for all stoves in all units (some are using extension cords).

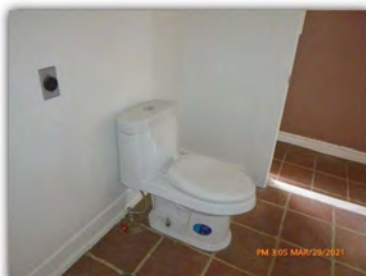
220 receptacle at unit #5 were dry goes is very close to commode.

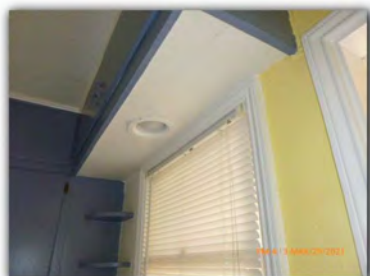
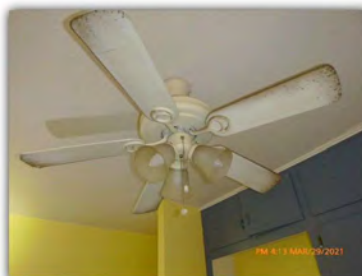
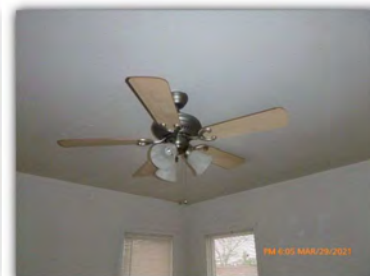
There are several light fixtures with burnt out lights, suggest replacing all lights and review fixtures during walk through.

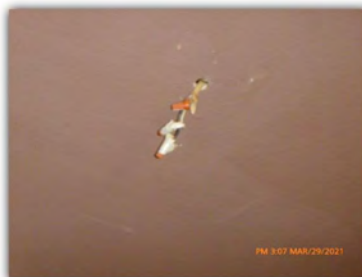
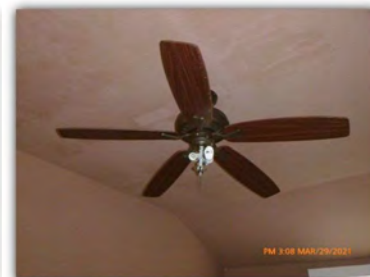
Not power to ceiling fans and missing fixture at unit #5.

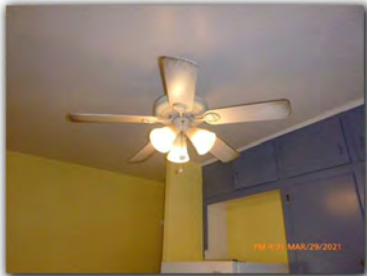
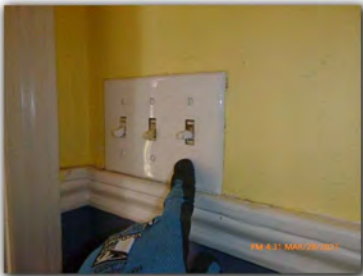
Unit #1 ceiling fan light switch damaged present at kitchen.

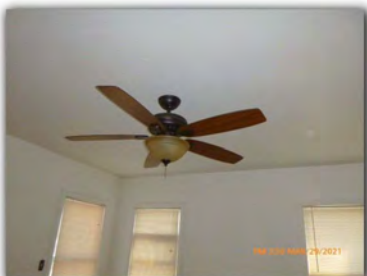
Unit #2 ceiling fan not functioning properly.

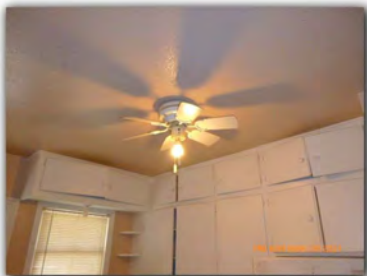
Missing ceiling fan cover at unit #2.

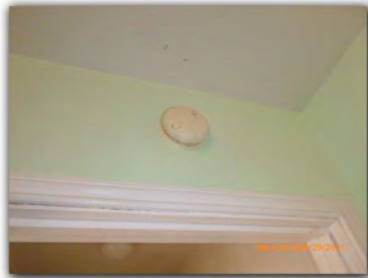
Smoke detectors were missing at most bedrooms & entry hall next to bedrooms and missing carbon monoxide detectors.

Smoke detectors appear to be older than 10 years should be replaced with new alarms.

**LICENSED ELECTRICIAN SHOULD BE CONSULTED PRIOR TO PURCHASE.**

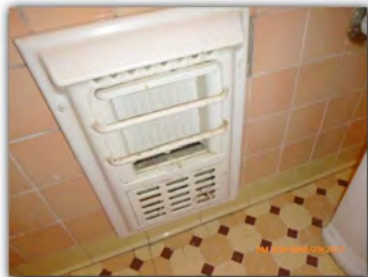
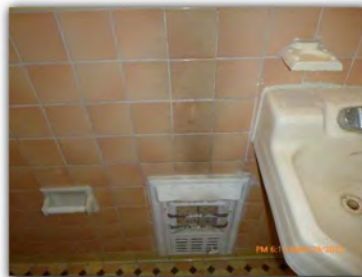
Wall units (in bathrooms) were not tested, it is highly recommended to cap off gas line and remove heater, has these heaters are not safe (open flame and burn up oxygen in the room without proper ventilation).

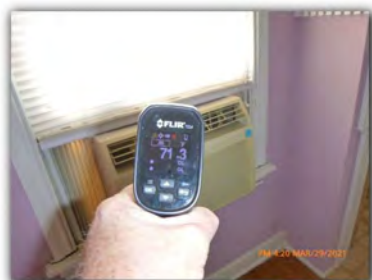
Unit #1 both units do not function properly.

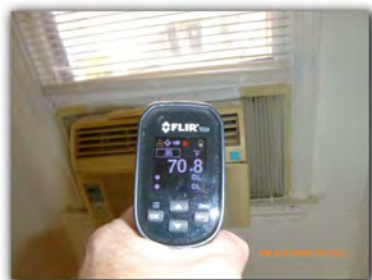
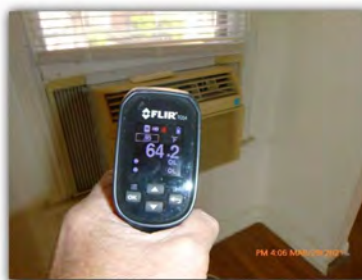
Unit #2 window unit functions in living room, sound loud.

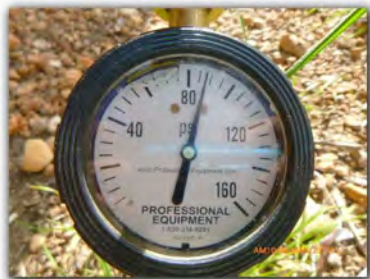
*Static water pressure reading:* 87(PSI) Pressure per square inch (pressure should be between 40 and 80 PSI)

Pressure test exceeds 80 PSI - reduction valve is needed, if not present (did not locate one at time of inspection). Note: when reduction valves are installed code requires the addition of expansion tanks on water heaters.

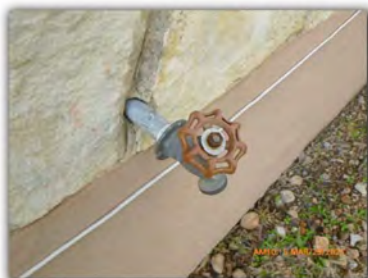
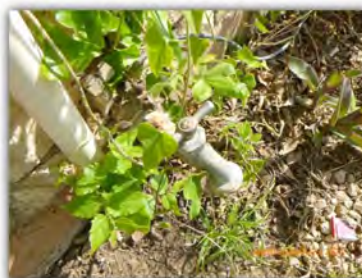
Hose bibs are missing back flow prevention (keeps water from being siphoned back into system) and insulation (keeps from freezing). Missing escutcheon plates on all hose

bibs.

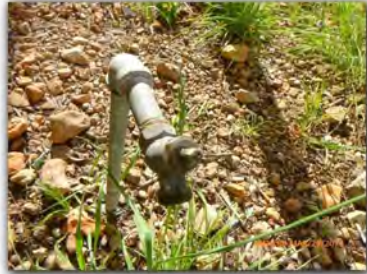
Handle on back side is broke.

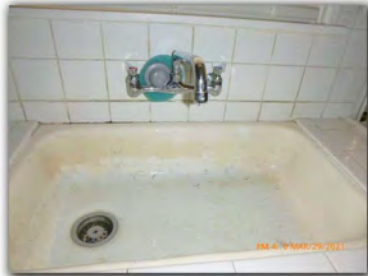
Kitchen faucet drips constantly.

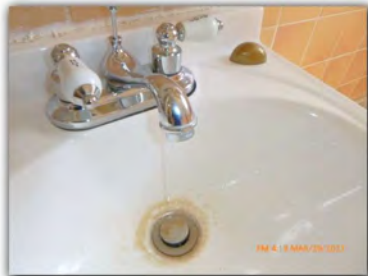
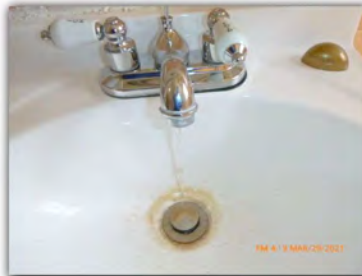
Very low pressure at vanity faucet.

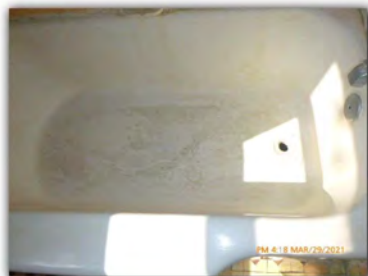
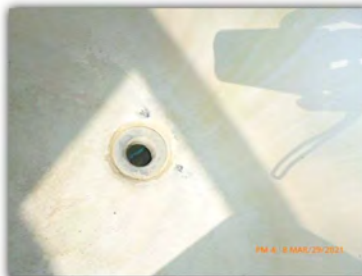
Tub in poor condition, missing drain guard.

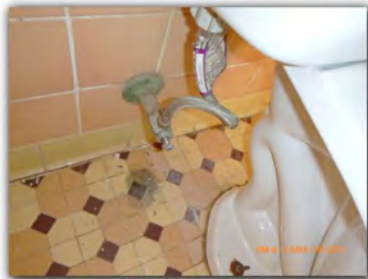
Control valve for commode is missing handle.

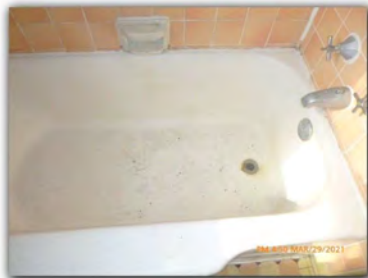
Tub in poor condition, missing drain guard.

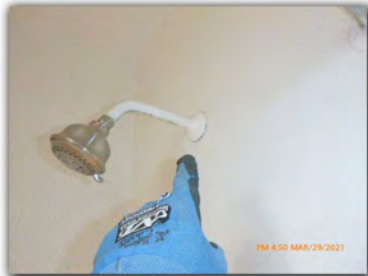
Loose shower head at unit #3 shower.

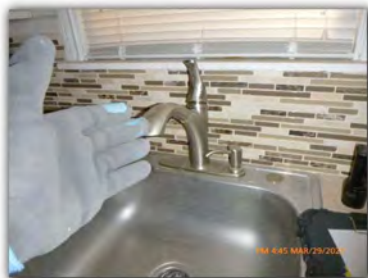
No water at kitchen sink, valves were turned on.

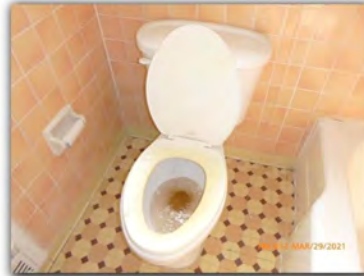
Very weak flush at commode.

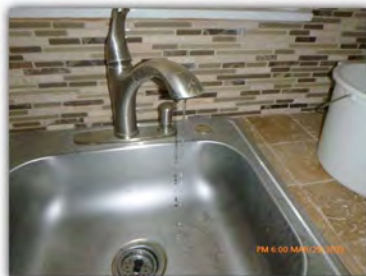
Very low pressure at valves in kitchen.

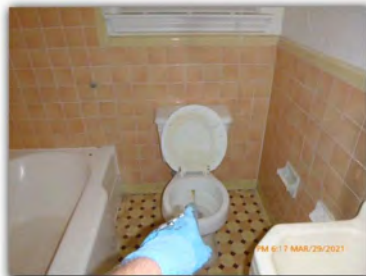
Commode runs on and needs repair.

Suggest replacing all commodes.

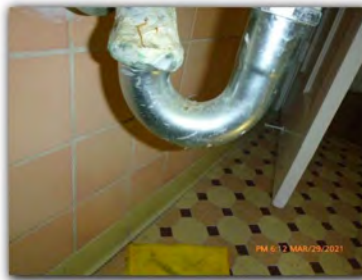
Leak at vanity sink.

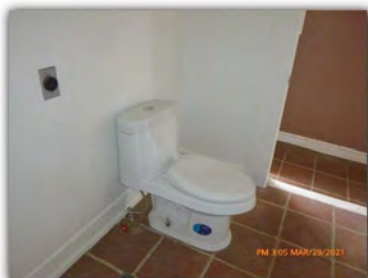
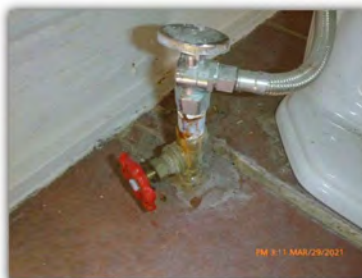
Commode does not flush and should be replaced. Supply valve to commode leaks.

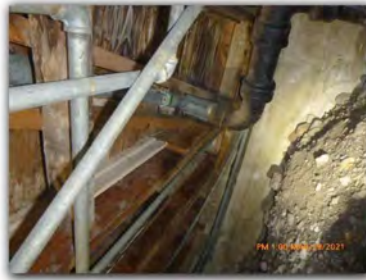
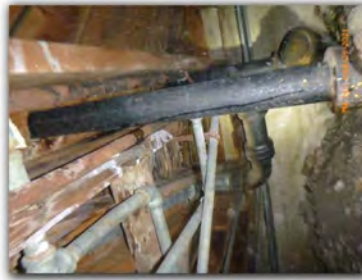
Under #2:

Located leaks under unit #1 & unit #2 bathrooms.

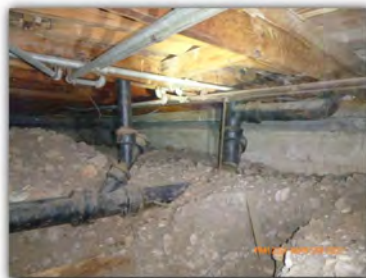
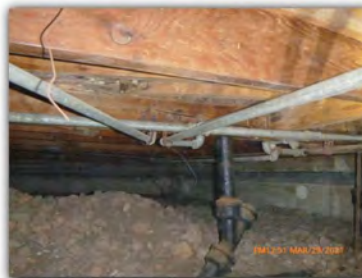
For the most part, the waste piping is older. It may be prone to unexpected problems (can not see condition of pipes under ground). Improvements are recommended on an as needed basis, for this reason a static drain system test highly recommended to determine the presence and or lack of hidden and or buried leaks.

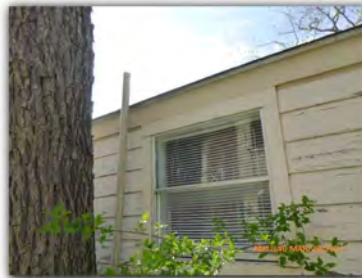
Exposed sewer lines present at detached back unit, (vent pipe should be inside wall).

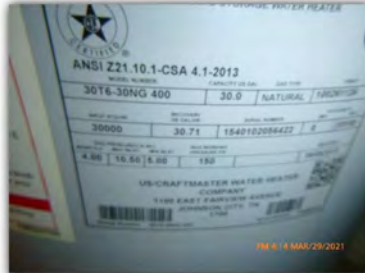
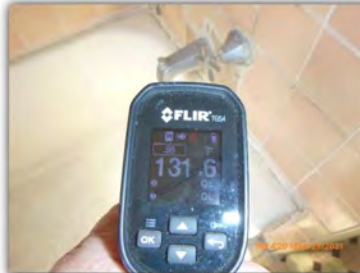
Capacity: 30 Gallons Unit#1

Comments: Expansion tank & vacuum breaker are not present

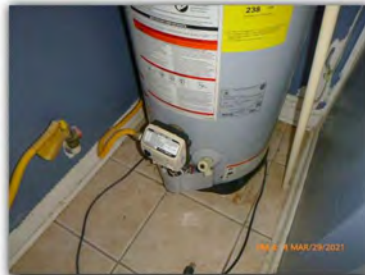
Safety pan is not present under water heater, Safety pans with drain line to exterior are recommended because they protect interior walls and flooring from possible water damage in the event that leakage occurs.

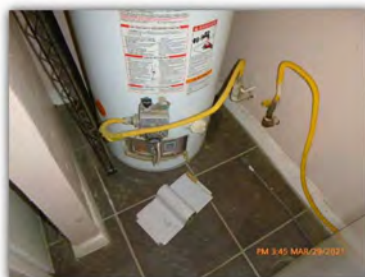
Safety pan is not present under water heater, Safety pans with drain line to exterior are recommended because they protect interior walls and flooring from possible water damage in the event that leakage occurs.

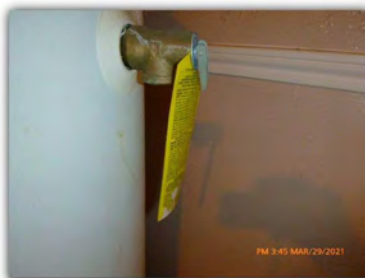
TPV drain line should run to exterior side of wall of structure 6" from soil (currently not connected)

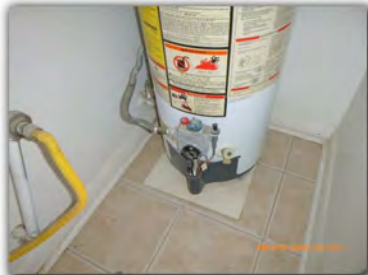
Safety pan is not present under water heater, Safety pans with drain line to exterior are recommended because they protect interior walls and flooring from possible water damage in the event that leakage occurs.

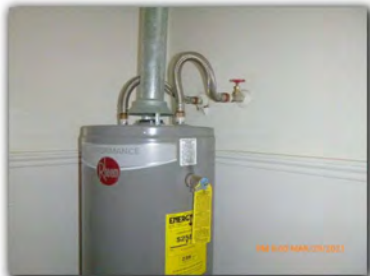
Capacity: 29 Gallons Unit#4

Comments: Expansion tank & vacuum breaker are not present

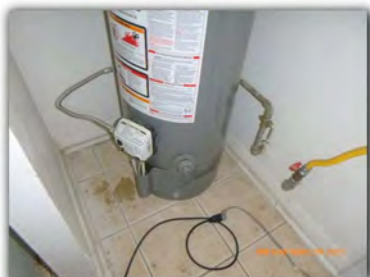
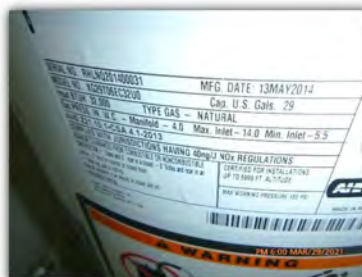
No hot water (unit turned down low).

Safety pan is not present under water heater, Safety pans with drain line to exterior are recommended because they protect interior walls and flooring from possible water damage in the event that leakage occurs.

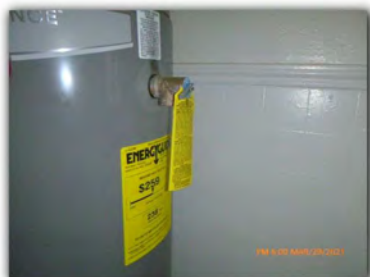
TPV drain line should run to exterior side of wall of structure 6" from soil (currently not connected)

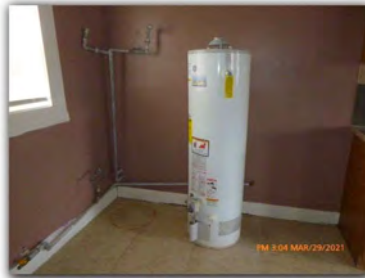
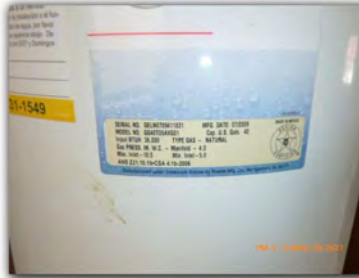
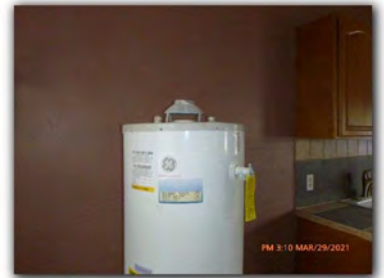
Capacity: 40 Gallons Unit#5

Comments: Expansion tank & vacuum breaker are not present

Safety pan is not present under water heater, Safety pans with drain line to exterior are recommended because they protect interior walls and flooring from possible water damage in the event that leakage occurs.

TPV drain line should run to exterior side of wall of structure 6" from soil (currently not connected).

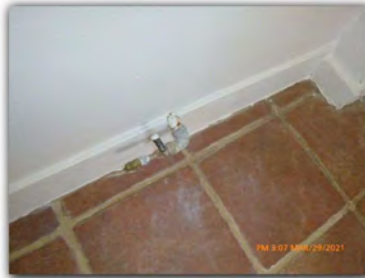
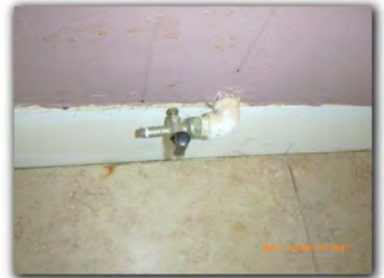
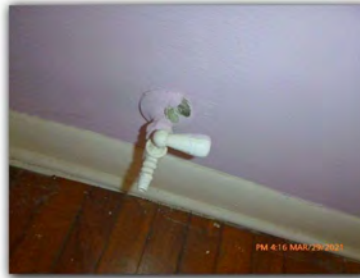
All unused gas valves should be capped off.

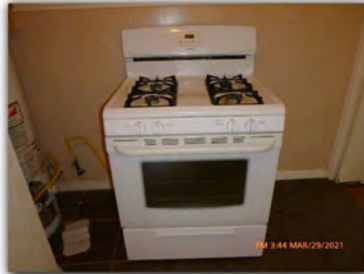
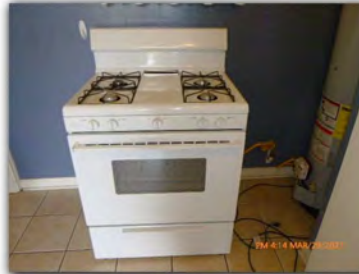
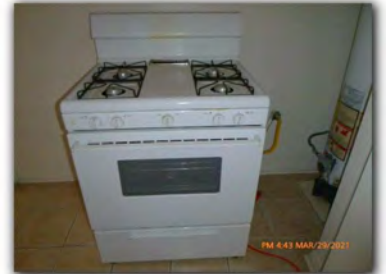
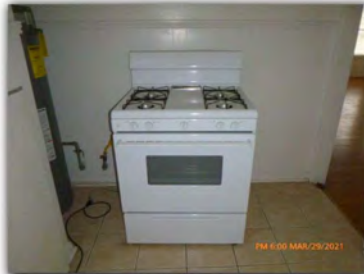
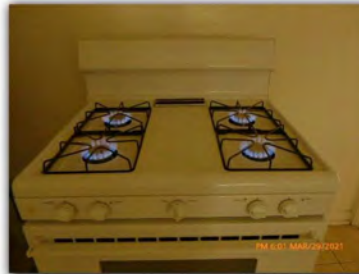
Anti-tip device was not present and should be added for safety reasons.

Anti-tip devices are not present (this keeps stove from tilting forward) and should be added for reasons of safety.
